Restoring severely discoloured anterior teeth using minimally invasive procedures

Daniel Edelhoff¹ and Oliver Brix²

This article discusses the rehabilitation of two upper central incisors by placing fibre-reinforced composite posts, using build-up materials and subsequently restoring the teeth with 360° veneers made from lithium disilicate ceramic (LS₂).

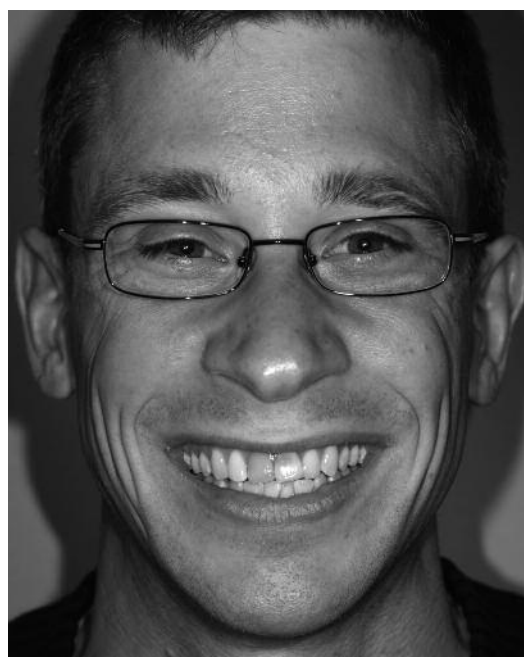
A 28-year-old male patient came to the practice and expressed the wish to have his endodontically treated and severely discoloured upper central incisors restored. He said that he had not experienced any problems since the resection of the root some years previously; however, he was dissatisfied with the impaired esthetic appearance caused by the affected teeth (Figures 1 to 3).

Figure 1: The pronounced discolouration and the inadequate tooth position of the upper central incisors impaired the esthetic appearance.

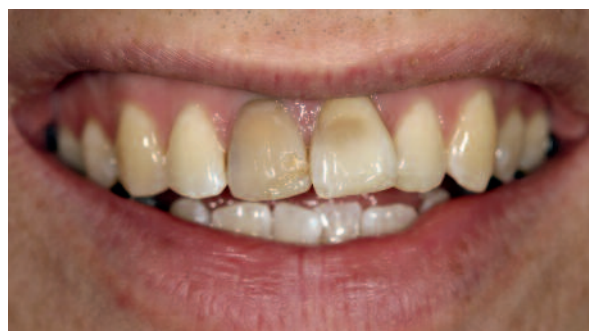
Figure 2: The severe discolouration of tooth 11 also caused a discolouration of the marginal gingival area.

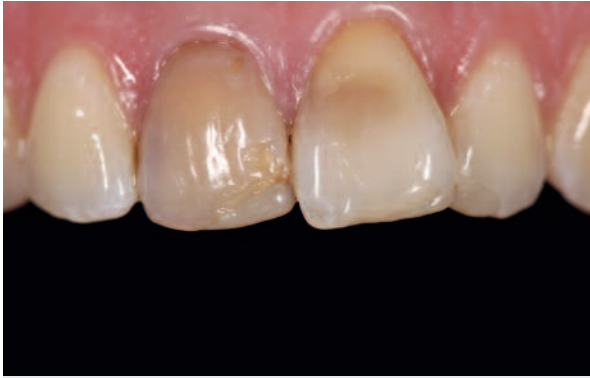
Figure 3: The asymmetrical tooth axes of the central incisors are clearly visible.

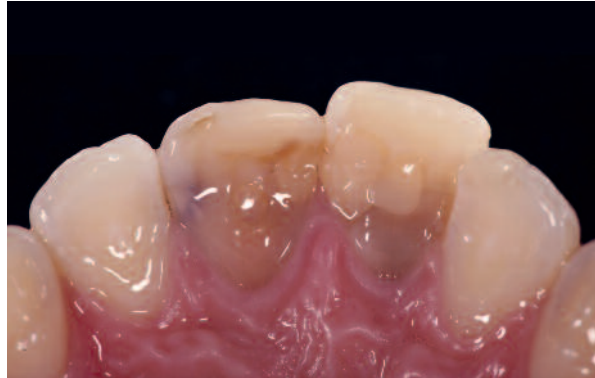
Figure 4: Leaking composite restorations and secondary caries in the endodontically treated teeth 11 and 21.

The clinical and radiological evaluations revealed tight and properly executed root canal obturations in teeth 11 and 21. There were no signs indicating the presence of root canal posts, but the extensive composite restorations in both teeth were leaking and showed secondary caries (Figure 4). At the time of the clinical evaluation, the restorations were already five years old. The specific challenges facing the treatment team was the patient's wish to have the esthetic appearance of his teeth restored in a timely fashion. The patient required that his natural tooth shade and position be restored and, to the extent possible, that the remaining tooth structure be stabilized in the long term.

Before we proceeded to planning the permanent restoration, the inadequate fillings of the anterior teeth as well as the secondary caries were removed. This allowed us to assess the extent to which the teeth had been damaged. In addition, a possible contamination of the two root canals with microorganisms – resulting from the inadequate fillings which had been in place for years – had to be ruled out.
