Restoring severely discoloured anterior teeth using minimally invasive procedures

Daniel Edelhoff¹ and Oliver Brix²

This article discusses the rehabilitation of two upper central incisors by placing fibre-reinforced composite posts, using build-up materials and subsequently restoring the teeth with 360° veneers made from lithium disilicate ceramic (LS₂).

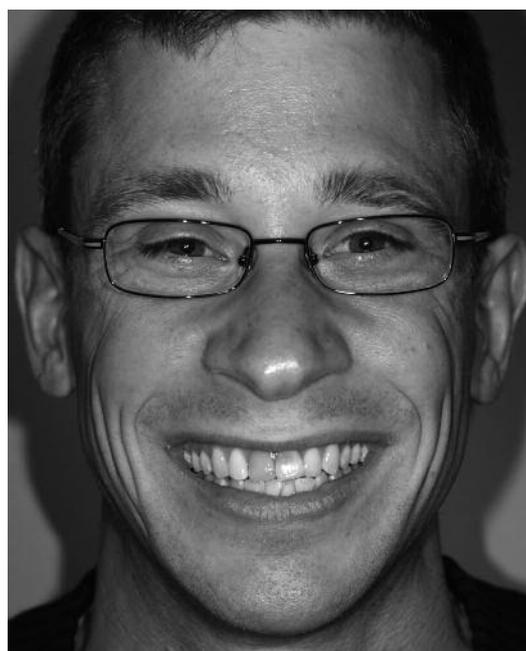
A 28-year-old male patient came to the practice and expressed the wish to have his endodontically treated and severely discoloured upper central incisors restored. He said that he had not experienced any problems since the resection of the root some years previously; however, he was dissatisfied with the impaired esthetic appearance caused by the affected teeth (Figures 1 to 3).

Figure 1: The pronounced discolouration and the inadequate tooth position of the upper central incisors impaired the esthetic appearance.

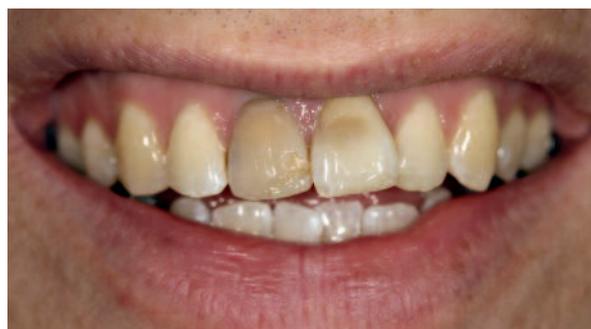
Figure 2: The severe discolouration of tooth 11 also caused a discolouration of the marginal gingival area.

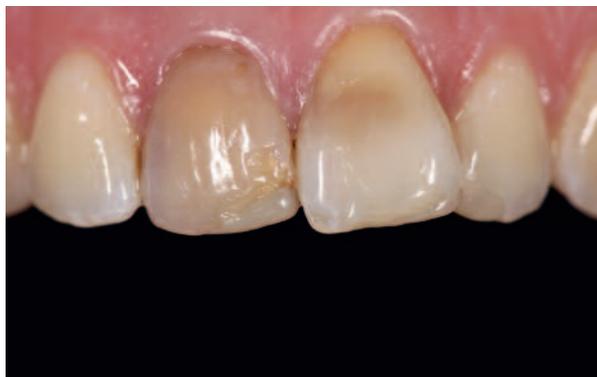
Figure 3: The asymmetrical tooth axes of the central incisors are clearly visible.

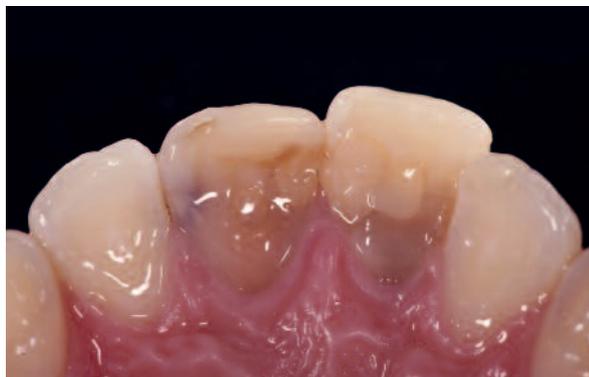
Figure 4: Leaking composite restorations and secondary caries in the endodontically treated teeth 11 and 21.

The clinical and radiological evaluations revealed tight and properly executed root canal obturations in teeth 11 and 21. There were no signs indicating the presence of root canal posts, but the extensive composite restorations in both teeth were leaking and showed secondary caries (Figure 4). At the time of the clinical evaluation, the restorations were already five years old. The specific challenges facing the treatment team was the patient's wish to have the esthetic appearance of his teeth restored in a timely fashion. The patient required that his natural tooth shade and position be restored and, to the extent possible, that the remaining tooth structure be stabilized in the long term.

Before we proceeded to planning the permanent restoration, the inadequate fillings of the anterior teeth as well as the secondary caries were removed. This allowed us to assess the extent to which the teeth had been damaged. In addition, a possible contamination of the two root canals with microorganisms – resulting from the inadequate fillings which had been in place for years – had to be ruled out.

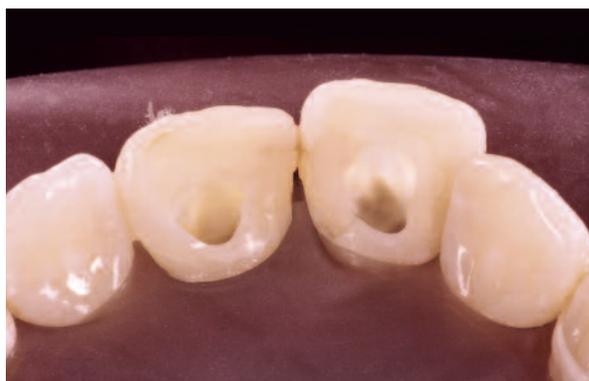
Figure 5: The root canal fillings were checked prior to the internal bleaching procedure, and the cemento-enamel junction was additionally sealed. The cavities were now ready for the application of the bleaching agent.

After the coronal pulp chamber of the two incisors had been cleaned, an additional seal was placed at the cemento-enamel junction using a small amount of phosphate cement. This measure ensured that the

bleaching agent which would be applied later did not diffuse into these sensitive areas (Figure 5). For the internal bleaching, a mixture of sodium perborate powder and distilled water was applied using the walking bleach method. The palatal access to the coronal pulp chamber was sealed with cotton pellets soaked in bonding agent (Heliobond) and a low-viscosity composite (Tetric EvoFlow®). The next appointment was scheduled one week later. The desired tooth shade had not yet been achieved, and therefore fresh bleaching agent was applied. After another week with the bleaching agent in place, a satisfactory brightness value was observed on both abutment teeth (Figure 6). A calcium hydroxide preparation (CalciPure®) was inserted into the pulp chamber and left in place for a week in order to neutralize the bleaching agent.

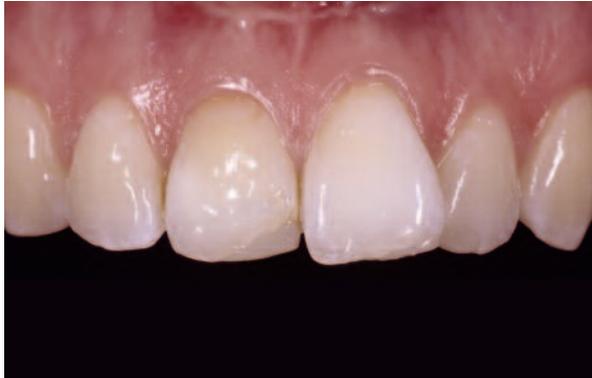
Figure 6: Two weeks later: The severe discolourations were almost entirely removed by the internal bleaching treatment.

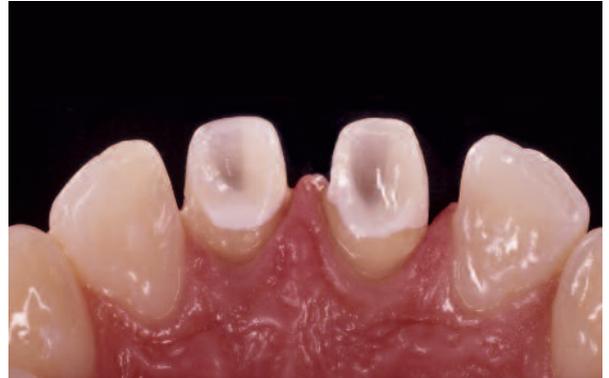
Figure 7: The built-up and prepared incisors. Given the severe degree of destruction, adhesively cemented fibre-reinforced composite posts combined with mouldable composite materials were used.

After the neutralization phase, we proceeded to the post-endodontic build-up of the abutment teeth. For this purpose, the coronal sealing of the root canal fillings was removed and standardized holes for the fibre-reinforced composite posts (FRC posts) were drilled. The posts were luted with Variolink® II (dual-curing, low viscosity, shade: white-opaque) and a multi-step adhesive (Syntac®). After the posts had been covered with a low-viscosity composite (Tetric EvoFlow), a bright, highly filled viscous composite (Tetric EvoCeram®, Bleach XL) was applied to create the direct build-up (Figure 7). A high-power curing light (bluephase® G2 with > 1,000 mW/cm²) was used for the final polymerization of the cementation and buildup materials. A diagnostic pattern was employed for the minimally invasive preparation. This template was fabricated on the basis of the wax-up and contained all information relating to the correction of the tooth position and the outer contour of the final restoration.

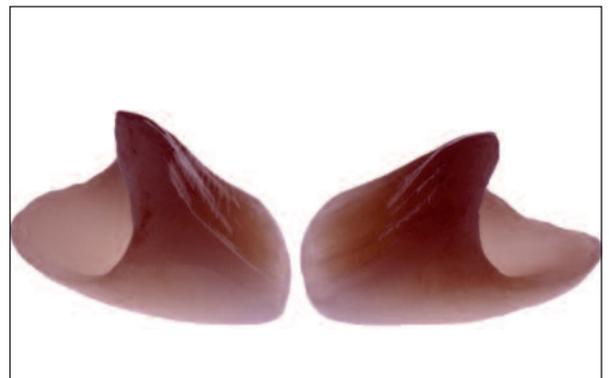
Figure 8: Lithium disilicate-based 360° veneers made of IPS e.max Press. In order to better mask the dental structure with a minimum layer thickness, an MO ingot was selected.

laboratory to assess the required degree of opacity for the framework structure. Given the different levels of translucency, the different buildups of the abutment teeth and to ensure an improved masking capability in case of a relapse of the discolouration, the treatment team chose to use press ceramic ingots with a medium opacity level in shade 0 (MO 0). The IPS e.max® Press frameworks were veneered with the IPS e.max® Ceram veneering ceramic in the shade A2 (Figure 8).

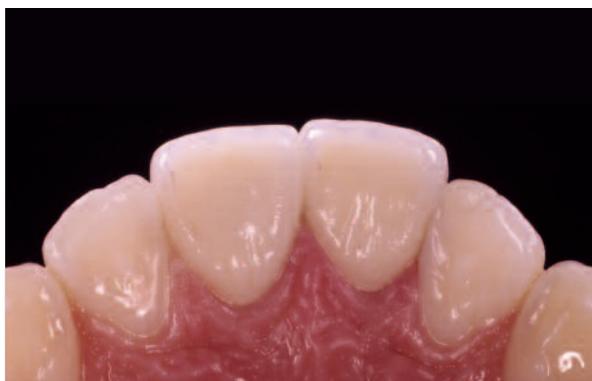
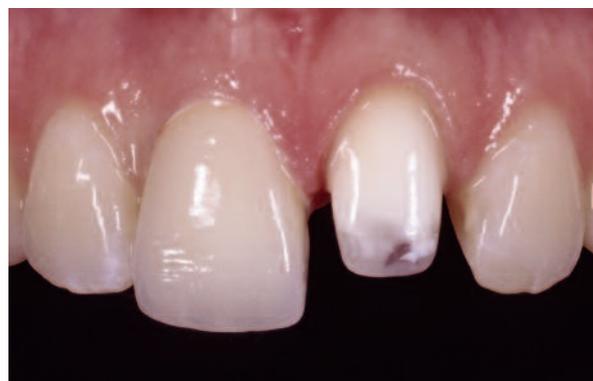
Figure 9: The optimum masking of the extensively built-up abutment teeth achieved by an MO ingot coping and a try-in paste in the shade white-opaque became evident already during the try-in of the veneers.

Figure 10: Frontal view of the veneers during try-in. The use of lithium disilicate as the basis of the restoration ensured a homogeneous appearance regardless of the substructure.

shape and shade of the veneers in the patient's mouth, the restorations were tried in with a shaded glycerine gel (Try-in Paste, Variolink II, white-opaque). A perfect masking of the abutment teeth was already achieved at this stage and the resulting situation showed a harmonious appearance regardless of the substructure (Figures 9 and 10).

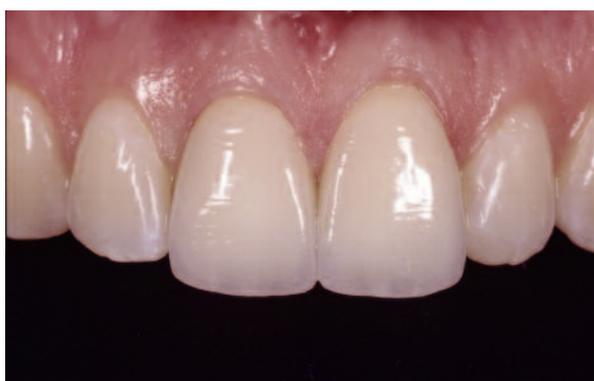
Figure 11: The 360° veneers were seated with the luting cement that corresponded to the try-in paste used; a multi-step dentin adhesive system was used. Thus, an excellent esthetic outcome could be achieved reliably and predictably.

The inner aspects of the glass-ceramic veneers were etched with a hydrofluoric acid gel (< 5% IPS® Ceramic Etching Gel) for 20 seconds. Subsequently, a bonding agent (Monobond Plus) was applied. Only the multi-step dentin adhesive system Syntac was applied to the tooth. The restorations were luted into place with the Variolink II system (white-opaque) (Figure 11).

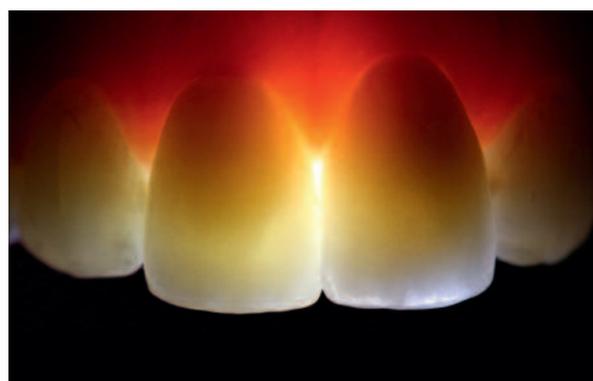
Figure 12: The restorations in transmitted light. By combining translucent build-up materials and glass-ceramic veneers, a light transmission that matches the properties of natural teeth was achieved.

A light transmission which corresponds to that displayed by natural teeth was achieved by using translucent build-up materials in conjunction with glass-ceramic lithium disilicate veneers (Figure 12). The final outcome with regard to functional and esthetic parameters was found to be very satisfactory at the final evaluation. The tooth shade was in perfect harmony with the surrounding dentition. In addition to removing the severe discolouration of the hard and soft tissues, we were able to correct the tooth position and adjust the tooth proportions (Figure 13). The patient was fully satisfied with the esthetically pleasing outcome and did not experience any phonetic problems resulting from the correction of the tooth position (Figure 14).

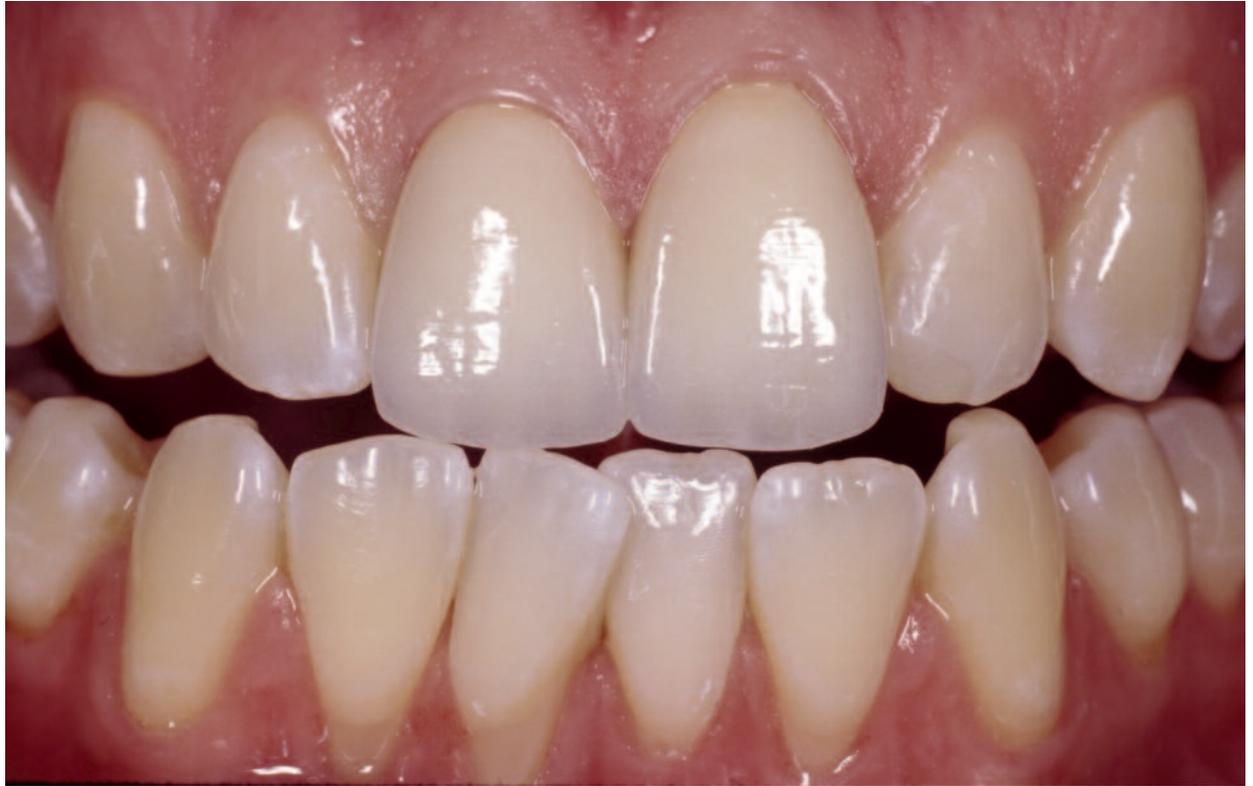
Figure 13: Postoperative view with mandible in protrusion. The final check of the functional and esthetic parameters was satisfactory. The tooth shade excellently matched the adjacent teeth.

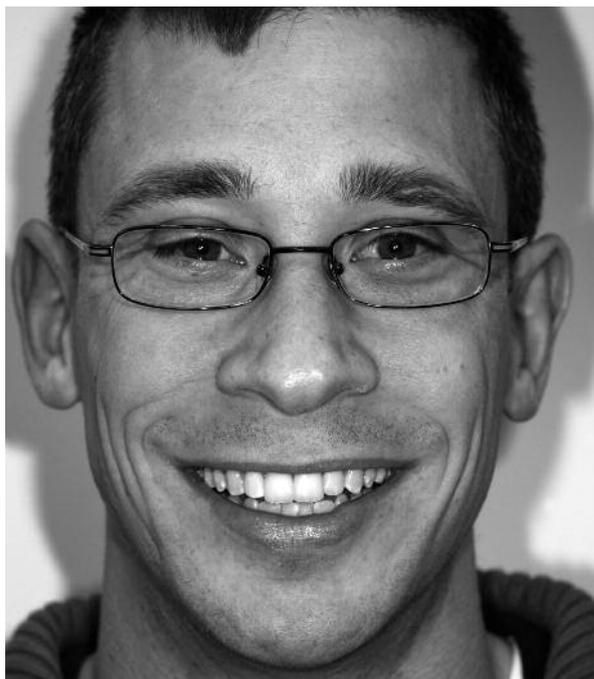
Figure 14: Portrait image of the final outcome: The discolourations were removed, the tooth position corrected and the tooth proportions adjusted (for comparison, see Figures 1 and 2).
