# Consecutive treatment failures of an immediate maxillary canine implant and the subsequent replacement and reconstruction of the site

Howard Gluckman,<sup>1</sup> Jonathan Du Toit<sup>2</sup>

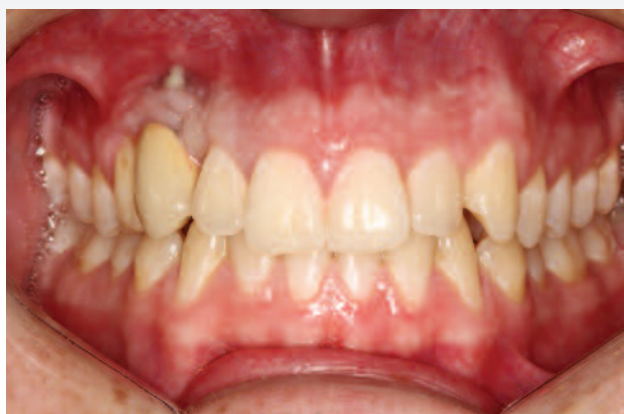
Figure 1: The preoperative presentation.

a period of healing. Subsequent to the chronic draining sinus buccal to the implant, the patient was advised by his general dentist to seek a third opinion. Clinical examination of the patient noted a screw-retained, implant-supported crown at site 13. Circumferential probing of the implant exceeded 15 mm, with bleeding upon probing, and exudate draining from a sinus midfacial at the implant site (Figs. 1, 2).

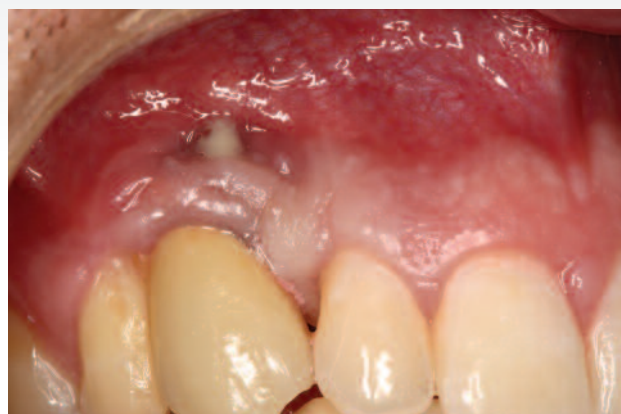
Figure 2: A draining sinus was noted buccal to the implant crown at 13.

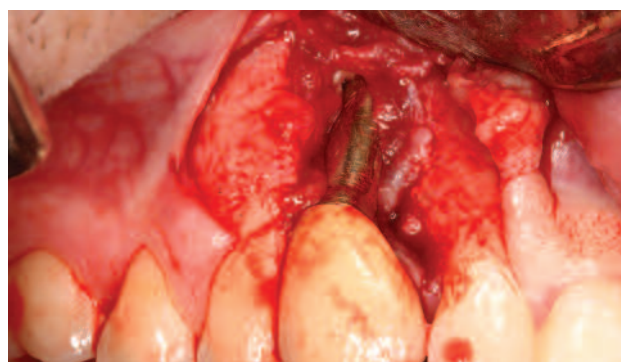
Figure 4: Full-thickness flap exposure of the site revealed an extensive buccofacial bony defect and soft tissue encapsulation of the implant abutment.

The site was anaesthetized and a full-thickness flap was raised over the implant at 13, exposing soft-tissue encapsulation of the abutment extending to the apices of the adjacent teeth (Fig. 4). The pathologic soft tissue was removed to send for histological examination, and the extent of the bony destruction at the area was exposed (Fig. 5). Bone appeared eroded at the surfaces proximal to the implant. The buccal bone had a large defect yet the palatal bone remained coronal. The prosthesis and restoration were torqued and fractured from the implant and thereafter the implant torqued out (Figs. 6-8). The root fragment was also located and removed, the area meticulously debrided and

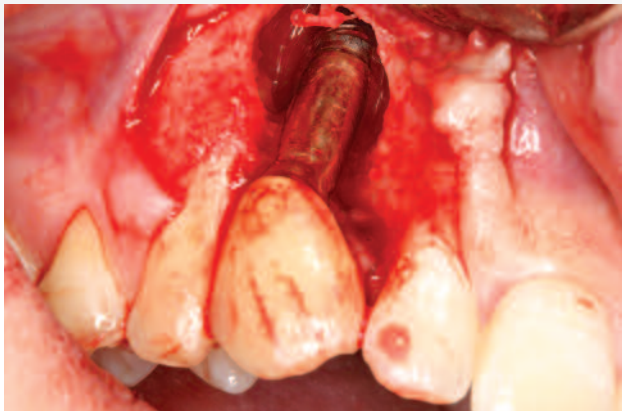
Figure 5: Removal of the pathological soft tissue revealed the extent of the bony destruction.

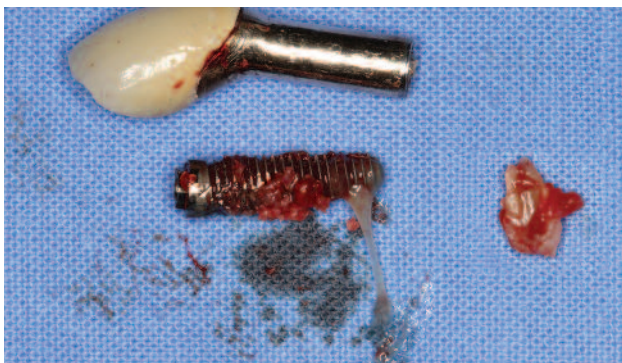
Figure 7: The infective tissue at the implant and root remnant.

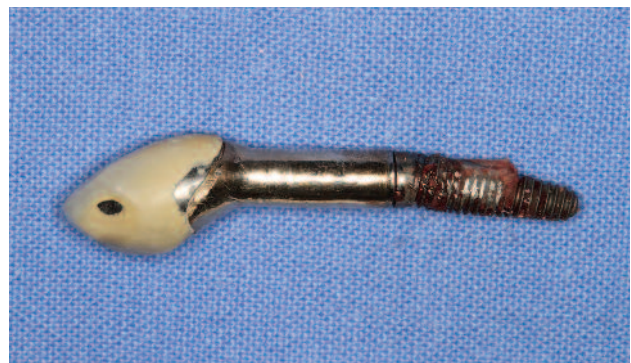
Figure 8: After removal, the restoration and abutment to implant ratio could be appreciated.

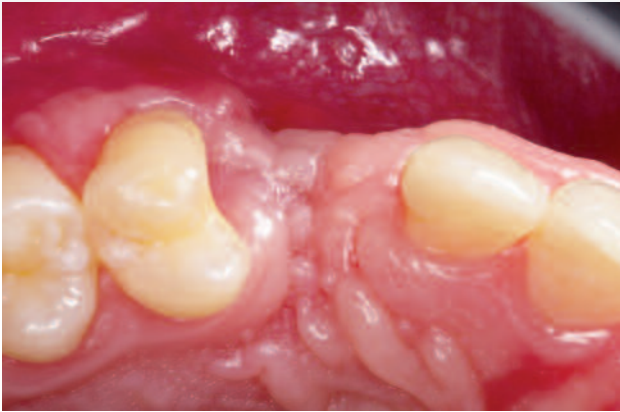
After 8 weeks of healing the edentulous site was re-approached and treatment planned from start. This included among many others a thorough clinical exam, periodontal examination, a holistic documentation of all pathologies and treatment needs, concise photographic documentation, study casts, restorative mock-up, and special investigative adjuncts including CBCT. The diagnostic list for the patient included a Class I malocclusion, recession defects, a mild fluorosis, and a missing 13. Diagnosing the healed, edentulous site at 13 noted a significant ridge defect, both horizontal and vertical, with a deficit of both hard and soft tissues. The soft tissue already showed significant scarring, recession distal to 12, and severe recession mesial to 14 with complete loss of the papillae (Figs. 9, 10). There was insufficient attached, keratinized tissue at the 14 with a Class IV recession defect.

Figure 9: After initial healing of the site. Note the mesial of tooth 14 that was cut away. And the horizontal defect, as well as the extensive scarring is evident.

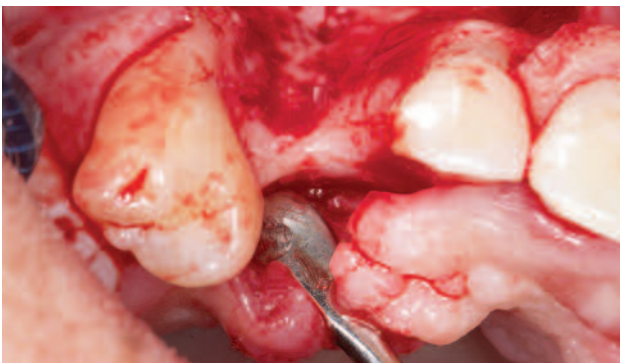
Figure 11: Re-entry at the site illustrated the extent of the horizontal defect.

anaesthesia a full-thickness flap was again raised at the site and the implant osteotomy was prepared via a restorative-planned surgical guide (Figs. 11, 12). A morse-taper, conical internal connection implant, 3.5 x 10 mm (NobelActive, Nobel Biocare) was inserted at the correct restoratively planned level, 2 mm below the palatal crest

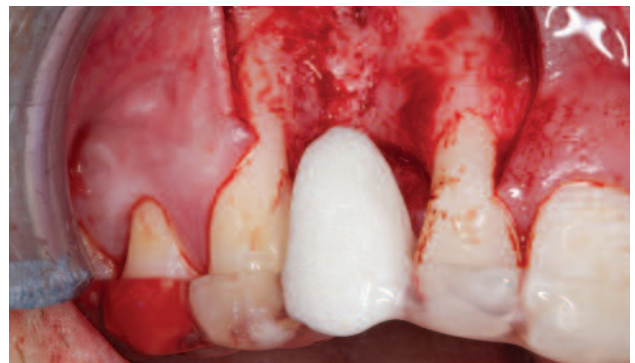
Figure 12: The radiographic-surgical guide in position and zenith of the pontic at the correct height. A severe vertical ridge deficit is not evident.

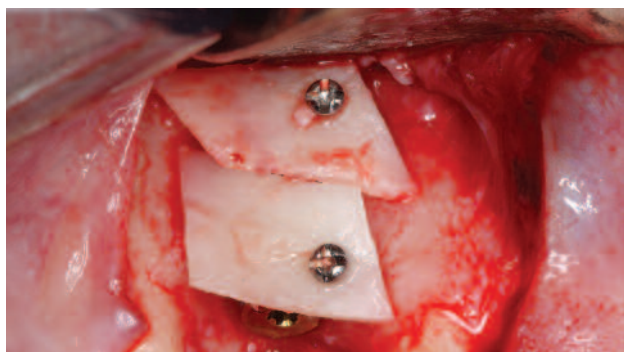
Figure 19: Buccal view of the bone blocks fixed in place.

with fixation screws, and the bone shavings packed within the defect between the implant and blocks (Figs. 18-20). PRF membranes were layered over the bone augmentation and the tension-free flap repositioned and sutured with 6/0 nylon (Figs. 21, 22). The site was then restored with a provisional partial denture free of pressure to the underlying augmentation site.

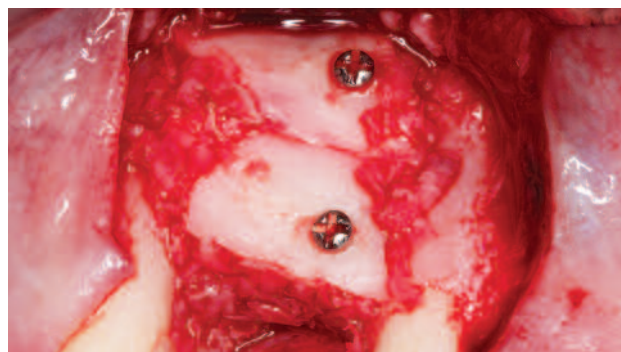
Figure 20: The harvested autogenous bone shavings were packed beneath and around the blocks.

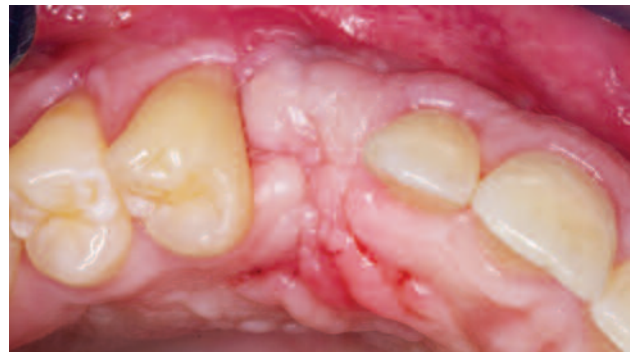
Figure 24: 12 weeks of healing.

After 12 weeks of healing the implant was exposed and its implant stability quotient (ISQ) checked – 78D 75M 75B

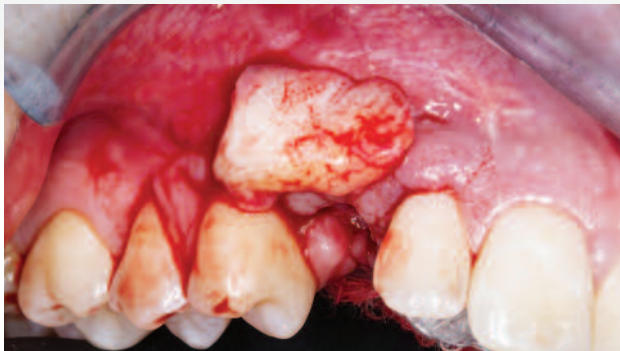
Figure 27: The connective tissue graft (CTG) harvested from the palate positioned over the recipient site.

(Fig. 23-26). The buccal soft tissue was undermined by a tunneling approach, creating a split-thickness envelope. A connective tissue graft (CTG) was harvested from the palate and transferred into the pouch, sutured in position, thereby augmenting the soft tissue buccal and coronal to the site (Figs. 26-28). The implant was then restored with a provisional restoration to begin developing the soft tissue profile. At 4 weeks of healing a black triangle was evident

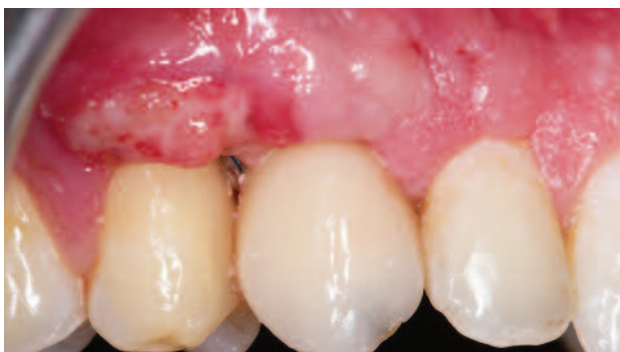
Figure 29: 10-day follow-up with the provisional restoration in place. The soft tissue augmentation healing without complication.

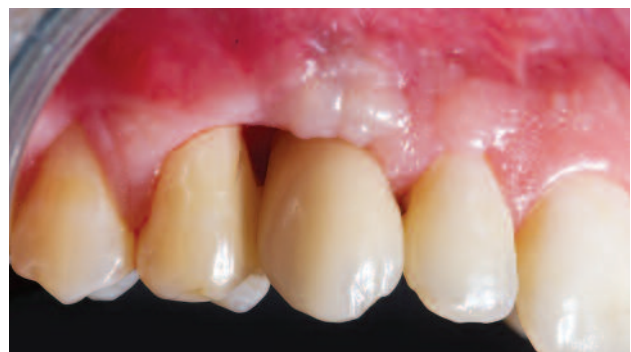
Figure 30: 4-week follow-up, soft tissues healed, provisional in place, yet the absence of a distal papilla is obvious.

where the distal papilla was absent. A further 8 weeks of healing allowed time for soft tissue in-fill of the area (Figs. 28-31).

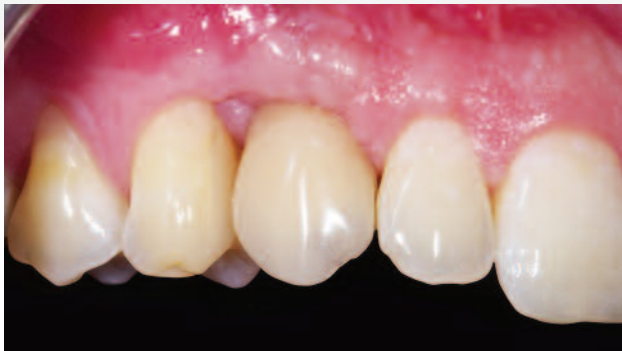
*Figure 31: A further 8 weeks allowed for soft tissue maturation and infill of the distal interproximal space.*

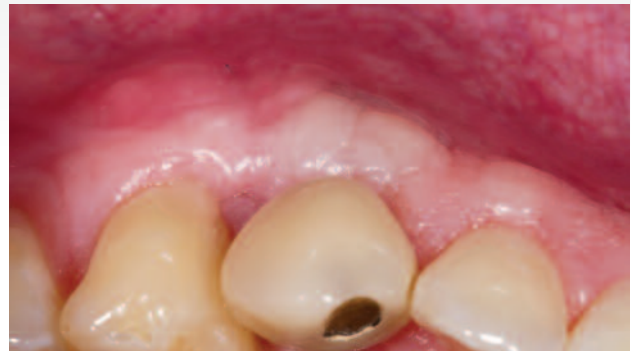
*Figure 32: The final screw-retained crown in place. Adequate bulk of tissue buccal to the implant restoration.*

At final restoration of the implant a bulk of ridge tissue buccal to the implant could be noted, with near complete restitution of both mesial and distal papillae (Fig. 32). Functional treatment goals were realized and adequate aesthetic rehabilitation of the previously failed treatment was achieved. The patient was satisfied, with the tissues and outcomes remaining stable at the 2-year recall (Fig. 32).

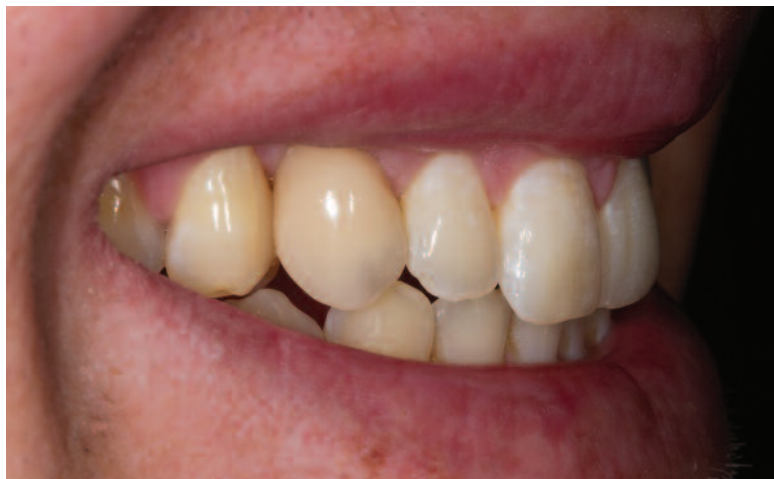
*Figure 33: 2-year follow-up, tissues stable with adequate aesthetic and functional results.*
