Ceramic materials and composites provide an esthetic solution

Seunghwan Chung¹ and Kyung-Sik Park²

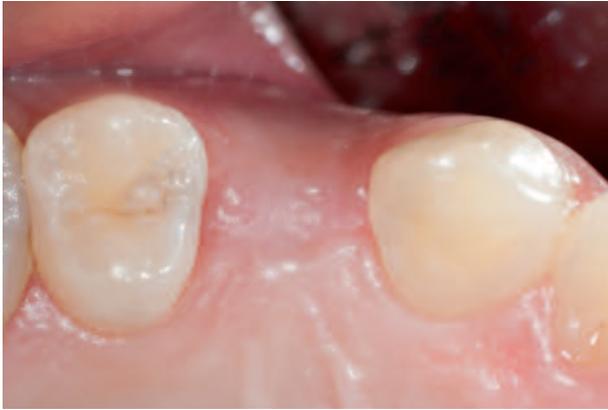
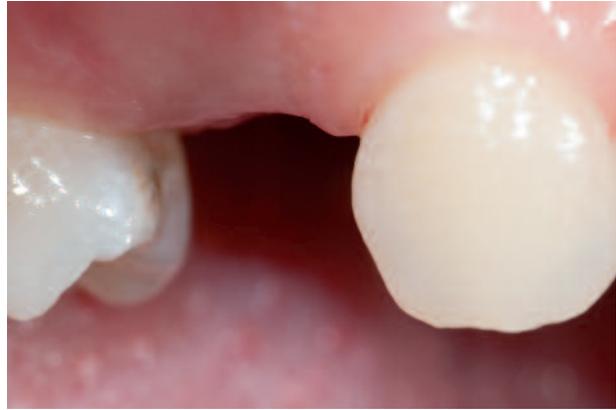
Figures 1 and 2: Starting situation: osseointegrated implant in the premolar region.

A 19-year-old female patient presented to our clinic in order for us to restore her osseointegrated implant at tooth 14 (Figs 1 and 2). After exposure of the implant, a mesial caries lesion was noticed in the adjacent premolar (Fig. 3). In a first treatment step, a local anaesthetic was administered, the caries removed and a clean cavity prepared. Subsequently, a rubber dam was placed in order to prevent any contamination of the working area with saliva during the restorative treatment (Fig. 4). Then, the cavity dimensions were measured using a probe. The maximum depth was 4mm – a perfect indication for Tetric N-Ceram Bulk Fill (Fig. 5), which would allow us to fill the cavity in only one layering step. Next, the matrix was placed and the cavity was

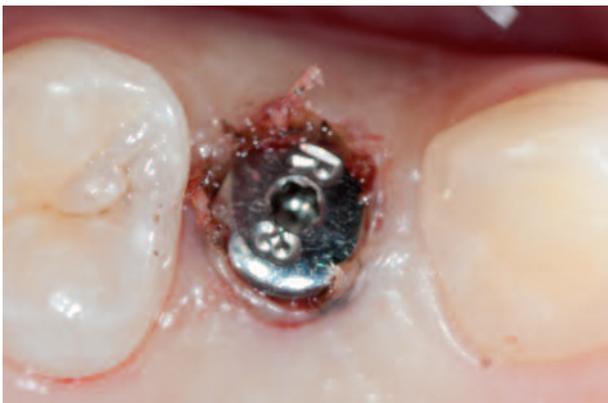
Figure 3: During exposure of the implant, a mesial caries lesion was noticed in the adjacent premolar.

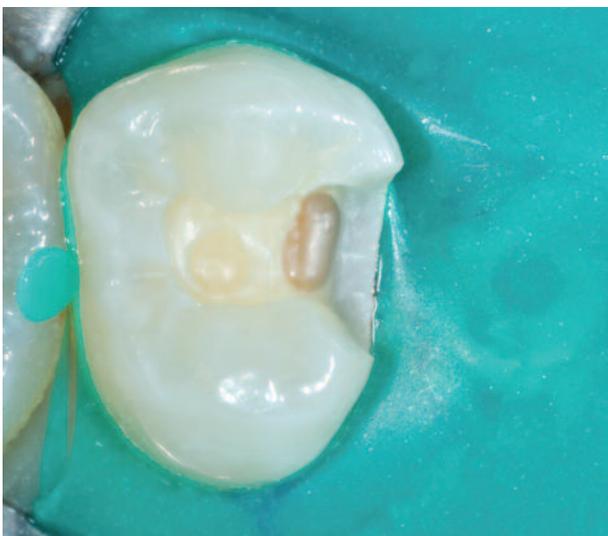
Figure 4: Caries in tooth 15 was removed and a rubber dam was placed in preparation for the restorative treatment.

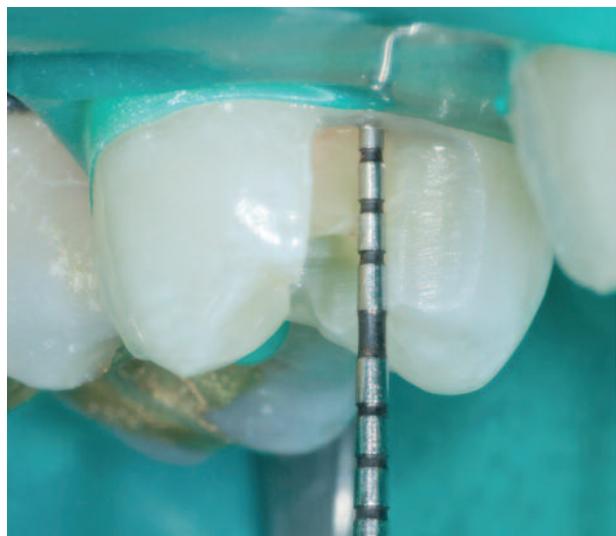
Figure 5: The measuring results produced with a periodontal probe showed a cavity depth of 4 mm.

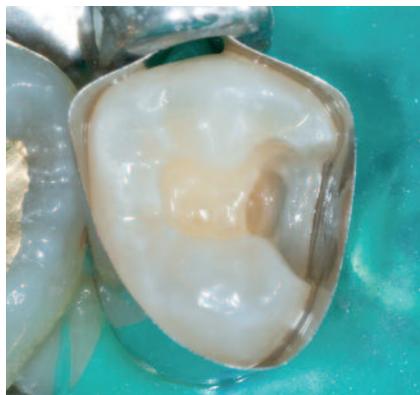
Figure 6: After the placement of a matrix band, the adhesive was applied.

prepared for the restorative procedure. Therefore, a primer (AdheSE®) was applied to the cavity, rubbed in for 15 seconds and allowed to react for another 15 seconds. Subsequently, the bonding agent was applied (Fig. 6), dispersed with a stream of air and cured with an LED polymerization device (Bluephase® 20i, LOW mode) for 10 seconds. Finally, the cavity was filled with the bulk fill composite (Tetric N-Ceram Bulk Fill, IVB) using only a single layer (Fig. 7).

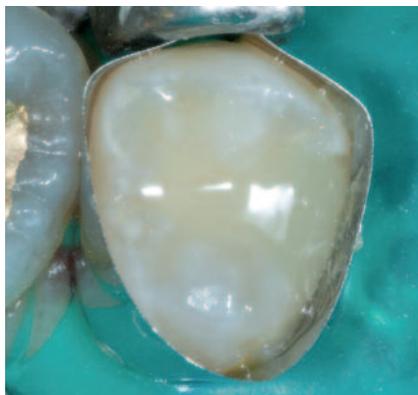
Figure 7: The cavity was filled with only one layer of bulk fill composite (Tetric N-Ceram Bulk Fill).

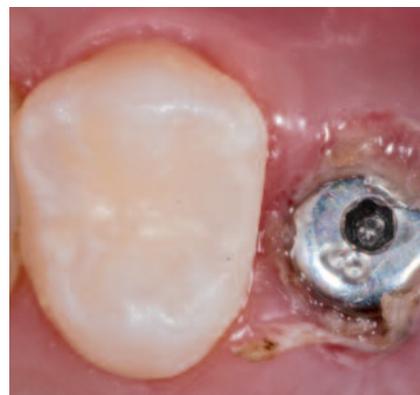
Figure 8: The completed composite restoration in tooth 15 (mesial).

After removal of the matrix, the composite was light-cured, finished and polished as usual (Fig. 8).

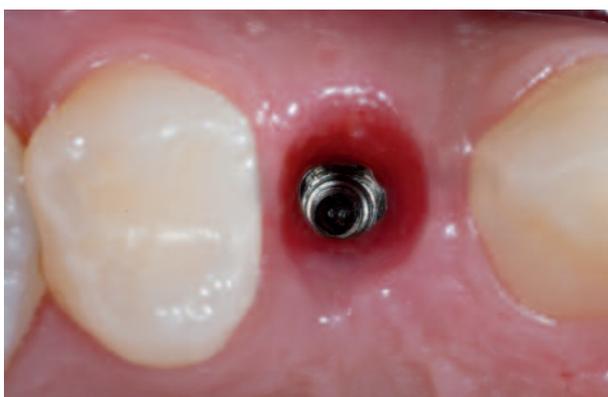
Figure 9: Two weeks after the implant exposure the time was ideal to take an impression of the situation.

In a next step, tooth 14 was prosthetically restored. Two weeks after the exposure of the implant, an impression of the dental situation was taken (Fig. 9). An individualized hybrid abutment was planned to provide the basis of the restoration. For this purpose, an abutment was modelled, pressed (IPS e.max® Press, HO) and then adhesively

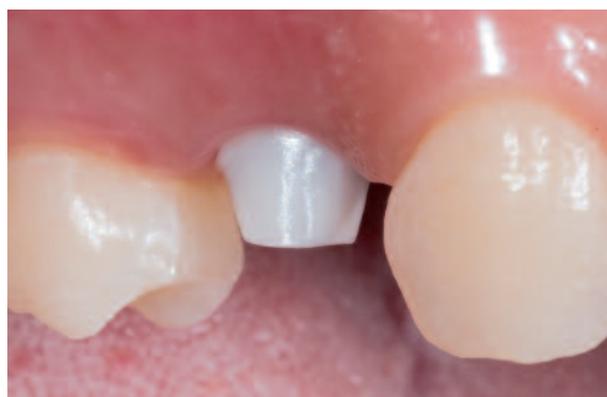
Figure 10: Try-in of the hybrid abutment.

cemented on a titanium base (Multilink® Implant). During the try-in of the abutment, the cervical margin and the emergence profile were examined (Fig. 10). As no additional adjustments were required, the crown was fabricated (IPS e.max CAD, LT A2) and characterized with stains (Fig. 11). In the permanent cementation of the crown on the abutment, retraction cords were used to minimize the occurrence of excess luting material in the gingival area and to easily and safely remove excess material after curing, if required (Figs 12 and 13).

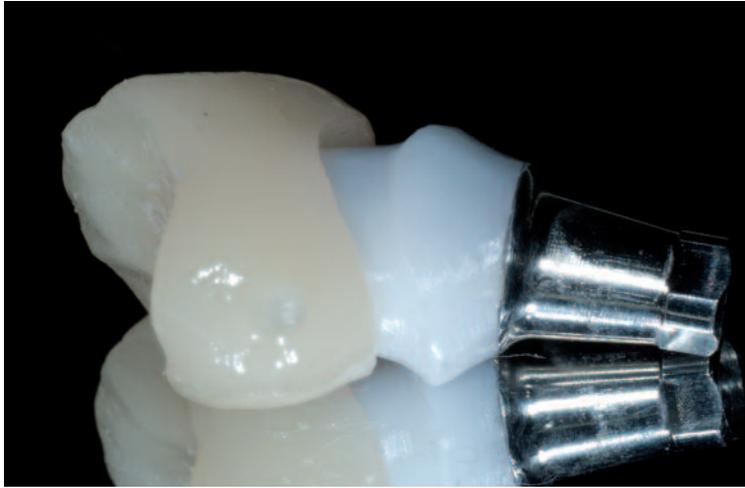
Figure 11: The abutment cemented on the titanium base and the completed crown (IPS e.max CAD).

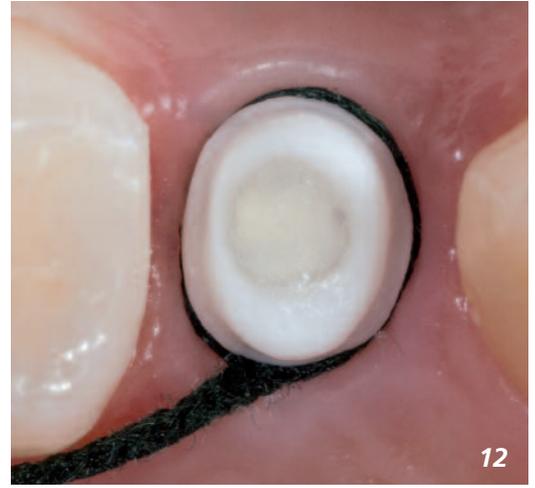
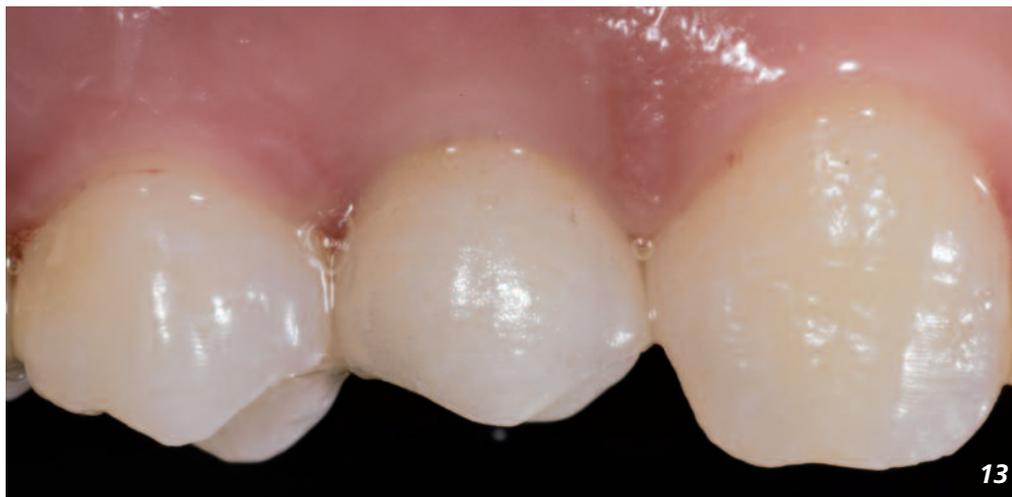
Figures 12 and 13: After the placement of the abutment, the all-ceramic crown was permanently luted in the oral cavity.

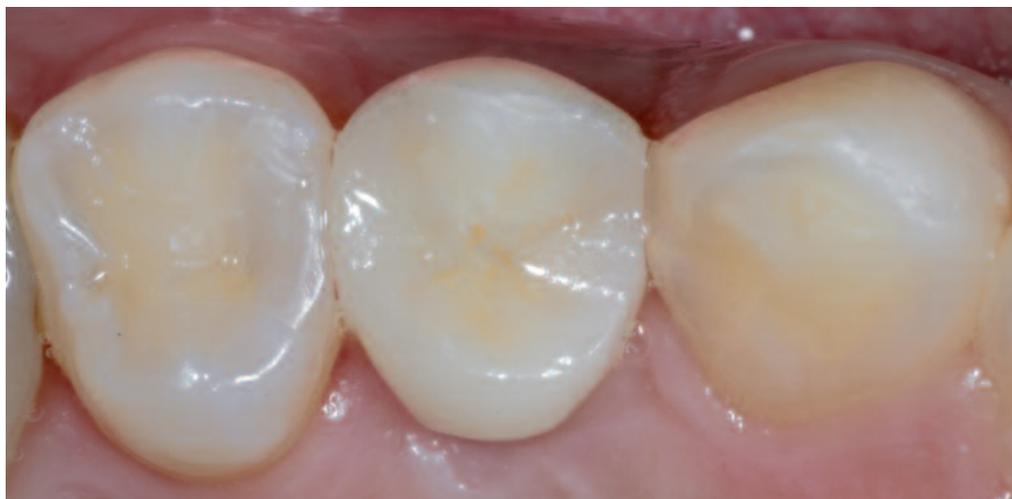
Figure 14: Occlusal view after the insertion of the crown.

CAD/CAM technology, renders the fabrication of restorations very efficient. Furthermore, individualized ceramic layering is no longer required for certain indications. In the presented case, the implant in the position of tooth 14 was restored with an all-ceramic restoration and premolar 15 was restored with a composite filling (Fig. 14). Although this indication does not

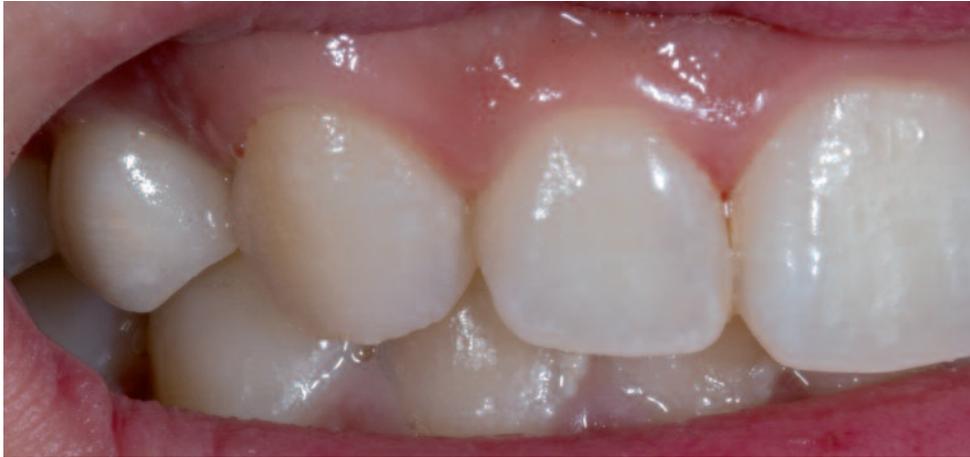
Figure 15: Labial view. The implant crown smoothly blends into the natural dentition. Similarly, the composite restoration is hardly visible with bare eyes.

seem to be as demanding as anterior restorations, patients nevertheless expect natural-looking results (Fig. 15). Therefore, both dentists and patients desire a simple and efficient procedure, which will produce esthetic results.
