## REPLACEMENT OF THE UPPER RIGHT CENTRAL INCISOR WITH A TAPERED EFFECT IMPLANT

MAKOTO SHIOTA AND KENJI MATSUURA

### Case Overview

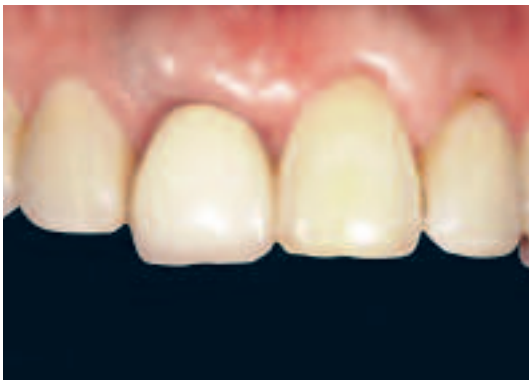
**Figure 1:** Right central incisor with horizontal and vertical fracture.

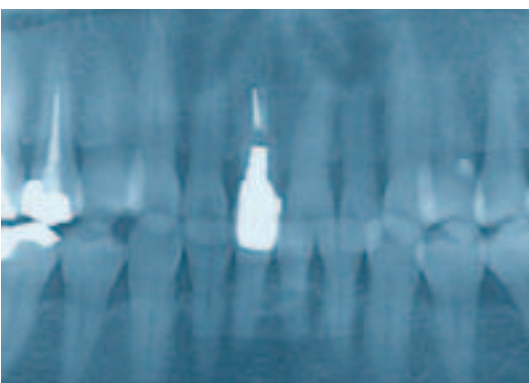
**Figure 2:** Orthopantomogram showing the situation before extraction of tooth 11.

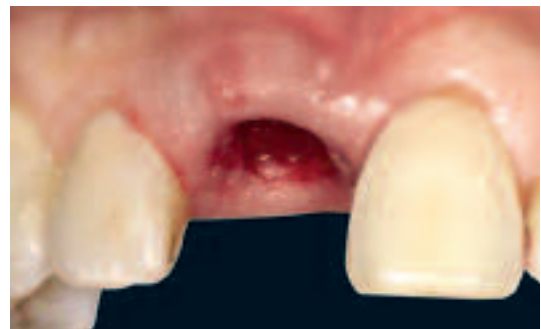
**Figure 3:** Situation after atraumatic extraction of tooth 11.

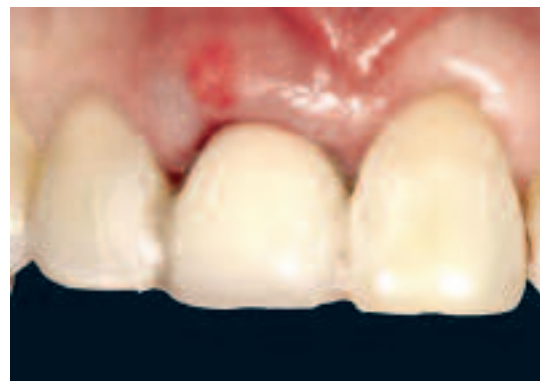
**Figure 4:** A provisional pontic (old PFM crown) was bonded to both neighbouring teeth immediately after extraction.

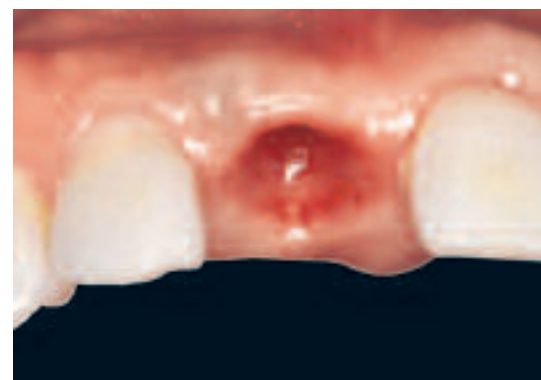
**Figure 5:** 6 weeks after extraction, the mucosal contours and adjacent periodontal tissues present well-maintained by the pontic, and the patient was scheduled for implant placement.

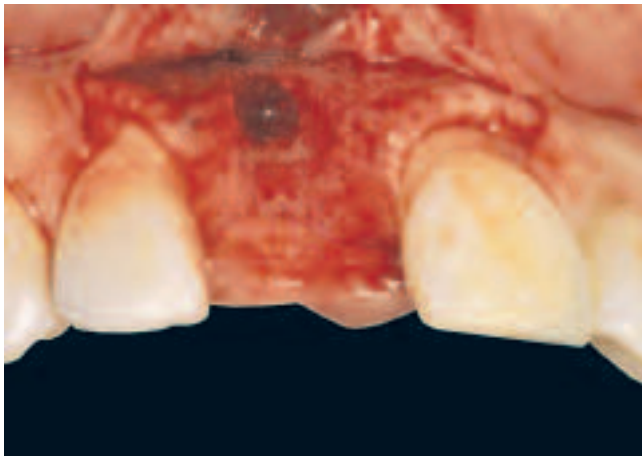
Figure 6: After elevation of a muco-periosteal flap, the remnants of the extraction socket are visible at the surgical site.

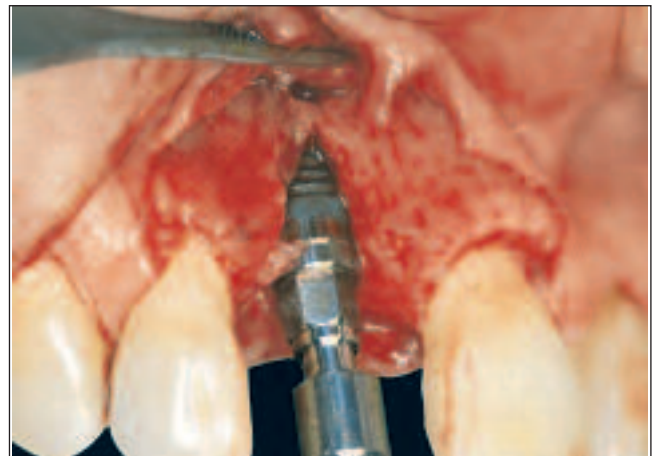
Figure 7: A Straumann Tapered Effect implant (TE, Ø 3.3 mm, Regular Neck, length 12.0 mm) was selected and placed. Note the labial dehiscence defect exposing part of the labial implant surface.

A 56 year old healthy female patient, non-smoker, presented complaining about a loose upper right central incisor. The tooth had been endodontically treated and restored with a porcelainfused- to-metal (PFM) crown a dozen years ago. Tooth 11 (FDI) was highly mobile and notably displaced. Clinical and radiographic examination showed a root fracture. However, adequate bone volume for implantation was anticipated around the root, and the periodontal tissues of the adjacent teeth were healthy. In order to achieve an optimal esthetic result, delayed implant placement, minor GBR and immediate loading were planned. Immediately after extraction of tooth 11, the PFM crown was attached to both adjacent teeth to serve as a provisional pontic. 6 weeks after extraction, a Straumann Tapered Effect Implant was placed and a prefabricated provisional crown was installed. The SLA®

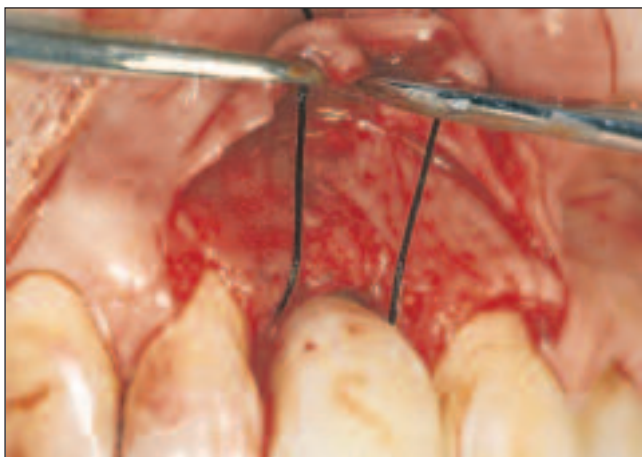
Figure 8: The implant was covered with autogenous bone chips and the provisional acrylic crown was screwed onto the implant. The provisional crown was taken out of occlusion.

surface exposed labially was covered with autogenous bone particles. The final crown was inserted 5 months after implant installation.

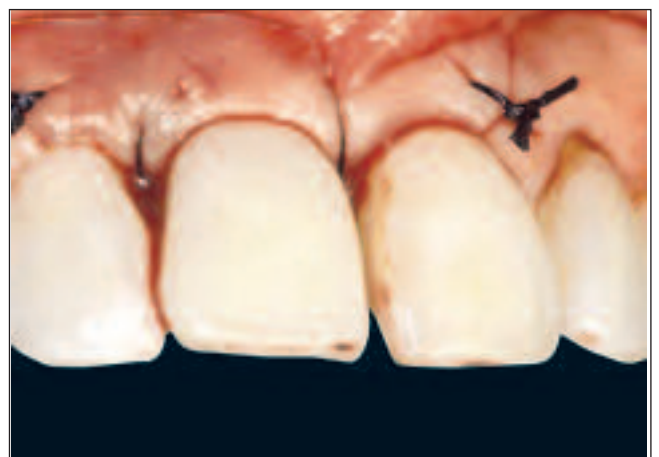
Figure 9: Wound closure was performed utilizing 4.0 suture material.

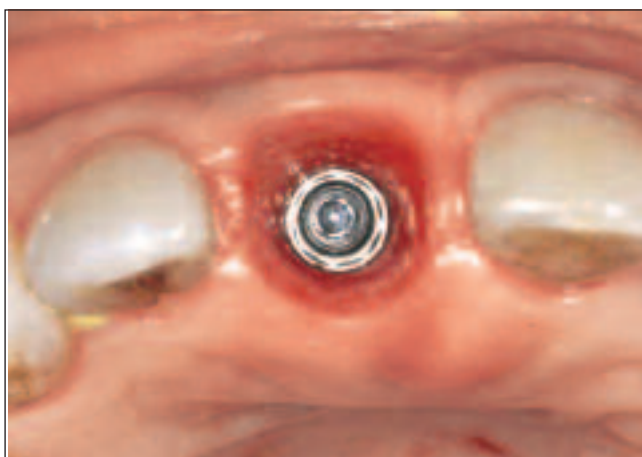
Figure 10: 3 months after implant placement, soft tissue morphology was appropriate and the final impression was taken.

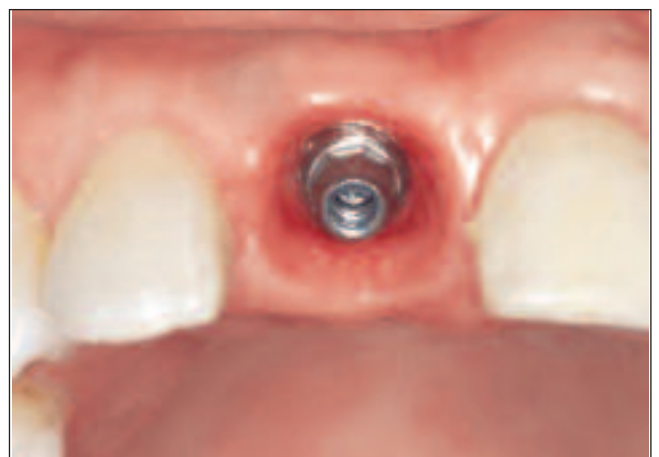
Figure 11: A RN synOcta® abutment was torqued into place at 35 Ncm.

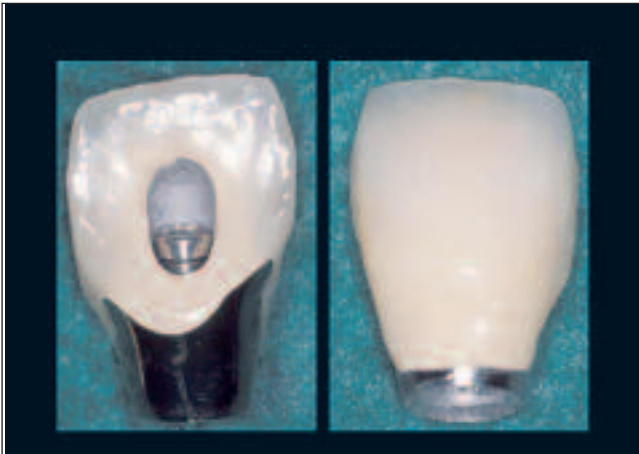
Figure 12: The PFM crown, ready for installation.

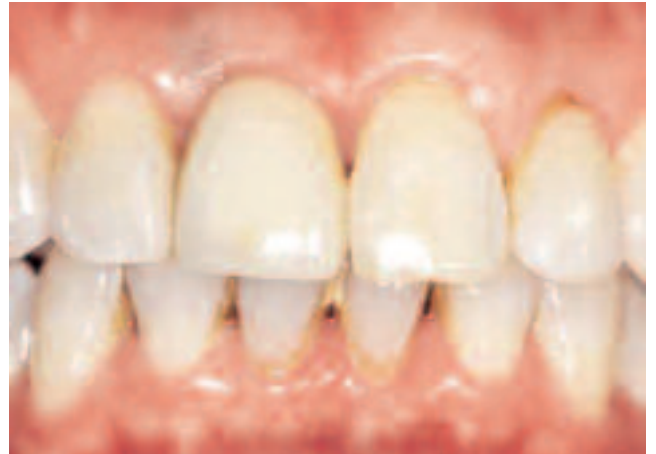
Figure 13: The definitive crown screwed onto the implant abutment at 15 Ncm.

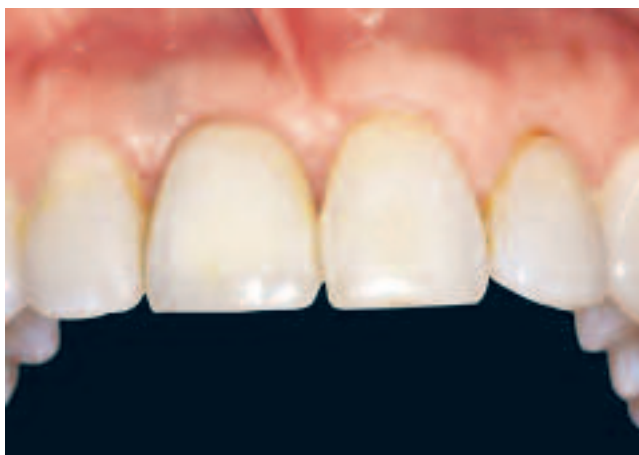
Figure 14: The implant borne restoration integrates into the line of natural teeth very nicely.

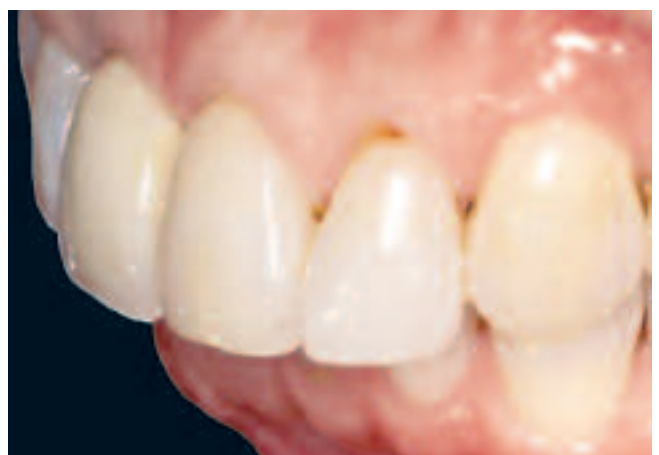
Figure 15: Lateral view at the implant site. The emergence profile matches that of the contralateral central incisor and integrates into the arch harmoniously.

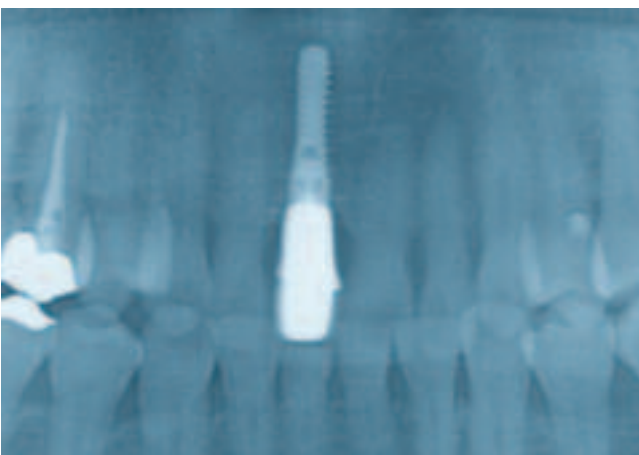
Figure 16:  
OPT follow-up at 18 months after implant loading.

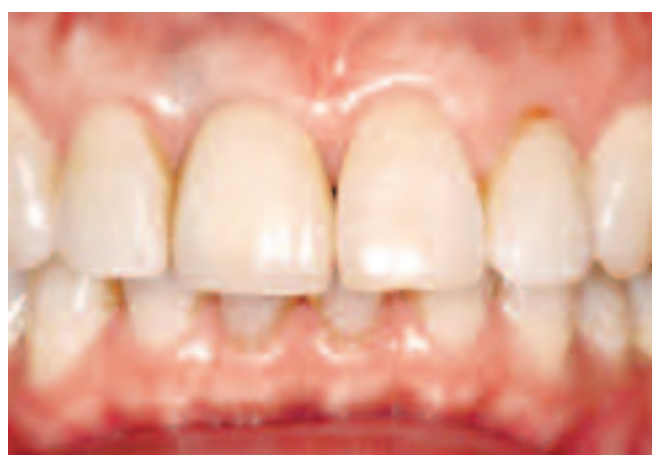
Figure 17:  
The follow-up at 18 months after implant loading demonstrates a stable and esthetically pleasing situation.
