LiSi Press monolithic crowns

Karyn M. Halpern¹ and Bill Marais²

Case background – Lisa

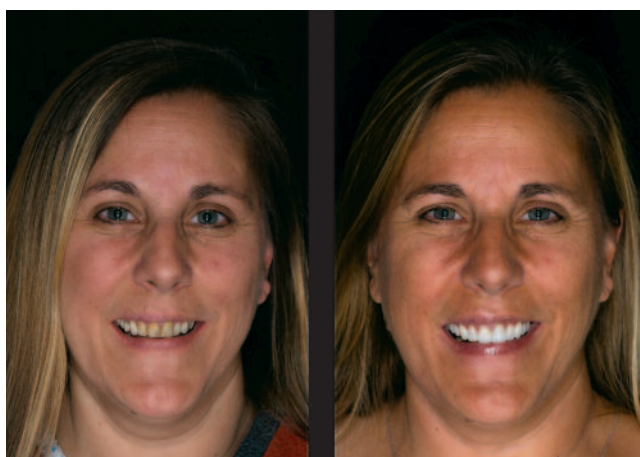
Lisa's maxillary anterior teeth had a history of a mosaic of multiple failing resin fillings per tooth as well as root canal treatments on teeth #'s 7,8 & 9.

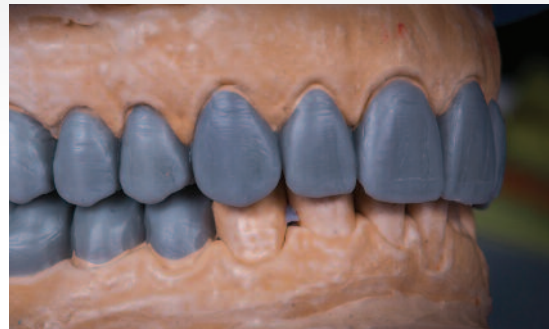
Figure 2. Diagnostic wax up.

Diagnostic impressions and photos were taken and sent to my technician Bill Marais for a full mouth diagnostic wax up.

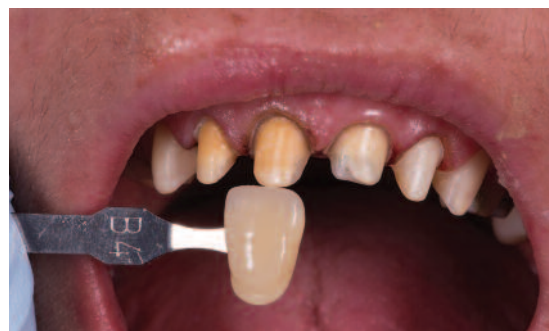
Figure 6. Stump shade selection.

Photos of the preparations against chosen shade tabs were taken for the technician to evaluate the prep shades.

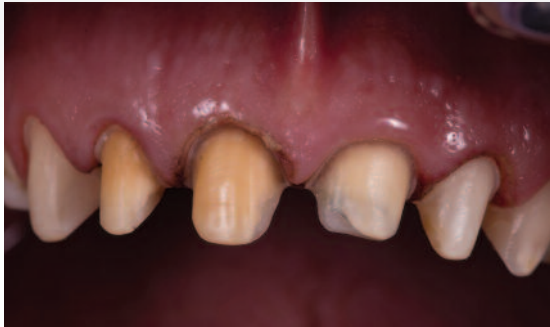
Figure 7. Preparations with core build up and gingivectomy.

All pre-existing composite and amalgam restorations were removed and all caries excavated. Core buildups were completed with a combination of direct composite on the anterior preps and core paste on the posterior teeth.

A gingivectomy was performed using a diode laser on teeth #'s 8 & 10 to correct her gingival asymmetries and

mimic the diagnostic wax up.

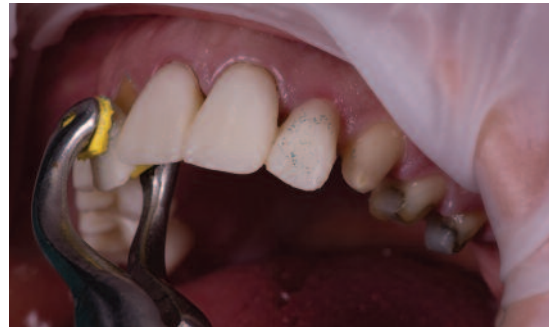
Figure 10. Removal of temporaries.

The patient returned for delivery of the final restorations. The provisionals were removed. The crowns were tried in individually and then together to check marginal fit and contacts.

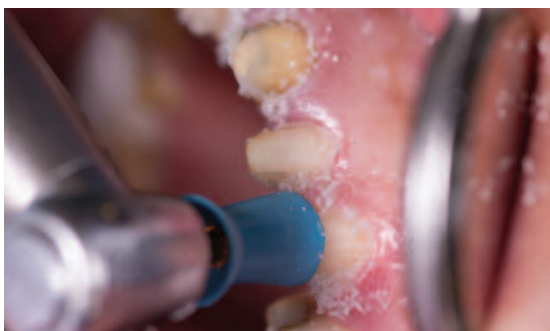
Figure 11. Cleaning preparations with pumice.

The teeth were then prepared for total adhesive bonding : pumice, 4% chlorohexidine scrub, gluma placed on vital preps.

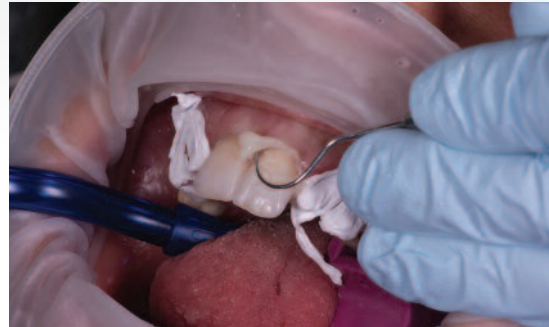
Figure 14. Cementation, removing excess cement.

Care was taken to remove all of the excess resin cement and the occlusion was then adjusted and verified in centric and excursions.

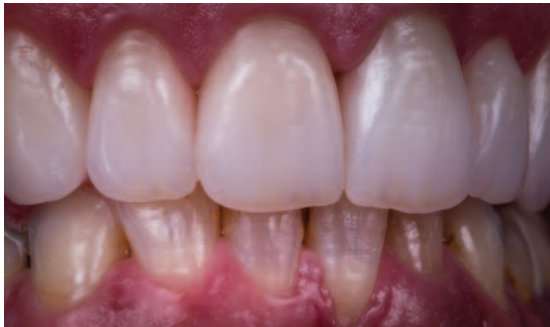
Figure 15. Final, front view.

The lab technician fabricated LiSi Press monolithic crowns with GC lustre paste stain & glaze for teeth #'s 3, 4, 5, 6, 11, 12, 13 and Lisi Press layered crowns with GC Initial™

LiSi ceramic on #'s 7, 8, 9, 10.

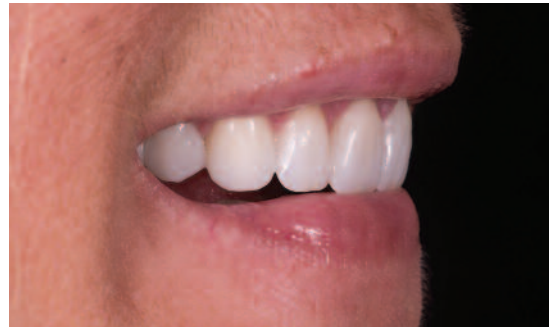
Figure 16. Final, side view.

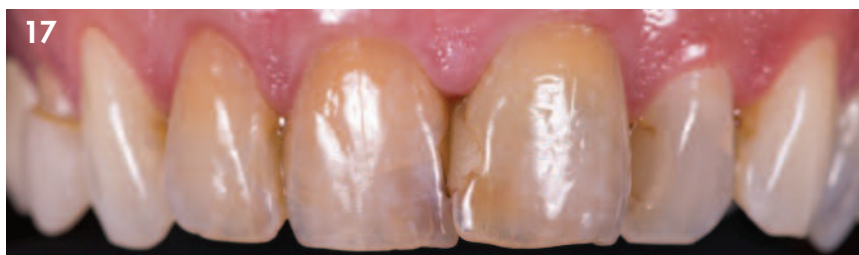
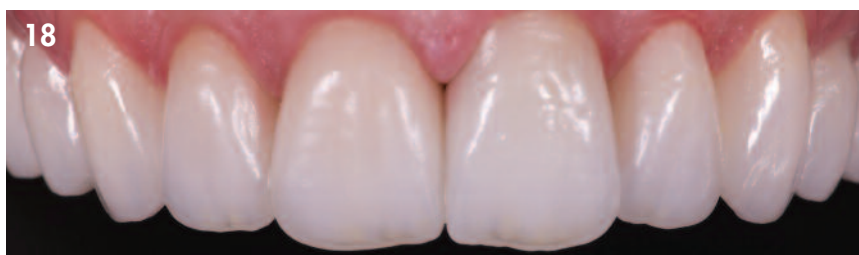
Figure 17. Before.
Figure 18. After.
