CLINICAL

Active care bleach: infiltrate and restore

Jordi Manauta¹

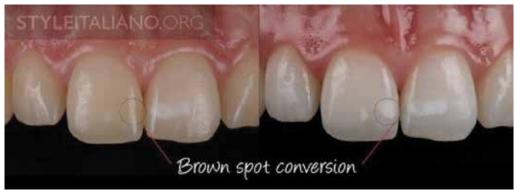
Figure 6: Cross-polarised image showing the latest situation. Some spots have vanished, the amber spots have turned white and other spots have softened in saturation
