REPLACEMENT OF AN UPPER LEFT LATERAL INCISOR WITH A STANDARD PLUS IMPLANT¹, NARROW NECK

CHRISTOPH SCHÄDLE, WERNER GROSSHANS

Case Overview:

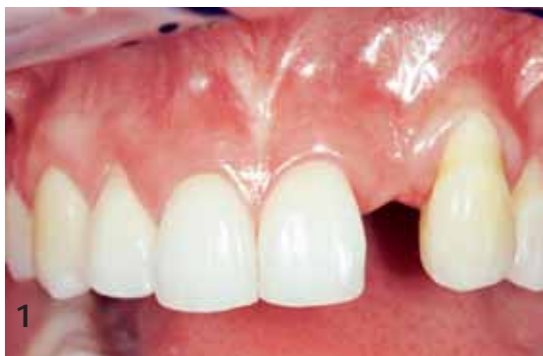
Figure 1: Status of referral after orthodontic treatment. The impacted upper left canine had been orthodontically extruded. Tooth 22 was lost during the treatment. The orthodontist did not want to correct the position of the canine because of severe general root resorption. The distance between tooth 21 and tooth 23 was 5mm.

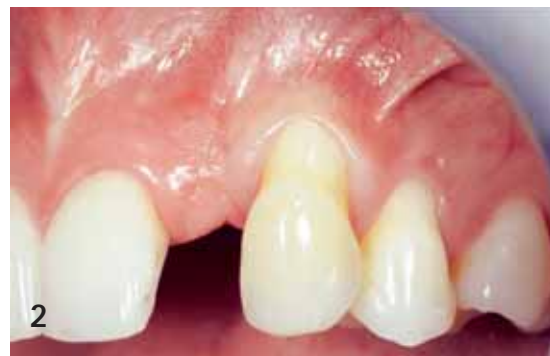
Figure 2: Gingival recession was about 4mm at tooth 23. The attached gingiva was very thin. The position of the tooth, especially of the root, was too far labial.

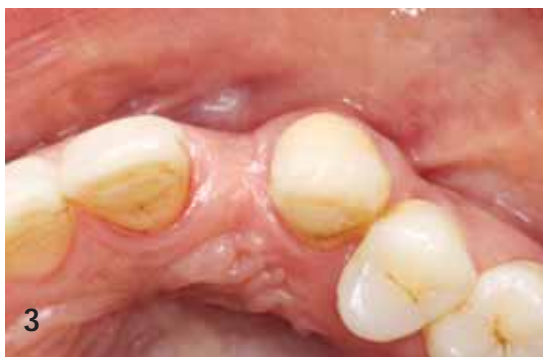
Figure 3: As a result of the orthodontic treatment, the canine was rotated and positioned buccally.

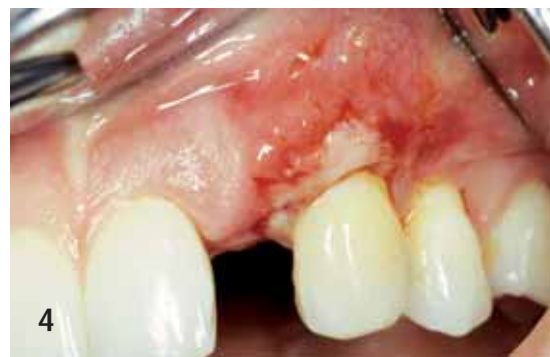
Figure 4: The gingival recession was surgically covered with a connective tissue graft. At the same time, the ridge was built up with a connective tissue graft. The figure shows the situation 7 days postoperatively.

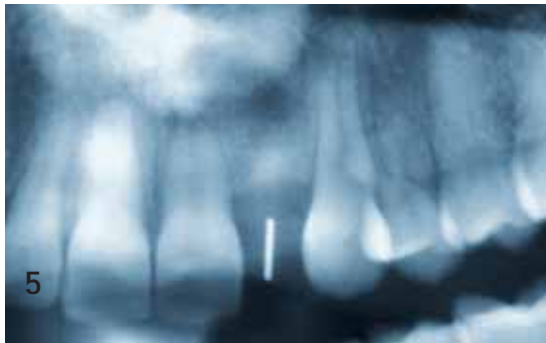
Figure 5: A diagnostic wax-up and a surgical splint were prepared. The X-ray with the splint demonstrates the root resorption of the teeth 21 and 24.

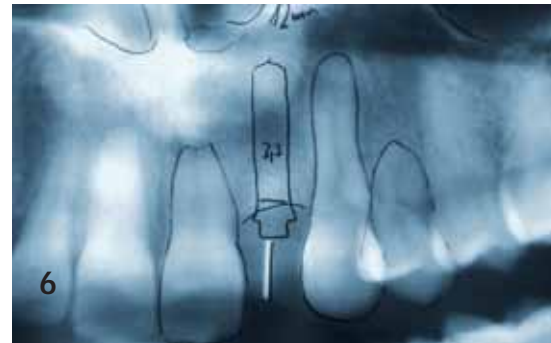
Figure 6: Planning for placement of a Narrow Neck Implant (endosseous Ø 3.3mm, length 12mm).

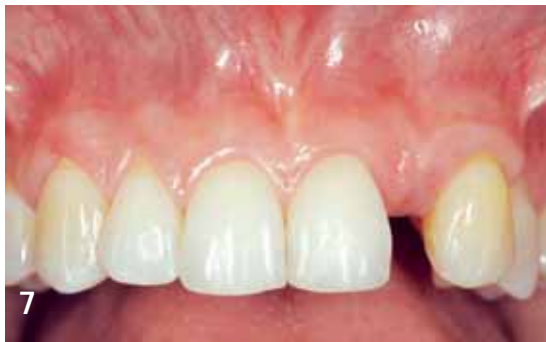
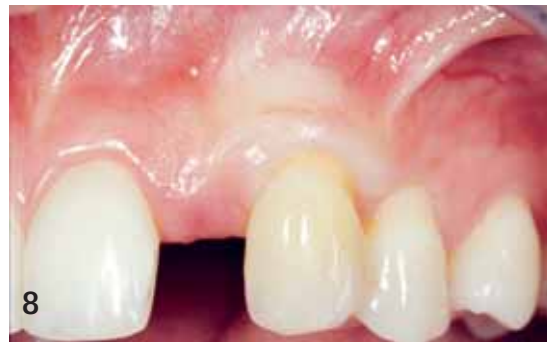
Figures 7 and 8: 5 months after surgical recession covering, the Narrow Neck Implant was placed for submerged healing.

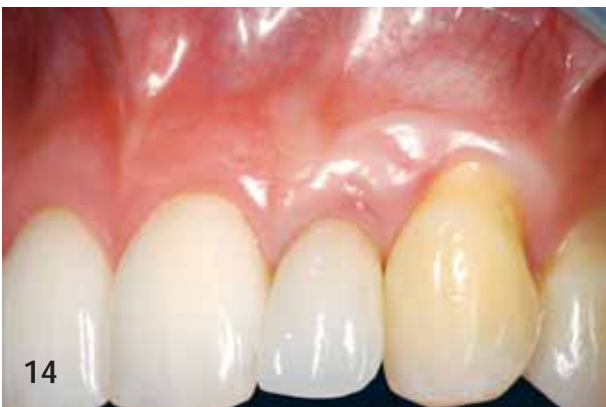
Figures 13 and 14: Situation 2 years and 4 months after crown placement. The periimplant mucosa presents healthy and stable.
