Cementation – a decisive factor

Sandro Pradella

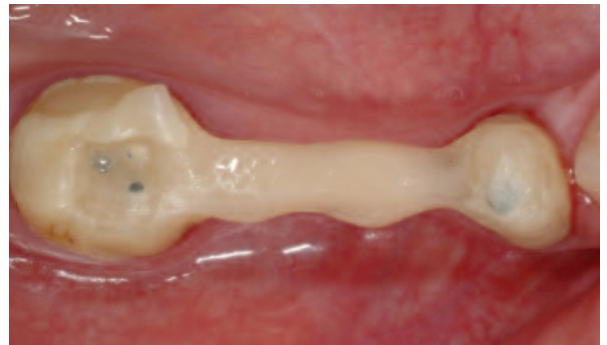
Figure 1: Occlusal view of bridge.

Only the glass fibre-reinforced composite bridge core was left of the original bridge in quadrant 4; the composite veneering material had completely delaminated from the framework (Figure 1). It was therefore necessary to fabricate a new bridge to restore the normal function of the jaw. The remaining part of the bridge had to be removed to prepare the abutment teeth for the new bridge. The abutment teeth had been restored with glass fibre posts and core build-ups ten years ago. At the time, both these reconstructions and the bridge proper were inserted using Variolink® II luting composite.

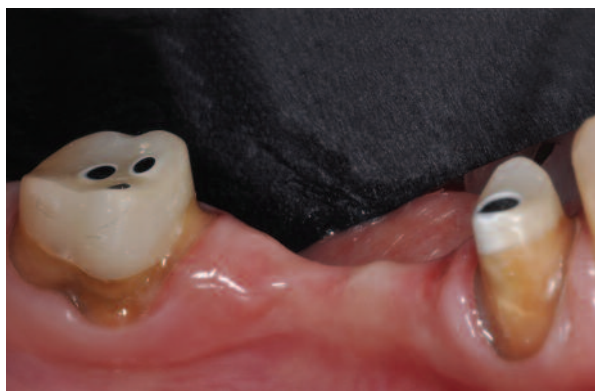
The abutment teeth were completely intact and did not show any signs of infiltration or secondary caries when they were prepared (Fig 2). This attests to the quality and durability of the luting composite used. After tooth reparation, a zirconium oxide bridge was fabricated according to conventional procedures.

Figure 2: Lateral view of prepared abutment teeth.

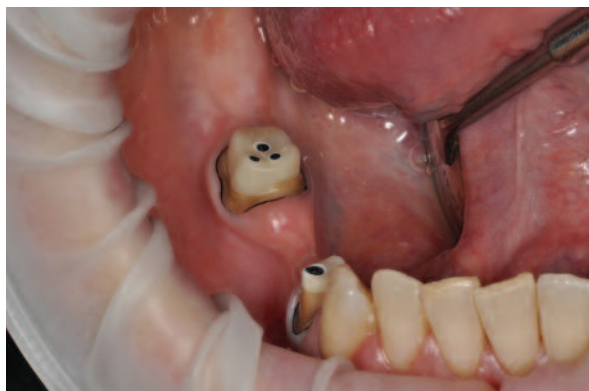
Figure 3: Relative isolation of the treatment field with OptraGate.

auxiliary device enhances the view and ensures relative isolation of the treatment field (Figure 3). It is also recommendable to place a retraction cord for sulcus fluid control to avoid contamination of the tooth surfaces with fluid.

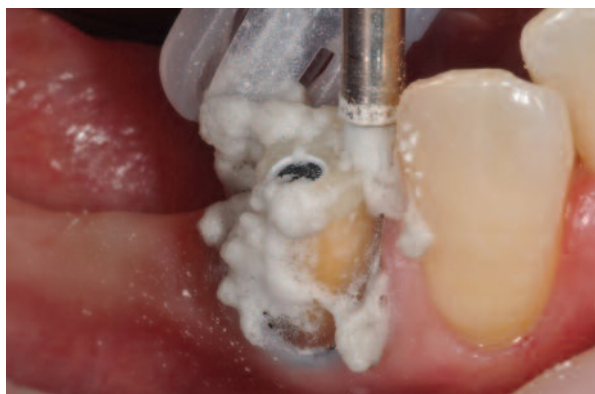
Figure 4: Cleaning of remaining tooth structure with water, pumice and soap.

a mixture of water, pumice and liquid soap. In the process, any residual temporary luting material and other impurities, which might adversely affect the bonding result, were completely removed (Figure 4). The preparation surfaces were thoroughly cleaned with water, gently dried and the adhesive Multilink® Primer A/B was applied. This adhesive consists of two components A + B, which are mixed together (Figure 5). Multilink Primer A/B is a self-etching one-step system, which eliminates the need for additional etching with phosphoric acid. After the primer, the dual-curing luting composite Multilink® Automix was applied. This material is supplied in an automix syringe containing both base and catalyst paste and does not require separate manual mixing. Whilst the material is extruded from the syringe, the two components are optimally mixed in the automix syringe tip, eliminating the risk of air entrapments. Multilink Automix can be dispensed directly onto the crown, which facilitates the working procedure and helps save time. Due to its optimal consistency, the material can be accurately applied to the area where needed without contaminating any other tooth surfaces. Excess material should be removed in a timely fashion, i.e. during the first

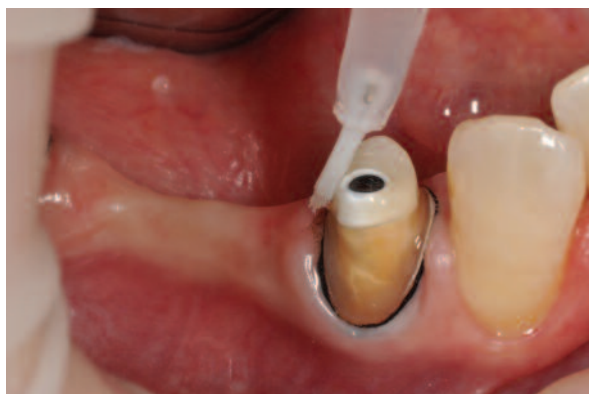
Figure 5: Application of adhesive

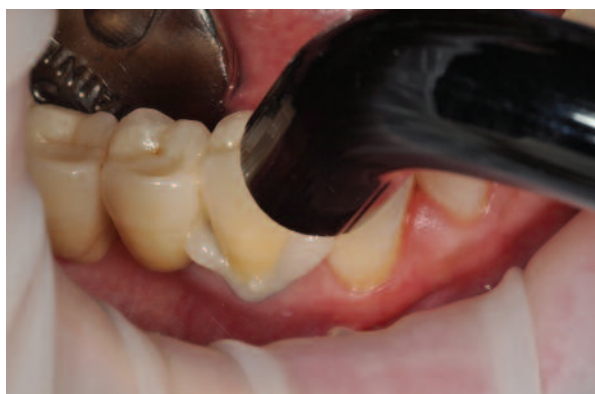
Figure 6: Light-curing of excess material.

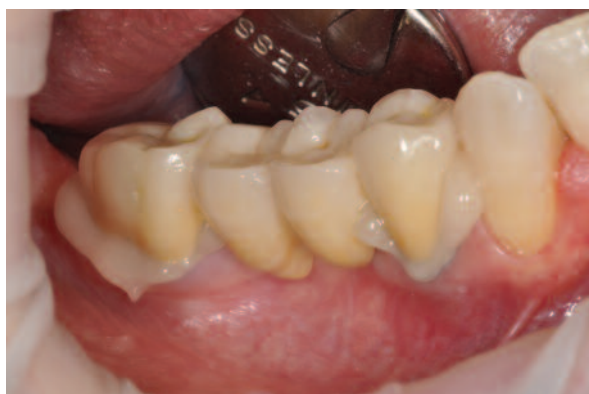
Figure 7: Bridge in situ with excess cement.

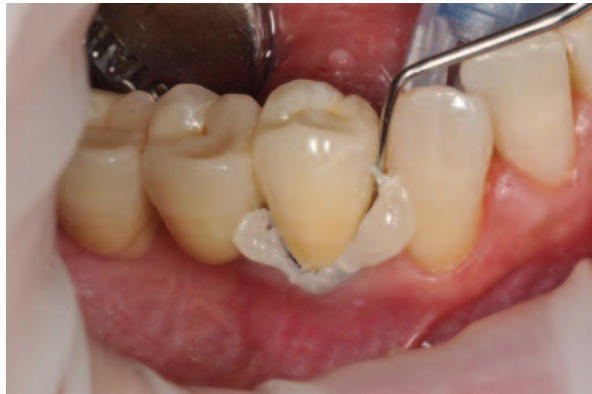
Figure 8: Easy removal of excess material.

phase of the curing process. Multilink Automix features an improved new "Easy Clean-Up" formula, which further facilitates excess removal and offers clear advantages in the clinical handling of the material. Excess cement is light-activated for approximately two seconds per quarter surface (eight seconds in total) using a curing light (Figures 6 and 7). In the process, the excess obtains a gel-like consistency and can be easily removed in one piece using a scaler (Figure 8).

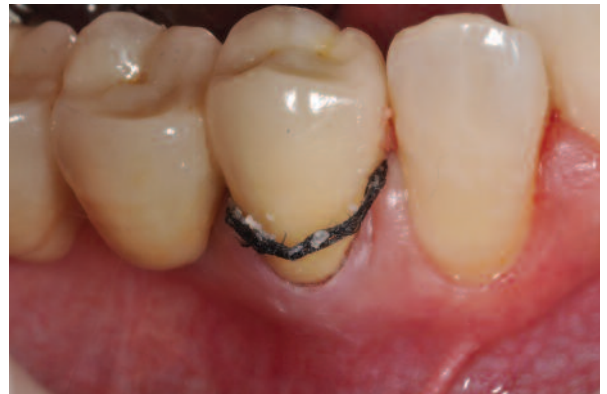
Figure 9: Removal of retraction cord placed for sulcus fluid control.

At the end of the cementation process, the retraction cord, which was instrumental to fluid control, was removed (Figure 9). The preparation margins were checked with a curette (Figure 10) to ensure that they were free of residual adhesive and cement, which may cause an inflammatory response. The pictures of the recall show that the treatment field has remained completely free of any inflammatory reactions (Figure 11). Both the shade and shape of the restoration blend imperceptibly into the surrounding tooth structure. A healthy gingiva is the best proof of a successful restoration.

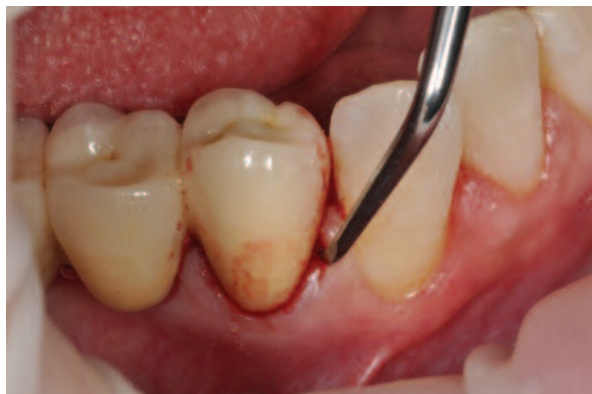
Figure 10: Removal of residual cement and adhesive with a curette.

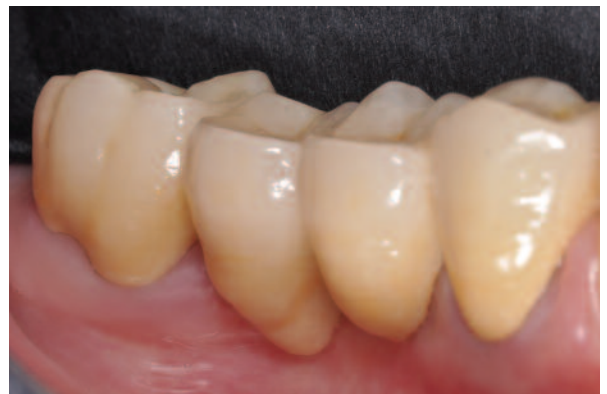
Figure 11: Lateral view of the bridge, two weeks after insertion.
