Endodontic perforation repair with light-cured glass ionomer

Manal Farea,¹ Adam Husein,² Cornelis H Pameijer³

In this case report, two cases of perforation repair are reported in which a light-cured glass ionomer was used. Post-operative evaluations were conducted after one and two years.

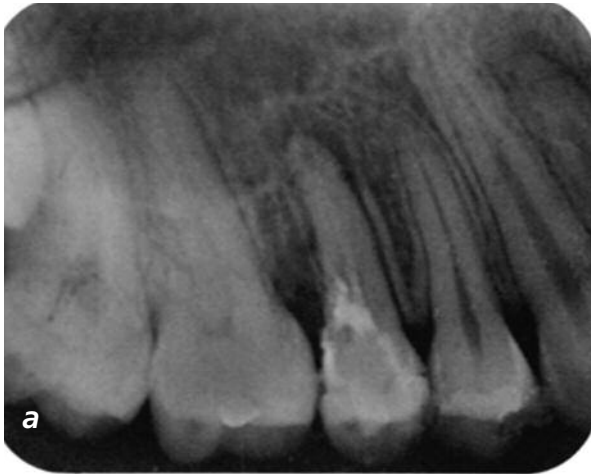
Figure 1a: Pre-operative radiograph.

Radiographic findings showed poor endodontic treatment with incomplete obturation of the canal, a periapical radiolucency, widening of the periodontal ligament, mesial loss of lamina dura and distal loss of alveolar bone crest (Figure 1a). A diagnosis of a failed root canal treatment and chronic periapical periodontitis with possible distal perforation was made. All possible treatment options were discussed and the patient expressed the preference to retain the tooth. Endodontic re-treatment with possible perforation repair by using light-cured glass ionomer (GC Fuji Lining

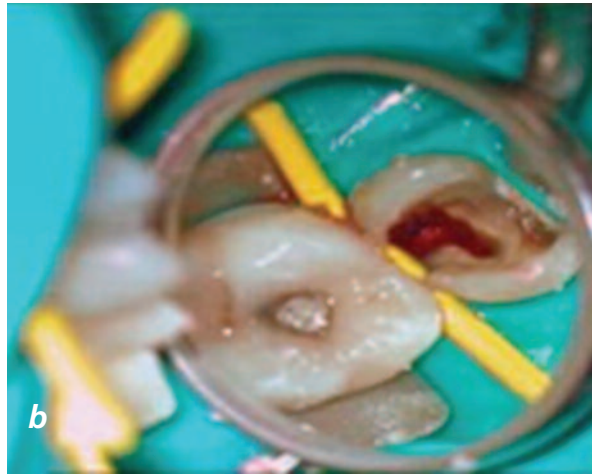
Figure 1b: Bleeding from the perforation site.

At the next treatment visit, the tooth was isolated with rubber dam and subsequent treatment steps were performed under a 2.5x magnification using a microscope (Zeiss operating microscope; Carl Zeiss, Jena, Germany). After removal of the existing restoration, a distal perforation of 3mm in width through to the base of the pulp chamber was detected through probing and by observing the presence of blood (Figure 1b). Bleeding was arrested by rinsing with 1% sodium hypochlorite and pressure packing with gauze. The next step was the removal of debris and remaining caries from the perforation site. After rinsing the cavity with distilled water followed by drying, a dentin conditioner (GC Corporation, Tokyo, Japan) was applied to the dentin surrounding the perforation and left in place for 10 seconds, followed by rinsing with distilled water for five seconds and lightly drying with air and a sterile cotton pellet. The perforation defect was then repaired using a light-cured glass ionomer, GC Fuji Lining LC (GC, Japan) following the manufacturer's instructions. The material was mixed to a slightly running consistency for ease of application and was carried into place by using a periodontal probe. The perforation site was gradually filled up from the base with the material covering about 2-3mm of the surrounding dentin (Figure 1c) and then light-cured (Bludent LED, Plovdiv, Bulgaria). Final thickness of the material was about 2mm. Care was taken not to occlude the orifices of the buccal and palatal canals. Subsequently, conventional endodontic re-treatment procedures were carried out. Remnants of the endodontic filling material were conventionally removed by using 32mm stainless steel #2 and #3 Gates Glidden drills (Premier Dental Co., Norristown, PA) and chloroform (Merck, Darmstadt, FRG). The canal was irrigated with 1% sodium hypochlorite and dried with paper points (Kerr Absorbent Points, USA). Calcium hydroxide (PD, Washington, USA) was placed as intracanal medication followed by a sterile cotton Caviton (GC, Japan) and a light-cured glass ionomer restoration (Fuji II, GC, Japan). The tooth was adjusted for minimal occlusal contact.

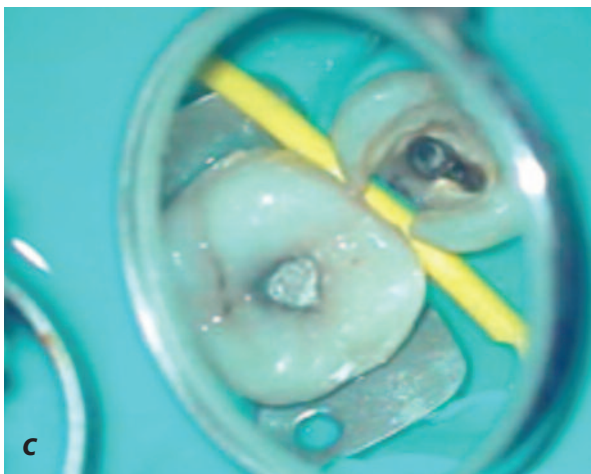
Figure 1c: Perforation site was repaired with light-cured glass ionomer.

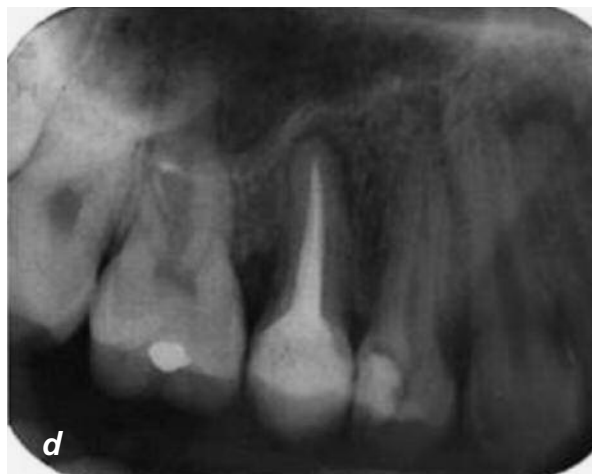
Figure 1d: One year post perforation repair and eight months post canal obturation showing signs of healing and intact repaired site.

Conventional root canal treatment was then continued with mechanical preparation of the canal with a step-back technique, followed by calcium hydroxide intracanal medication. Obturation was completed one month later with AH 26 (Dentsply De Trey GmbH, Konstanz, Germany) and cold lateral condensation technique of gutta percha (Dentsply Maillefer, Ballaigues, Switzerland). A year after the first visit, the tooth remained asymptomatic (Figure 1d). Regular recalls were continued at six-month intervals. The patient was advised of the necessity of a crown to restore the tooth.

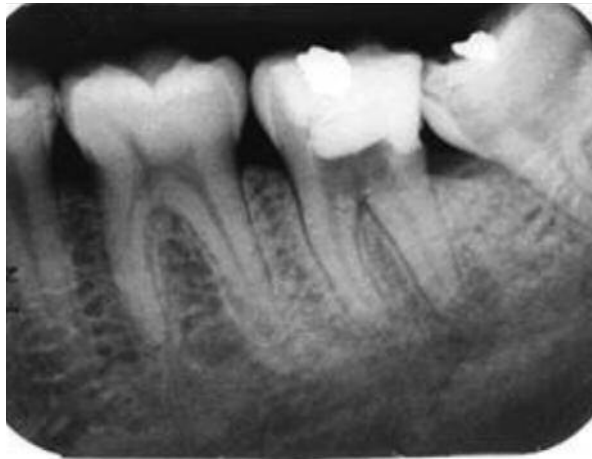
An intra-oral periapical radiograph revealed areas of radiolucencies associated with the furcation and distal root (Figure 2a). A diagnosis of acute periapical periodontitis and abscess formation with a possible lingual furcation perforation was made. All possible treatment options were presented to the patient and he was advised of the condition and poor prognosis of the tooth. However, he insisted that attempts be made to save the tooth and agreed to the perforation repair with a light-cured glass ionomer followed by definitive endodontic and restorative treatment. The patient was also informed about the unavailability of the more suitable material (MTA) for perforation repair in the clinic.

Figure 2a: Tooth 37 showing periapical radiolucency with furcal perforation.

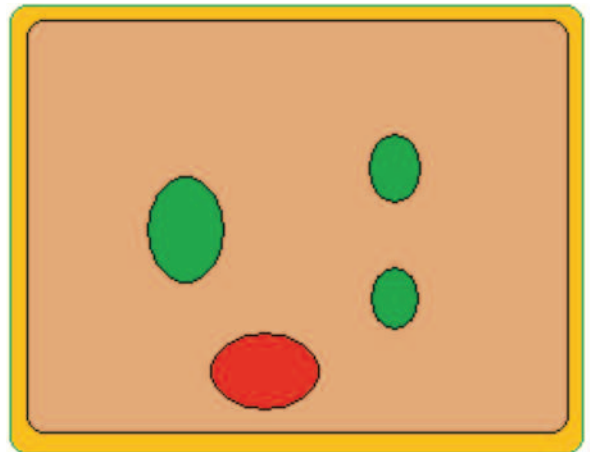
Figure 2b: Illustrated perforation site lingually.

report one. Upon establishing access and removal of all existing restorative material and caries, a round perforation defect measuring about 2mm in diameter was detected on the pulpal floor towards the lingual aspect of the tooth (Figure 2b). Unlike the previous case, the perforation showed minor hemorrhaging and had no caries. One percent NaOCl irrigation followed by pressure packing with sterile gauze as described in case report one was used to achieve hemostasis. After rinsing with distilled water and drying, the perforation site was etched with a dentin conditioner (GC Corporation, Tokyo, Japan), which was applied to the surrounding dentin for 10 seconds, followed by rinsing with distilled water for five seconds and light air drying. Subsequently, the perforation site was repaired with a

light-cured glass ionomer (GC, Tokyo, Japan). Mixing and application was similar to what has been described in case report one. The perforation site was gradually filled up with the material covering about 2-3mm of the surrounding dentin and then light-cured (Bludent LED, Plovdiv, Bulgaria). Final thickness of the material was about 2mm. Care was taken not to occlude the orifices of the root canals.

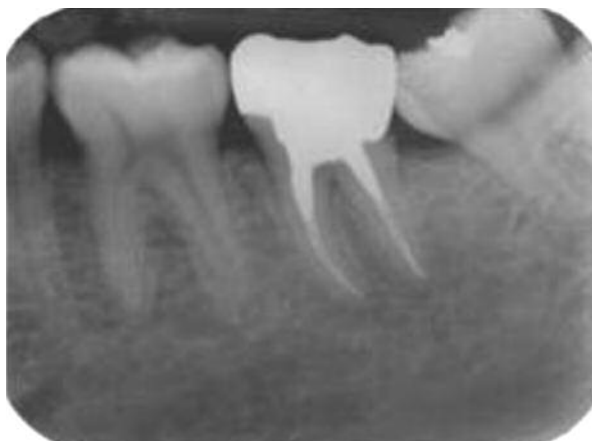
Figure 2c: Two years periapical radiograph revealed complete bone formation at the apex and furcation.

intra-canal medication. Obturation was completed one-month later with AH 26 (Dentsply De Trey GmbH) and cold lateral condensation of gutta percha (Dentsply Maillefer, Ballaigues, Switzerland). The restorative treatment consisted of an amalgam post and core and complete metal crown. At a one-year post-operative visit the patient presented with an asymptomatic tooth. Regular recalls were carried out at six-month intervals. Two years after treatment, the patient presented with a normal functioning tooth (Figure 2c).
