# PORCELAIN VENEERS: TECHNIQUES AND PRECAUTIONS

BASIL MIZRAHI

## Abstract

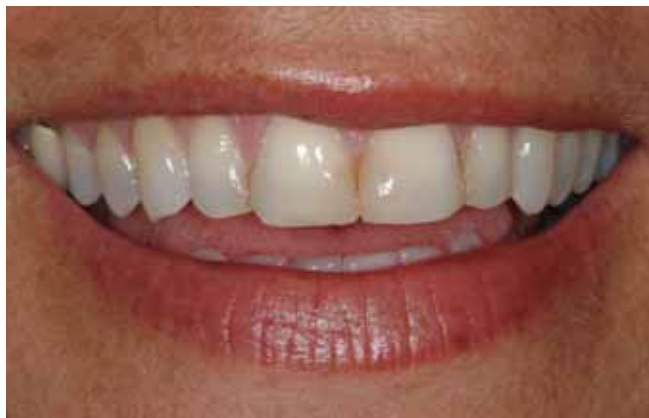
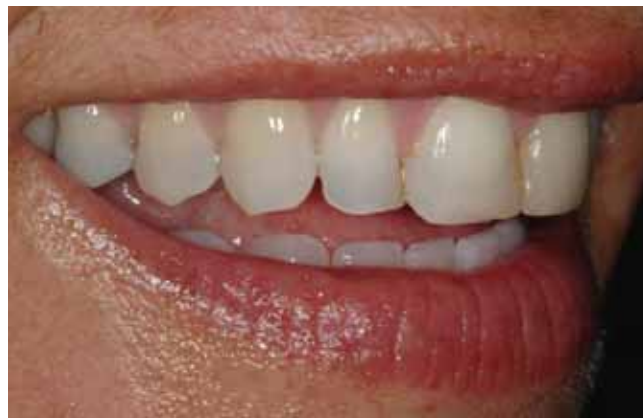
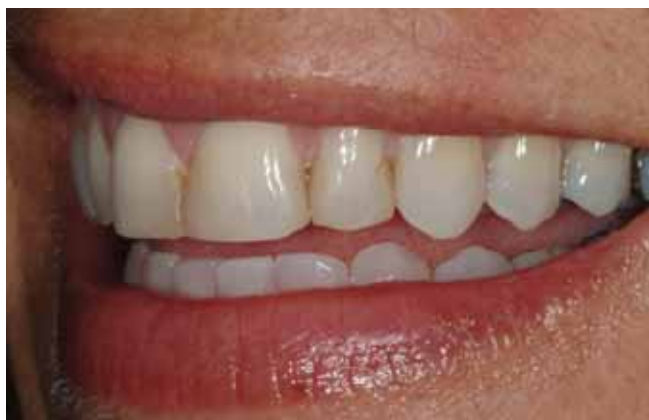
Figure 1. Pre-op smile

Figure 2. Pre-op smile

Figure 3. Pre-op smile

On examination the following findings were noted (Figures 1-4) :

- Wear of the central incisor edges creating a flat anterior occlusal plane
- Discolouration and marginal staining of the existing composite restorations.
- Gingival recession around the necks of lateral incisor, canine and first premolar teeth.

The combination of the worn incisal edges and increased width of the upper incisors due to the composite bonding, detracted from the smile in two aspects.

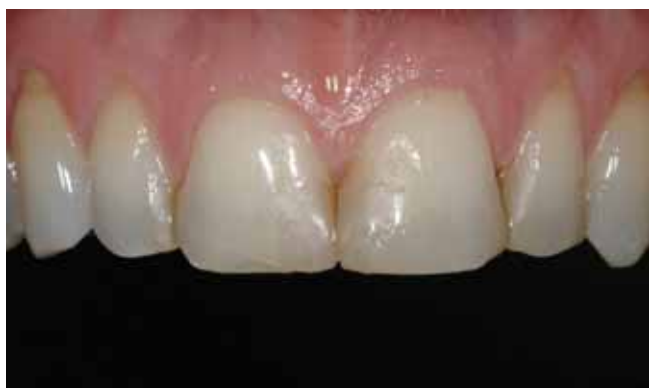
Figure 4: Gingival recession with exposed dentine. Note the large interproximal composite restorations on the four incisors

A potential complicating factor for porcelain veneers was the fact that the gingival recession meant that the cervical margin of the veneers would be on dentine (Figure 4), since it has been shown that veneers with their margins in enamel are more successful than those in dentine (Tjan et al, 1989, Lacy et al 1992, Ibaura et al 2007, Dumfahrt 2000, Friedman 1998).

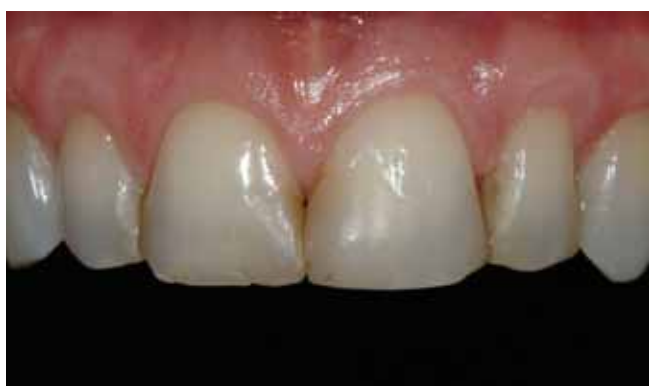
Figure 5: Post-periodontal surgery with root coverage (Dr Jonathan Lack)

After discussing both options with the patient it was decided to carry out a root coverage procedure on the upper canine and lateral incisors. Following the mucogingival surgery, the gingivae were allowed to mature for about four months before the restorative phase of treatment was begun (Wise 1985) (Figure 5).

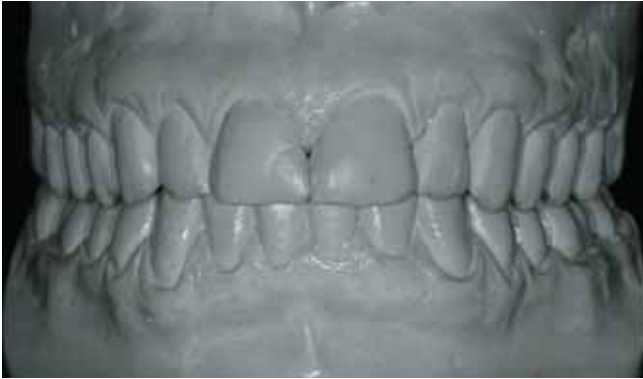
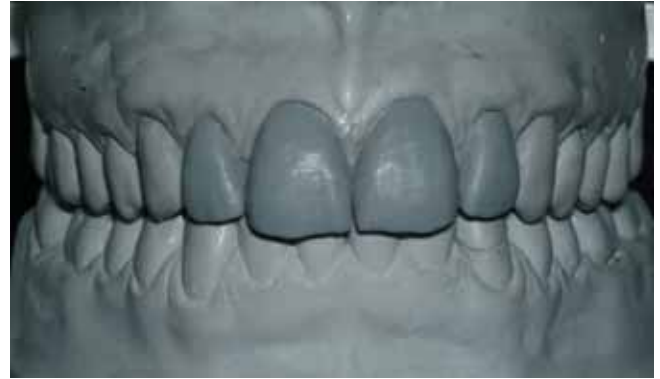
*Figures 6a and b Original study casts compared to diagnostic wax-up*

The first step in this visualisation process is the diagnostic wax-up (Figure 6). This wax-up should be highly indicative of the final result and it is important to verify that it corresponds to the intended outcome of both the dentist and the patient. The key element of porcelain veneers is the preservation of existing enamel.

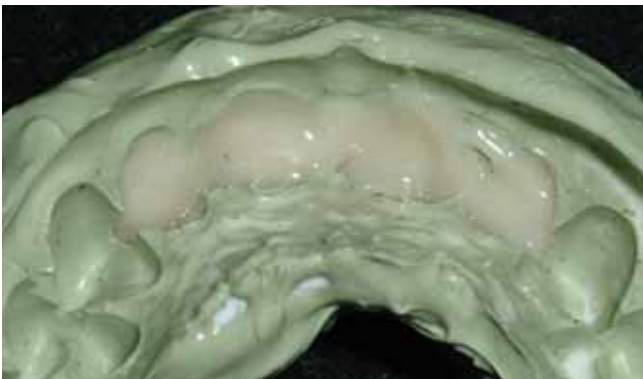
*Figure 7: Bis-acryl resin in silicone matrix*

silicone matrices which would later be used for making an intra-oral diagnostic mock-up, a tooth preparation guide and the temporary veneers. An intra-oral mock up of the final proposed result was made using a Bis-acryl resin temporary resin material (PreVISION CB, Hereaus Kulzer) in a silicone matrix (Figure 7). Once the resin had polymerised, the matrix was removed and an aesthetic and functional analysis was made of the result (Gurel and Bichacho, 2006) (Figures 8-10).

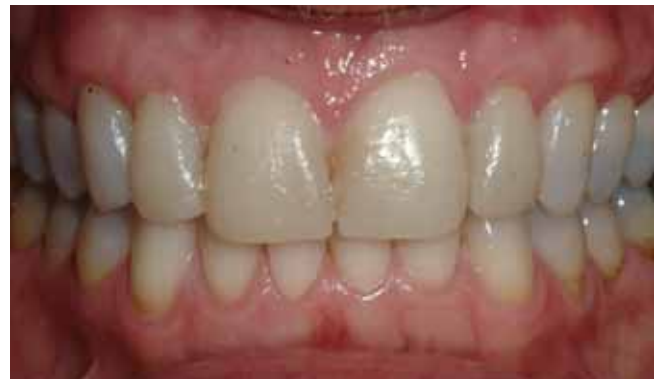
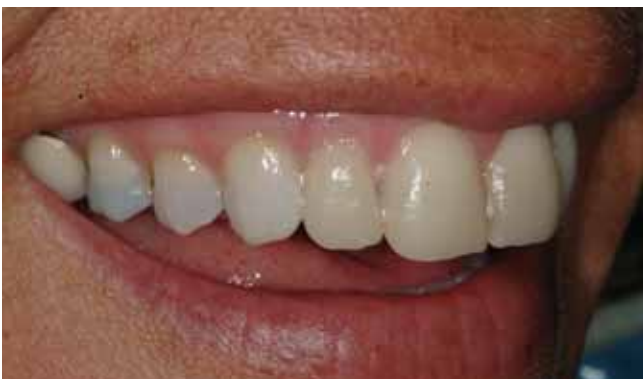
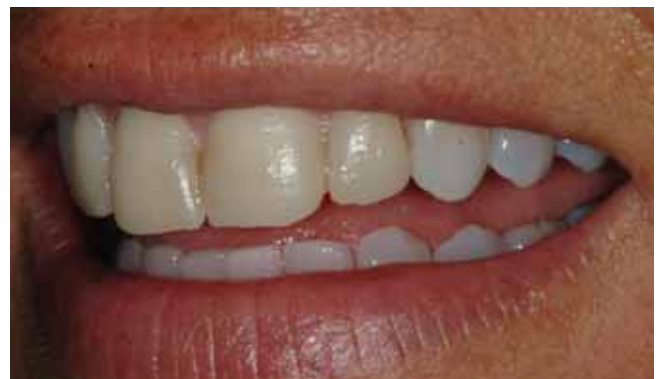
*Figure 8: Bis-acryl mock up on teeth*

*Figure 9: Bis-acryl mock up on teeth*

*Figure 10: Bis-acryl mock up on teeth*

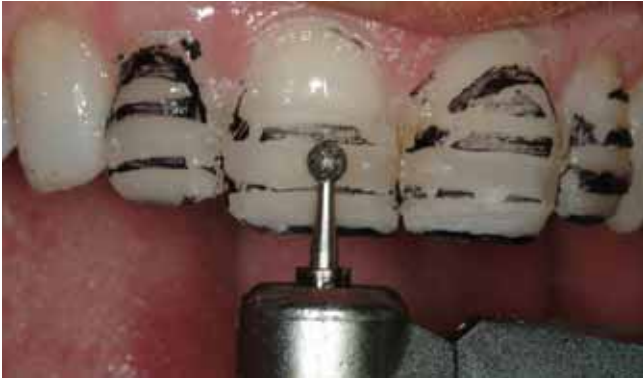
*Figure 11: Use of depth cutting burs through Bis-acryl mock up*

and depth limiting burs (Cherukara et al, 2005). It is important that whatever tooth reduction guide method is used, it is based on the definitive wax up and not the original tooth. Failure to do this may result in excessive and unnecessary removal of tooth enamel. In this case depth limiting burs were used to prepare directly through the bis-acryl mockup, as described by Gurel (2003) (Figure 11). The teeth were prepared with a marginal chamfer labially and interproximally, and a butt fit margin palato-incisally with no wrap around onto the palatal aspect (Castelnuovo et al, 2000, Magne and Douglas, 1999) (Figure 12).

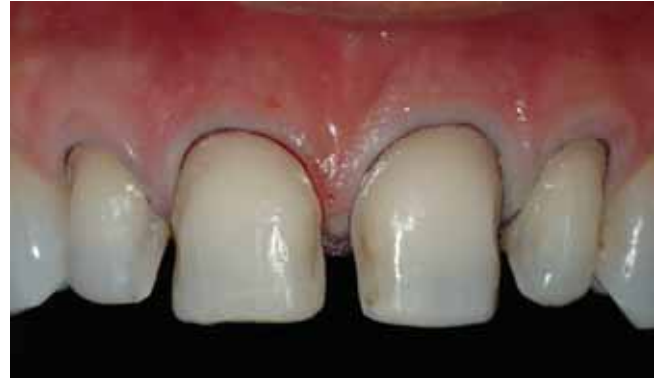
*Figure 12: Final preparations with single retraction cord ready for final impression*

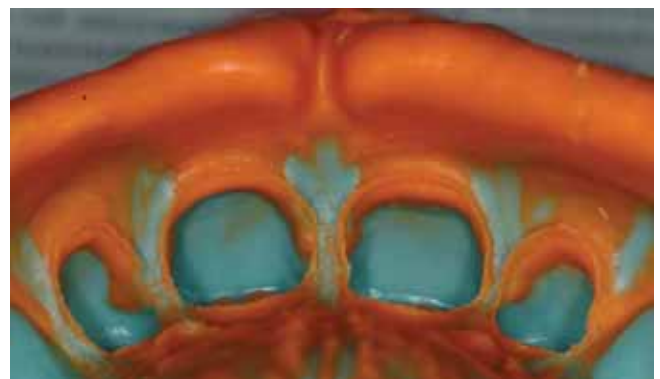
*Figure 13: Polyvinyl siloxane impression*

diastema between them. This also allowed for the changing of the tooth widths in the final restorations. Following tooth preparation, the final impression was made. Even though the preparation margins were at the level of the gingival margins, a retraction cord was used to allow an impression of the tooth surface beyond the margins to be captured (Figure 12). This ensures accurate and complete capture of the entire margin and aids the dental technician in obtaining the correct cervical profile for the restorations. An impression was taken using a well-designed custom tray and a single stage impression technique. Polyvinyl siloxane impression material was used, with heavy body material placed in the tray and light bodied material syringed around the teeth (Figure 13).

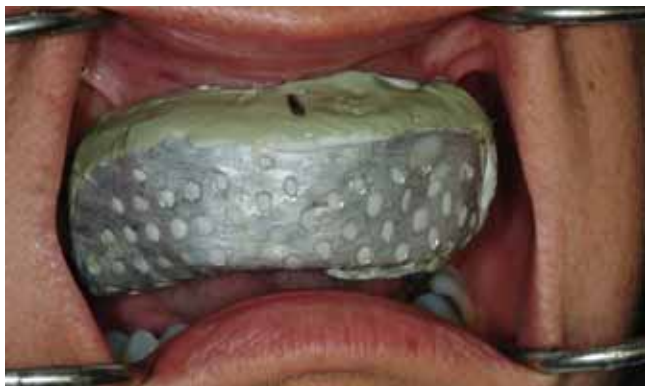
Figure 14: Silicone matrix in place for fabrication of temporary veneers from Bisacryl resin

has been removed, the temporary no longer has mechanical retention and can be gently removed. Where necessary, the margins are relined/refined with a methylmethacrylate acrylic resin, which is more versatile for marginal relining than bisacryl resin (Figures 14-16).

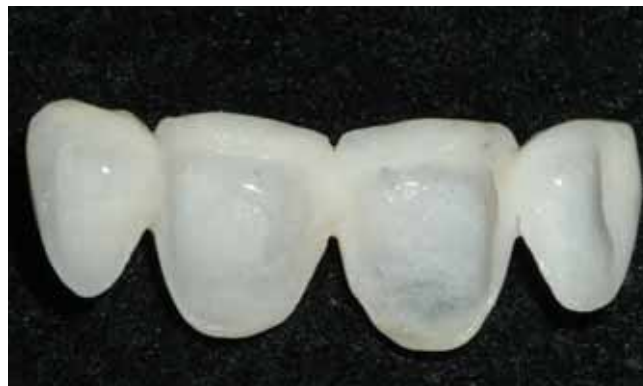
Figure 15: Bis-acryl temporaries with margins refined/relined with methylmethacrylate acrylic resin.

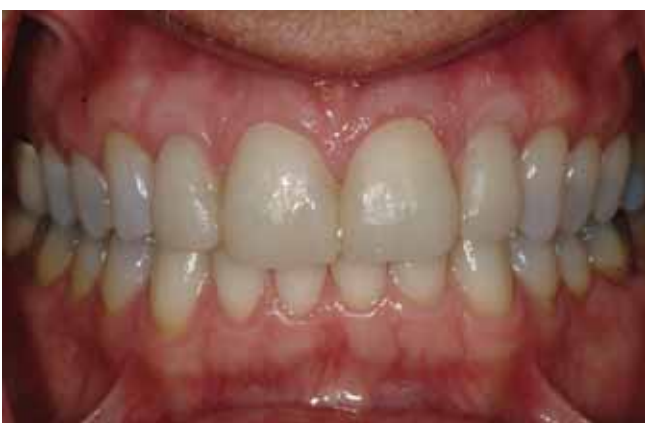
Figure 16: Temporary veneers cemented into place.

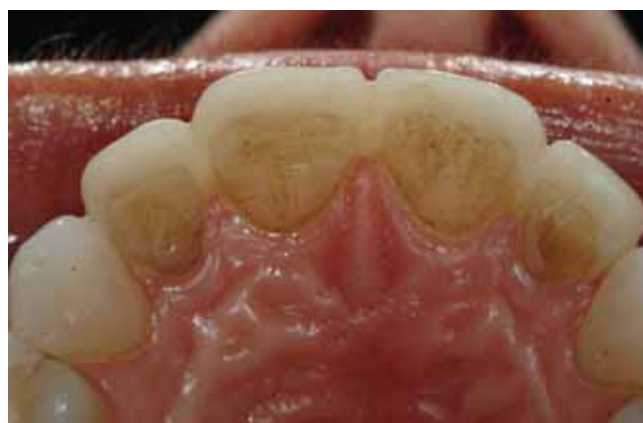
Figure 17: Temporary veneers mechanically locked in place after cementation with methylmethacrylate acrylic resin

The temporary veneers are then cemented in place with a clear temporary cement (Temp Bond Clear, Kerr). The excess cement is cleaned away and then small amounts of the acrylic resin are applied to the palatal, interproximal and incisal aspects to once again lock the temporaries into place mechanically and augment the retention provided by the temporary cement (Figure 17).

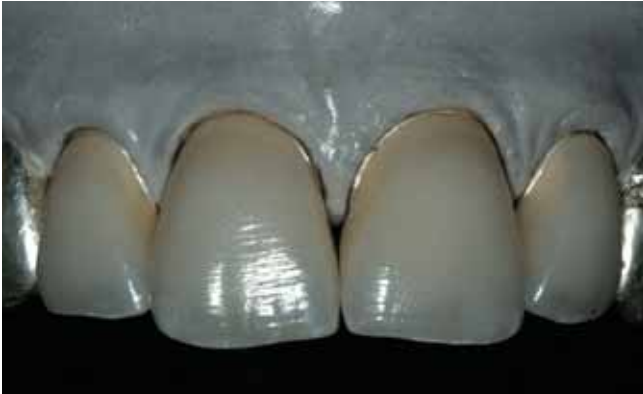
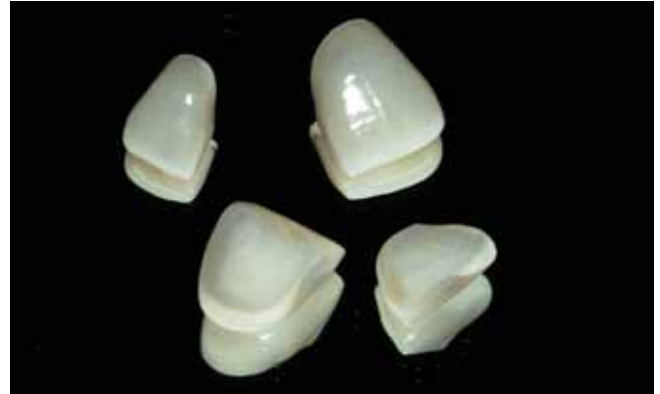
Figure 18: Final veneers. Note detailed, natural morphology, texture and characterisation

Figure 19: Final veneers. Note detailed morphology, texture and characterisation

In the laboratory, the veneers were fabricated from feldspathic porcelain. This allows incorporation of multiple shades and characterisations into the porcelain while maintaining minimal thickness (Figures 18 and 19).

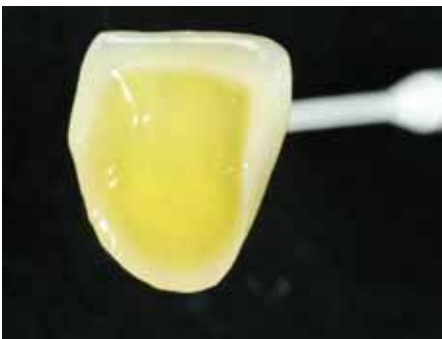
Figure 20: Hydrofluoric acid (9%) etching internal surface of veneer

The internal surface of the porcelain veneers were etched for 90 seconds with 9% Hydrofluoric Acid (Figure 20). Hydrofluoric etching generates a significant amount of crystalline debris that contaminates the porcelain surface and may reduce bond strength by 50%.

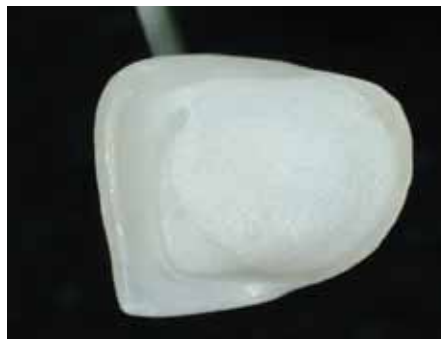
Figure 21: Clean frosty appearance of well etched porcelain

To remove this debris, the veneers were rinsed with water for 20 seconds, then cleaned with 37% Phosphoric acid (gentle brushing with microbrush for a minute), re-rinsed with water for 20 seconds and then finally immersed in 95% alcohol in ultrasonic bath for five minutes. Following this protocol the veneer surface should appear clean and have a similar appearance to etched enamel (Figure 21). Silane coupling agent is then applied and if possible, dried well with warm air (Filho, 2004, Barghi, 2000, Shen et al, 2004).

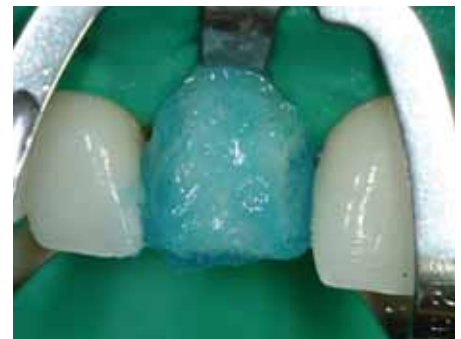
Figure 22: Phosphoric acid (36%) etching of enamel

rubber dam one tooth at a time. The advantages of improved visual and instrument assess and moisture control far outweighs the disadvantage of the increased time needed. The clamp used is a butterfly style clamp with care taken to ensure the jaws of the clamps are stabilised on the tooth surface and not the gingivae (Figure 22). Warm impression compound can be used to stabilise the clamp on the adjacent teeth if necessary.

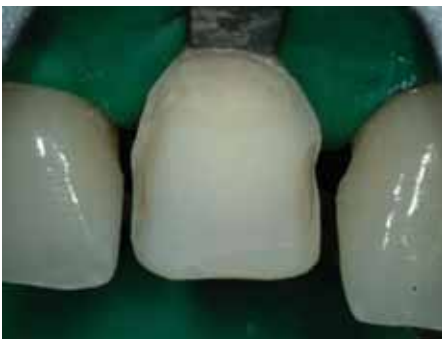
Figure 23: Clean frosty appearance of well etched enamel

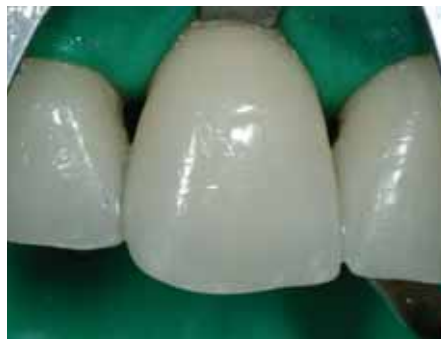
Figure 24: Bonded veneer in place. Note excellent visibility of margin due to rubber dam retraction.

The veneers were cemented in place with a light cured veneer luting resin cement (Rely X veneer cement, 3M ESPE). With rubber dam retraction of the gingivae, excess resin cement can be easily removed prior to polymerisation. This eliminates the need for damaging rotary instrument finishing/polishing of the tooth-veneer interface (Figures 23-25).

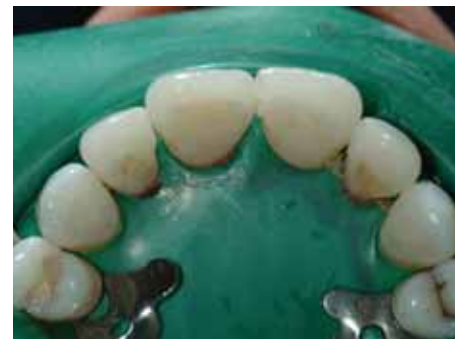
Figure 25: Palatal fit of porcelain veneers

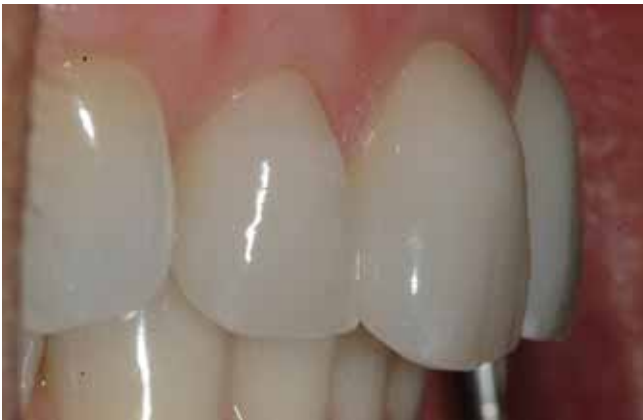
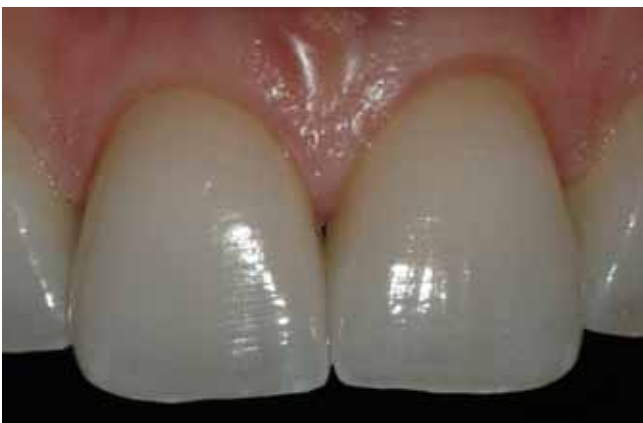
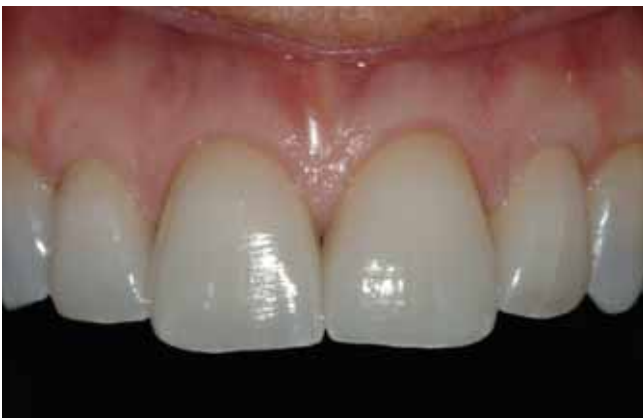
Figure 26: Final veneers bonded in place

Figure 27: Final veneers bonded in place

Figure 28: Final veneers bonded in place

Together with precision in marginal fit, this technique will ensure excellent marginal integrity and a healthy tissue response (Figures 26- 28). At completion of cementation, a successful result was obtained and both clinician and patient were extremely satisfied (Figures 29-31).

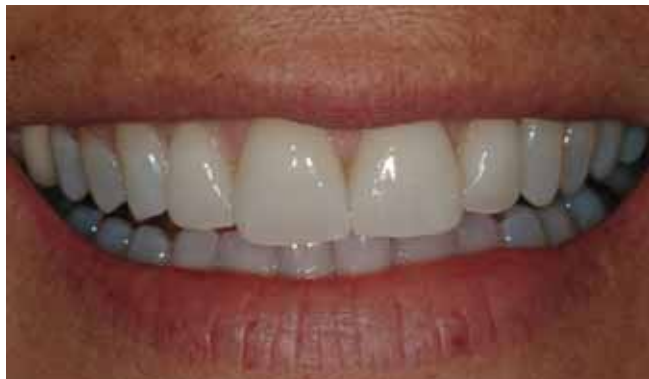
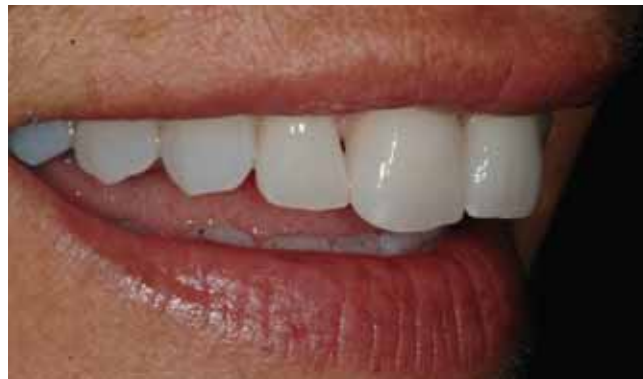
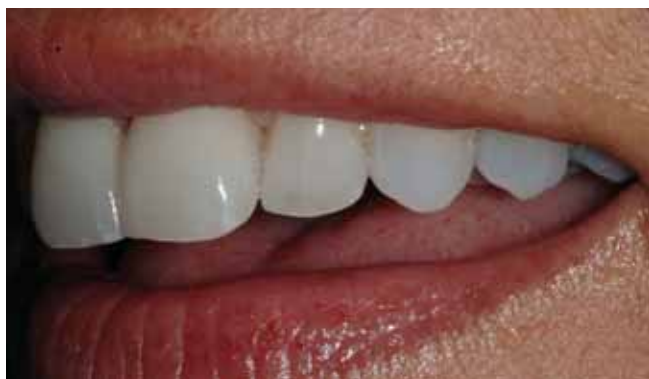
Figure 29: Post op appearance of smile

Figure 30: Post op appearance of smile

Figure 31: Post op appearance of smile

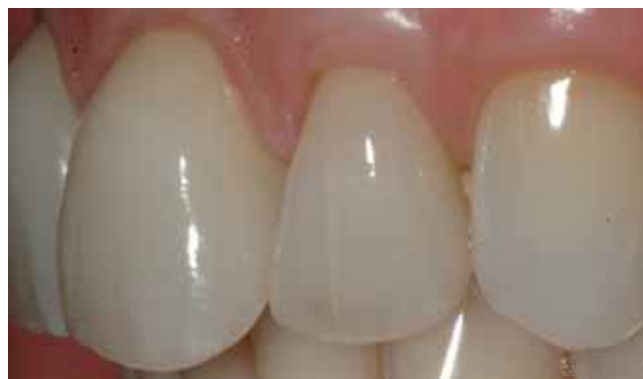
Figure 32: Post-bonding crack on left lateral incisor

When the postoperative photos were viewed, it was apparent that a vertical crack was present in the lateral incisor. This was not noticed by either patient or dentist at the time of

cementation and seemed to be made apparent by the camera flash. The patient was recalled and the crack was pointed to her on the photos. Even at this time, despite the knowledge of the crack it was not noticeable with direct vision and as such, it was decided to leave the veneer in place.

Magne et al (1999) have proposed that a possible cause of this is a ceramic to luting is well bonded onto the underlying enamel a post bonding cracks does not jeopardise the longevity of the veneer and if the crack is not an aesthetic concern, the veneer should be left in place (Barghi and Berry, 1997). If the crack is obvious and detracts from the appearance, it is then necessary to remove and remake the veneer.

above 3:1. When this ratio is large, the forces created by the polymerisation shrinkage of the luting cement may cause fracture of the thin porcelain veneer. Post bonding cracks are an acknowledged, albeit rare, complication of porcelain veneers.
