Case Report on the use of bone level implants in an esthetically demanding case

Paul van Zyl and Gerrit Wyma

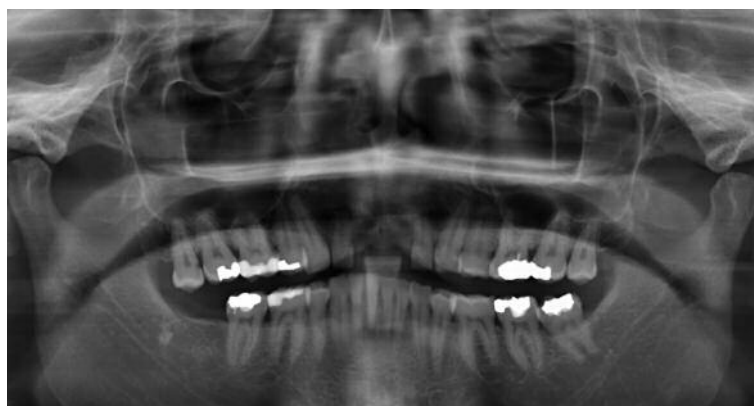
Figure 1: Pre operative panoramic xray.

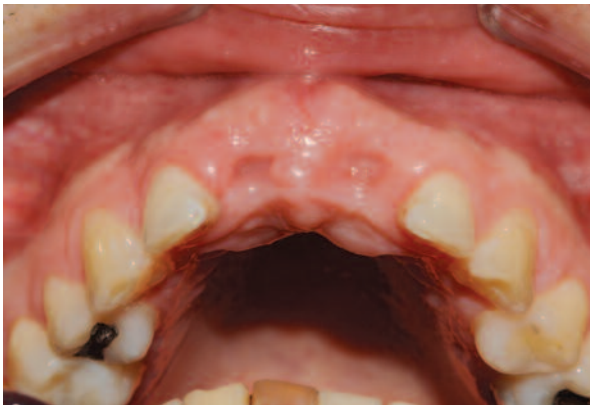
Figure 5: Inter dental space measured 14,6 mm, note the deficient buccal bone volume.

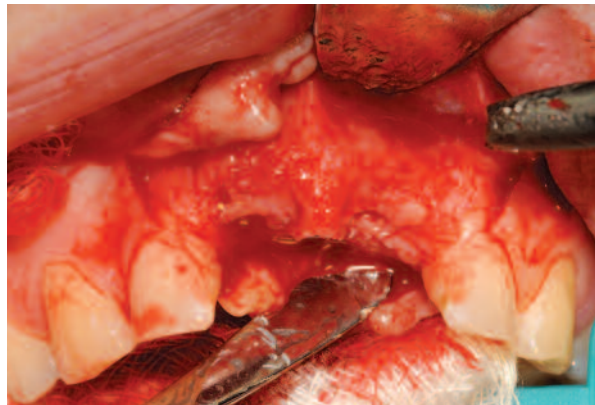
Figure 6: Full thickness flap with vertical relief incisions from the center of the adjacent lateral incisors.

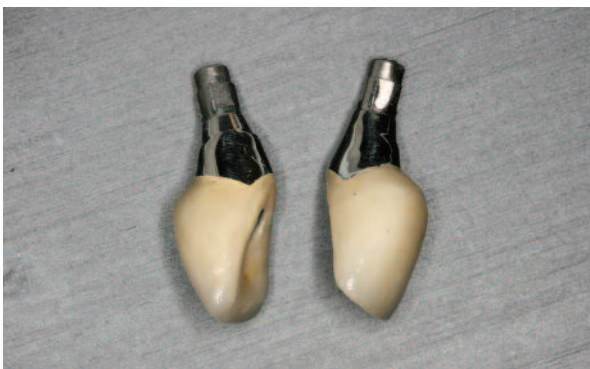
Figure 26: Note the buccal concavity to predict the gingival margin height.

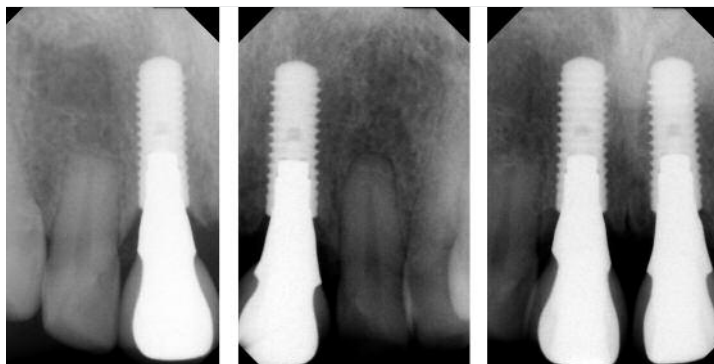
Figure 33: Radiograph 1 year post insertion of the restorations, note the preservation of the marginal bone level.
