Treatment of a crown-root fracture using a composite endodontic post

Jozef Minčík,¹ Marián Tulenko²

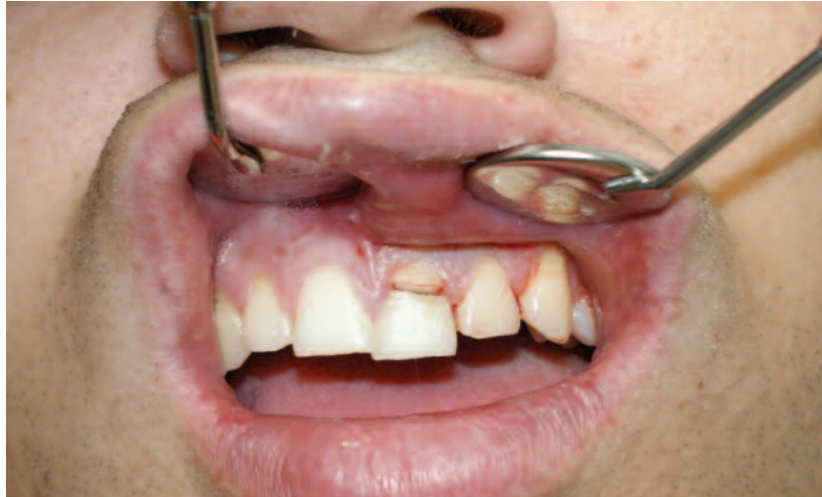
Figure 2: Crown-root fracture: The coronal opening communicates directly with the pulp.

A 20 year old patient presented at the surgery after an accident during a contact sport. The crown of tooth 21 was in a supra-occlusion and proved to be very mobile and sensitive. The cervical range of the crown exhibited a straight fracture that bled slightly (Figure 2).

Exact reposition was carried out under local anesthesia immediately after the diagnosis. We sealed

the opening with light-curing, glass ionomer composite cement (Ionoseal, VOCO). The coronal fragment was splinted labially with a glass fibre strip, which was attached to the neighbouring teeth with composite (Figure 4). This immediately provided the patient with the ability to chew with only slight aesthetic impairment.

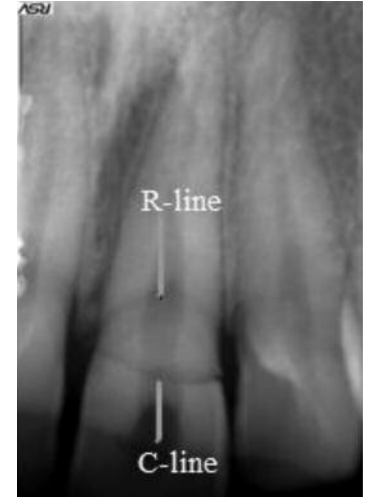
Figure 3: X-ray of tooth 21 with the typical progression.

The diagnosis of a combination crown-root fracture was confirmed with an x-ray, which showed an ill-defined ellipse. The bottom line displayed the intra-coronal portion of the fracture opening (C-line), the top line the intra-radicular portion (R-line) (Figure 3).

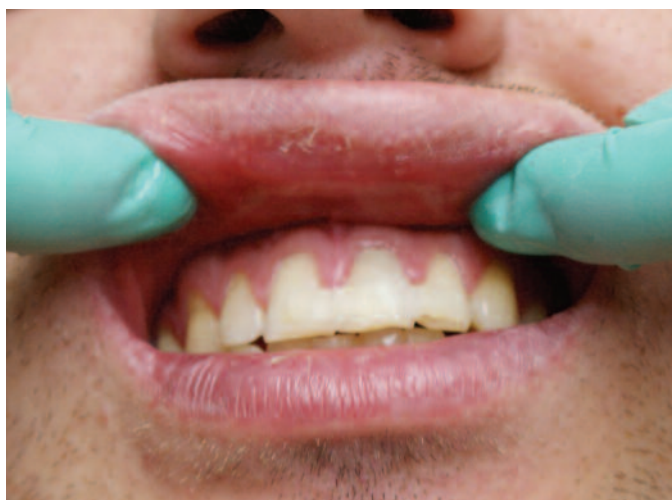
Figure 4: Splinting of the fragments that support the crowns using glass fibre strips and composite.

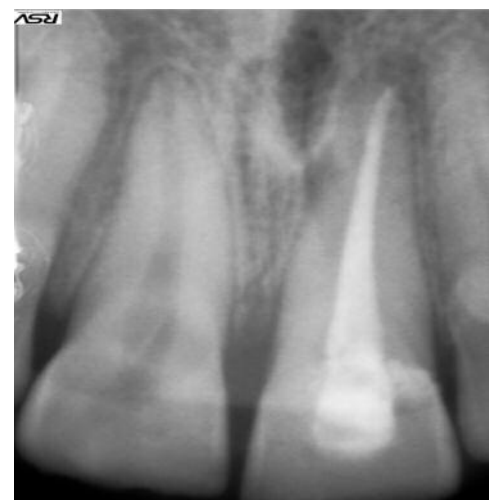
Figure 5: Definitive endodontic treatment of tooth 21.

Trepanation and pulp extirpation were carried out after the splinting. A definitive endodontic treatment was not possible during the first treatment, because the root canal bled heavily. Calcium hydroxide was thus applied as a temporary filling. The root canal was then definitively treated in the second appointment (Figure 5).

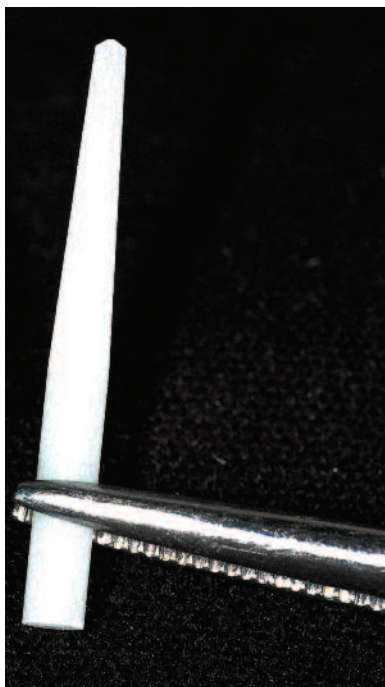
Figure 6: Rebilda Post (VOCO).

The Ebelseder (Ebelseder et al., 1993) method of internal splinting was carried out to secure the refixation result, whereby the two fragments were connected with a glass fibre-reinforced composite endodontic post (Rebilda Post, VOCO, Figure 6).

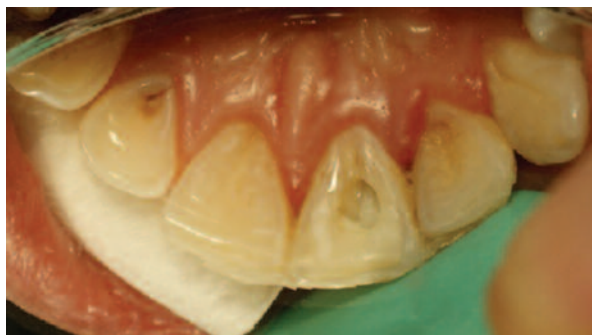
Figure 7: The inserted endodontic post Rebilda Post (palatal view).

The root canal was prepared – with the exception of the apical 4 mm – with the appropriate bur. The treatment then began by trying in the endodontic post and subsequently trimming the post to the necessary length extra-orally. After the application of a dual-curing, self-etching adhesive (Futurabond DC, VOCO), the endodontic post was inserted in the root canal with a twisting motion (Figure 7).

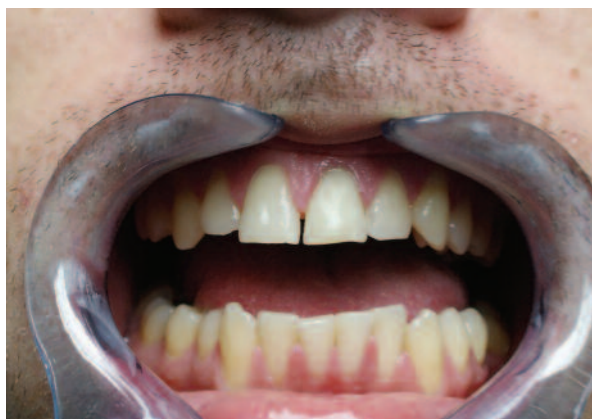
Figure 8: Tooth 21 after treatment.

The combined labial splinting was eliminated after the internal fixation. The coronal fracture that was sealed with glass ionomer cement during the initial presentation and then covered it with a layer of highly aesthetic, light-curing composite (Amaris, VOCO) was then carefully ground out. The treated tooth could now withstand full chew loading and the natural aesthetic was restored (Figure 8).
