Complex esthetic and functional rehabilitation using glass-ceramic materials - long-term documentation of a restoration

Daniel Edelhoff¹ and Oliver Brix²

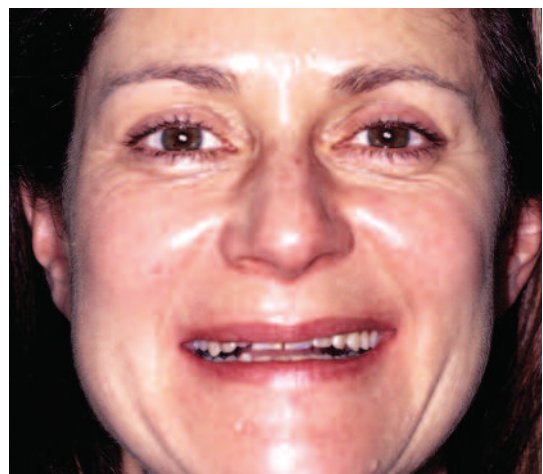
Fig. 1: Preoperative situation: severely impaired esthetic appearance due to a loss of vertical dimension of occlusion (VDO) and the formation of a reverse smile line due to extensive loss of tooth structure.

A 40-year-old female visited the practice with the request to have her severely worn dentition restored. She said that she had begun to experience increased sensitivity to thermal and chemical stimuli and complained about the unfavourable esthetic impact of her teeth (Fig. 1). When we recorded her dental history, she told us that she had become aware of an untoward change in her anterior teeth and in the fullness of her lips, particularly when she was looking at photographs of herself. The clinical findings and dental history showed a large and, at times, substantial destruction of her tooth structure and extensive changes in the proportions of her teeth. These changes were primarily caused by abrasive processes and resulted in a reduction of the vertical dimension of occlusion (VDO). The functional analysis of the dentition did not reveal anything unusual. However, the loss

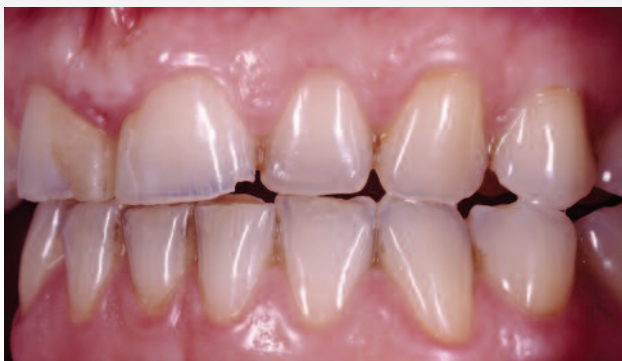
Fig. 2a: Lateral view from the left at dynamic occlusion: traumatic contacts during functional movements have led to extensive loss of enamel and exposure of dentin.

of canine guidance and the rise of anterior and posterior group guidance were conspicuous (Figs 2a and b). The special challenges of this case were: high complexity of the rehabilitation, the patient's request for a prompt and minimally invasive improvement of her situation, the need for creating an appropriate tooth morphology and therefore for reconstructing the VDO as well as the permanent placement of the restorations on damaged tooth structure.

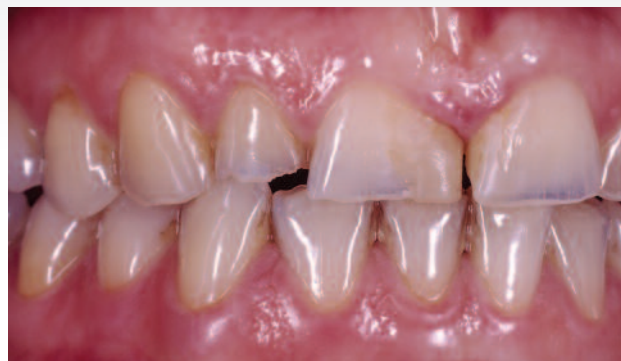
Fig. 2b: Lateral view from the right at dynamic occlusion: loss of canine guidance and severe destruction of maxillary and mandibular anterior teeth.

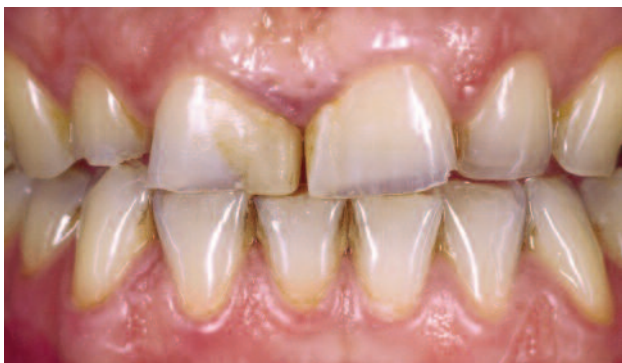
Fig. 3a: Frontal view at protrusion: traumatic contacts have led to substantial changes in the morphology of the teeth.

Crowns made of lithium disilicate ceramic in the layering technique (IPS e.max[®] Press/Ceram) were used for the upper anterior region because of the high degree of tooth destruction present (large composite fillings, Fig. 3a). In the lower anterior region, glass-ceramic veneers layered on refractory dies (IPS d. SIGN[®]) were inserted (Fig. 3b). Full-contour onlays pressed from leucite-reinforced glass-ceramic and customized using the staining technique were placed in the posterior region (IPS Empress[®] Esthetic). The onlays exhibited a minimum occlusal thickness of 1.5 mm (Fig. 4). Cementation was achieved with a multi-component adhesive system in conjunction with the total-etch technique (Syntac) and a dual-curing lowviscosity luting composite, using where possible rubber dam isolation (Fig. 5).

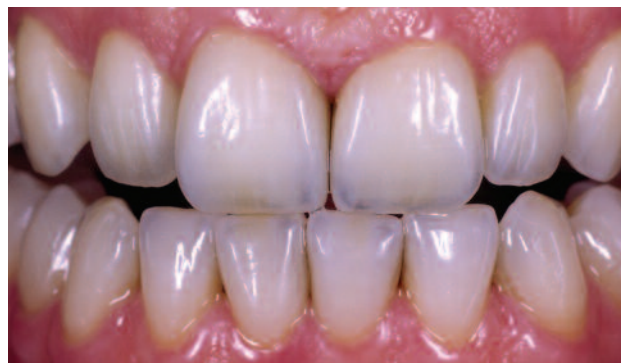
Fig. 3b: Frontal view at protrusion following the restoration: the function and esthetics of the dental morphology has been restored.

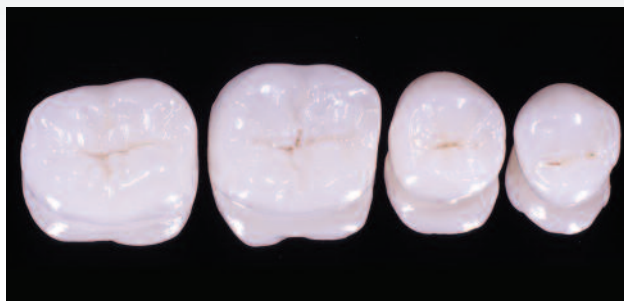
Fig. 4: Onlays made of leucite-reinforced glass-ceramic (IPS Empress Esthetic). The minimum layer thickness of the occlusal surface is 1.5 mm.

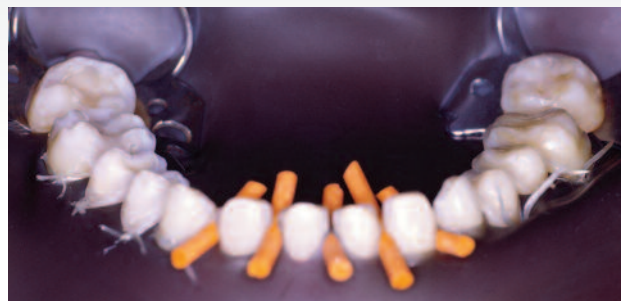
Fig. 5: Adhesive placement of the restorations in the mandible using the total-etch technique and rubber dam isolation.

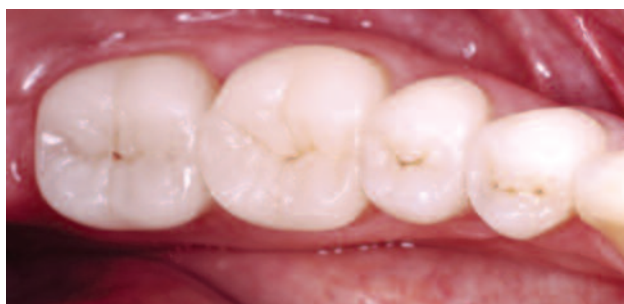
Fig. 6a: Onlays on teeth 34 to 37 after adhesive cementation in 2004 (cf. Fig. 4)

At a follow-up examination conducted more than eleven years after the restorations had been placed, 15 posterior onlays were retained in an undamaged state (Figs 6a and b). However, cracking had been noticed on the glass-ceramic onlay of tooth 24 after more than six years of clinical performance and for this reason the onlay had subsequently been replaced. Close inspection of the mandibular anterior veneers revealed a severe wear facet on veneer 43 (Figs 7a to c). Similar to the other veneers, this area was in direct

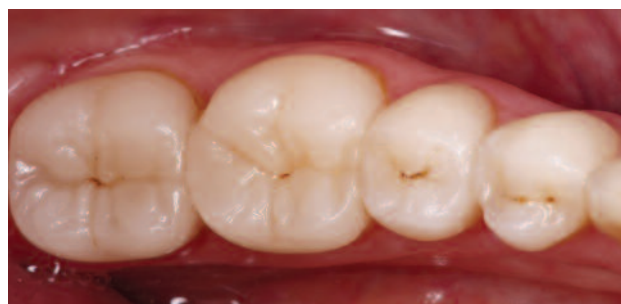
Fig. 6b: Onlays on teeth 34 to 37 in the summer of 2015, after having been in situ for eleven years (cf. Fig. 6a)

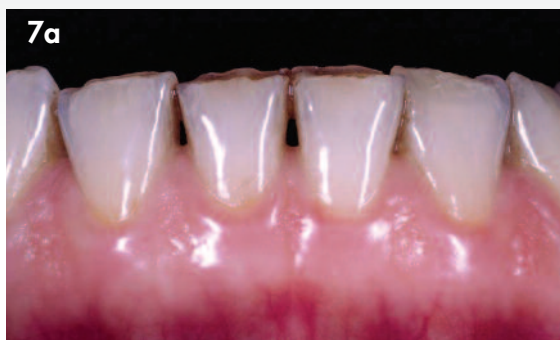
Fig. 7a: Preoperative situation: mandibular anterior teeth showing substantial changes in proportion and exposure of dentin due to a reduction in VDO.

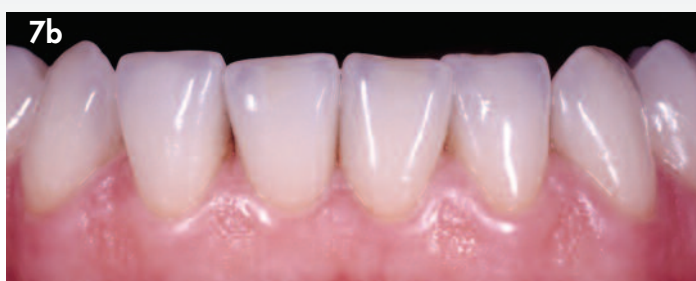
Fig. 7b: Layered veneers (IPS d.SIGN) in the mandibular anterior region after adhesive cementation

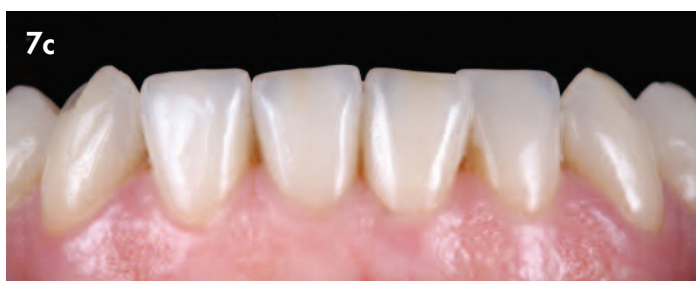
Fig. 7c: Mandibular veneers in the summer of 2015: a severe wear facet has formed on tooth 43 over the eleven years since the veneers were placed (cf. Fig. 8b).

contact with the lithium disilicate crowns on the maxillary anterior antagonists during dynamic occlusion.
