Application of the Straumann® BLT Ø 2.9 mm implant in a narrow interdental space

This case report describes the application of the Straumann® BLT Ø 2.9 mm implant in a narrow interdental space. It can be concluded that Straumann® BLT Ø 2.9 mm Bone Level Tapered (BLT) implants represent a safe and reliable solution for both narrow interdental spaces and narrow ridges.

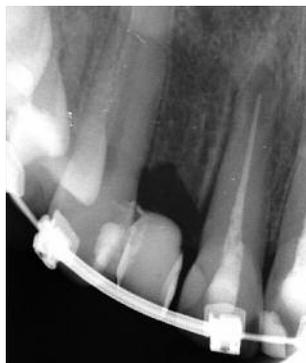
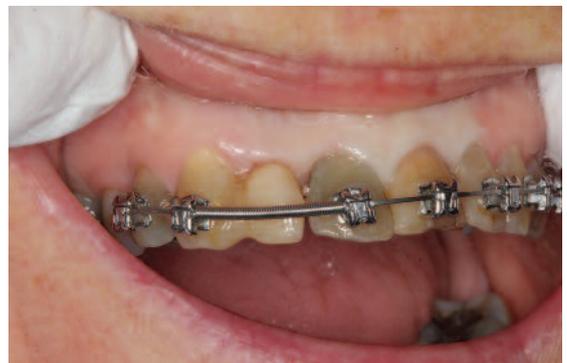
The patient, a healthy non-smoking 55-year-old female, presented at the practice after losing her tooth #12 due to chronic apical infection. On clinical examination we observed very limited space in the region 12 (Figs. 1,2). The patient also suffered from a TMJ condition with wear facets and daily headaches.

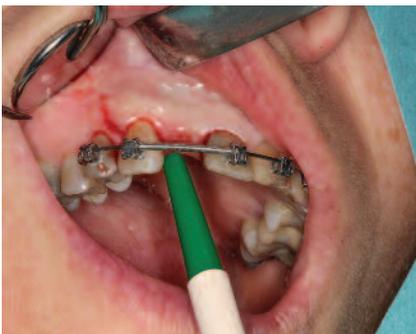
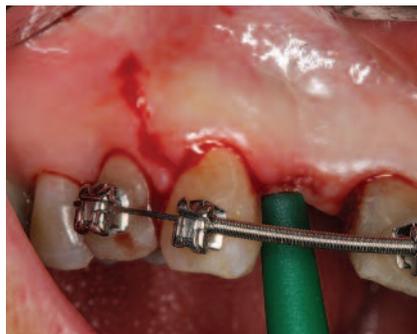
To reduce scar formation a marginal incision was made from #13 to #11, with a distal releasing incision at #13 (Figs. 4,5). The flap was deflected at the exposed bone – a narrow ridge in all dimensions (Figs. 6,7). After the pilot drilling and x-ray control of the axis (Figs. 7-9), the preparation of the implant bed was continued with the 2.2mm drill and the profile drill (Figs. 10-13). Next, the 2.9mm Straumann® BLT implant (Roxolid®, SLActive®) was inserted with a primary stability of 25Ncm, and the anatomical healing abutment was then connected (Figs. 14-

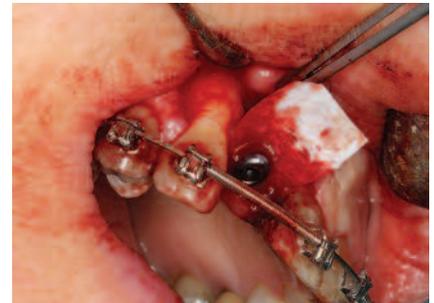
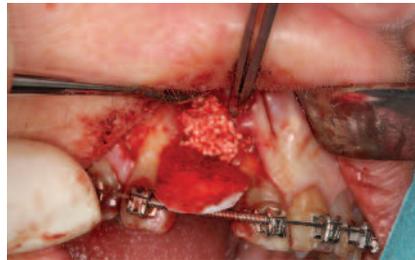
18). Due to the limited bone thickness in the buccal region and a small coronal dehiscence, bone augmentation with botiss cerabone® and a Jason® membrane was also performed (Figs. 19-23). The flap was closed passively with 5-0 Prolene sutures (Figs. 24-27). The patient was prescribed antibiotics, analgesia and anti-inflammatory medication, as well as chlorhexidine rinse for 1 week. Suture removal and subsequent healing was uneventful.

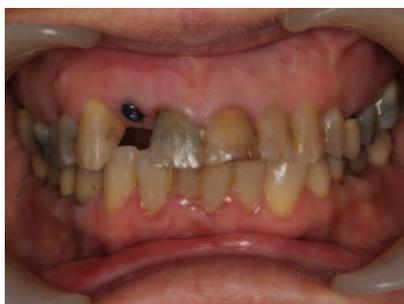
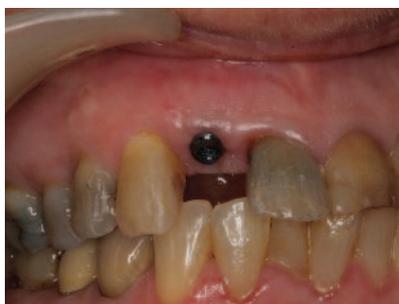
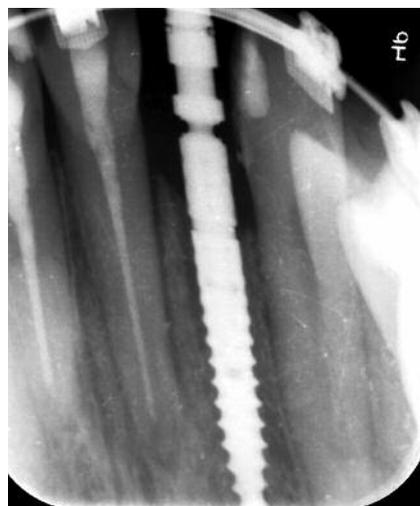
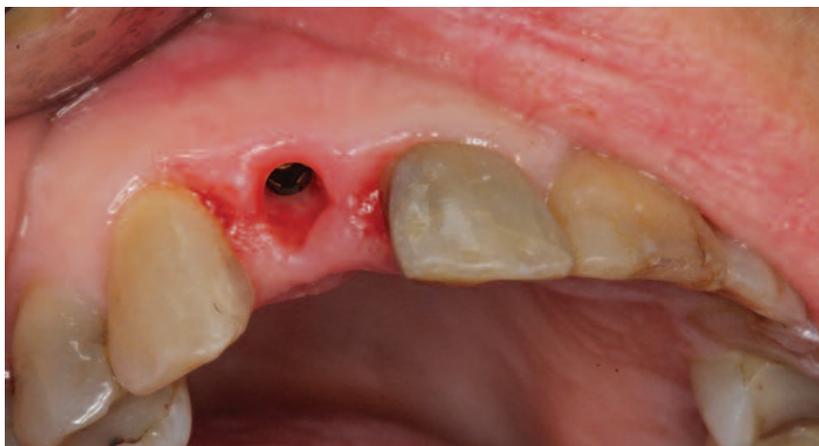
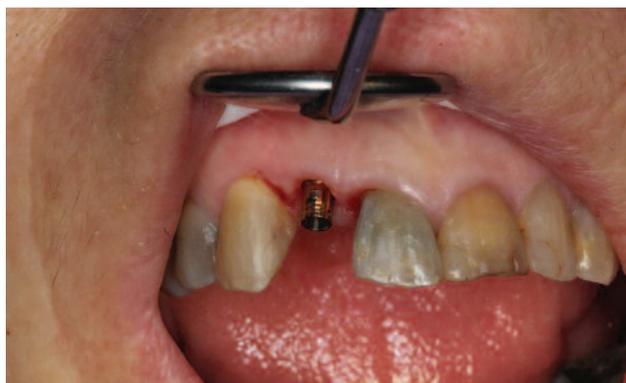
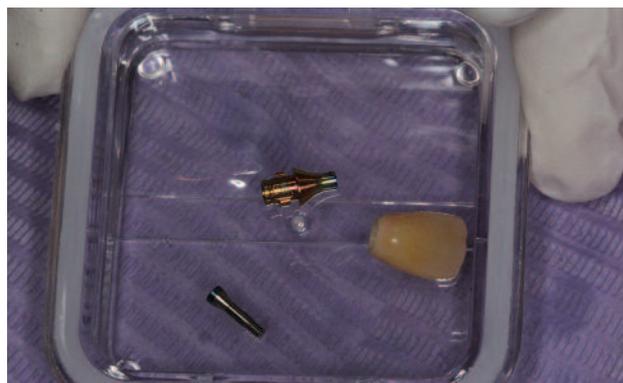
After 3 months healing time (Figs. 28-31), the healing abutment was removed and a conventional impression taken. Because of a slight facial inclination of the implant, and due to the very limited bone and space, a cemented full ceramic crown on a Straumann® Variobase® abutment was chosen (Fig. 33) to avoid possible localization of a screw channel on the incisal edge. The papilla was given

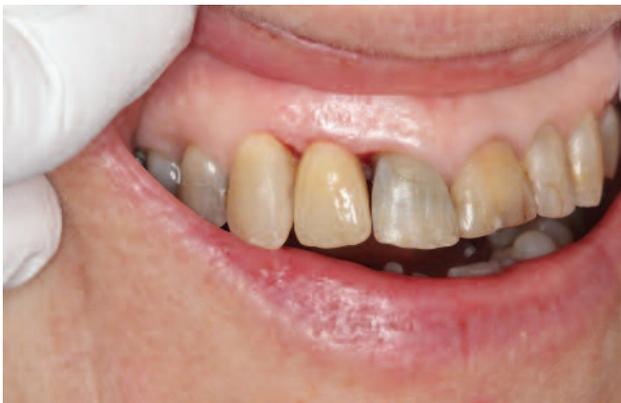
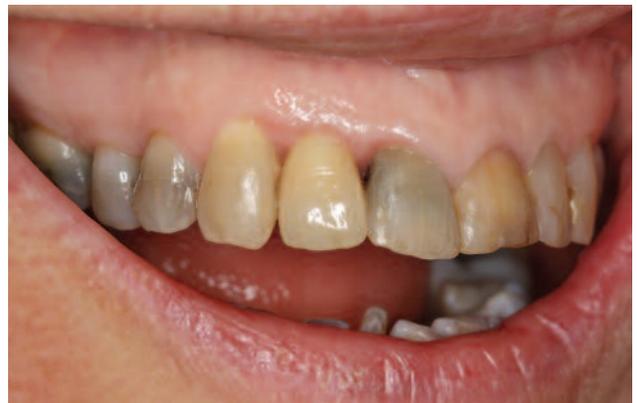
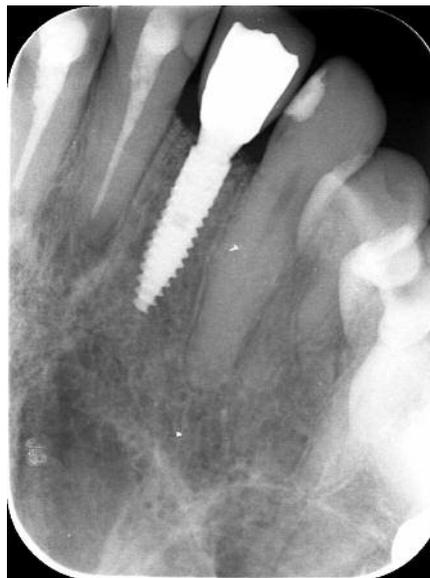
Both the patient and dentist were very happy with the final treatment result (Figs. 34-36). The occlusion was balanced, the headache had gone and the smile was restored. The patient is currently considering veneers on #11 and #21.
