Managing the failing dentition

Kamal Suri¹

Patient case - Adele

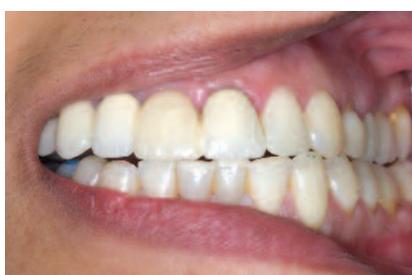
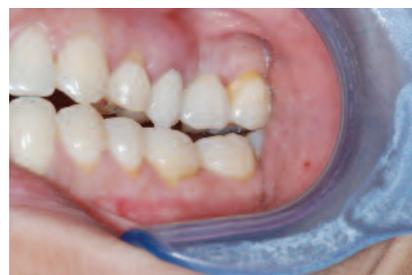
Figure 8a: Left lateral excursion.

Figure 8b: Left lateral excursion.

- Group function guidance on left excursion, finishing on the UL5 (Figures 8a and 8b)
- Group function guidance on right excursion involving UR1 (Figure 9)
- In right lateral excursion UL4 and UL5 non-working side interferences – palatal cusps (Figure 10)
- Anterior guidance all on the UR1 (Figures 11a and 11b)
- Functional mobility (fremitus) of upper anterior teeth and left premolars on biting in ICP.

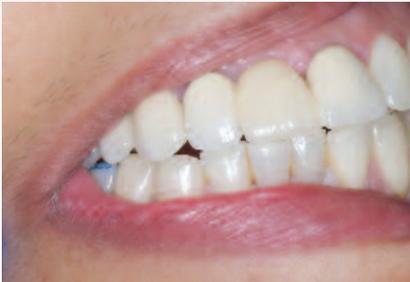
Figure 9: Right lateral excursion.

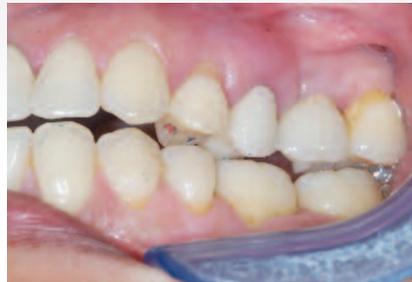
Figure 10: Non-working side interference.

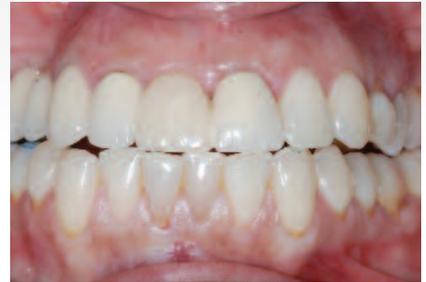
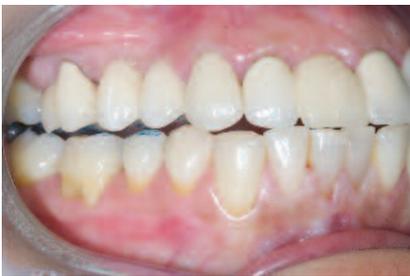
Figure 11a: Anterior guidance.

Figure 11b: Anterior guidance.

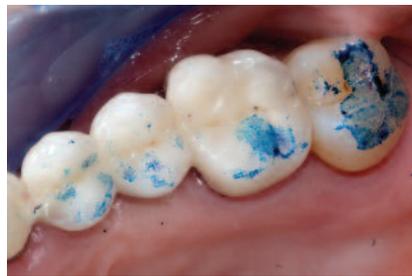
Figure 12: Markings showing heavy occlusal contacts during function on UR7 and UR6.

The UR6 had a narrow area of interproximal bone and significant buccal recession. This tooth was in working and non-working side interference in lateral excursion; primary

occlusal trauma. The tooth was also a major retainer for a four-unit bridge. By restoring it as a single unit and reducing the interfering contacts and sharing the lateral load the prognosis of the tooth would improve.

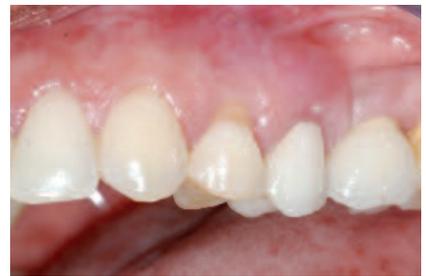
Figure 13a: Recession around the UL4 relating to the bone loss around the tooth.

The UL4 and UL5 were deemed hopeless due to the bone loss and mobility around the UL4 and the fracture, caries and heavily restored nature of UL5.

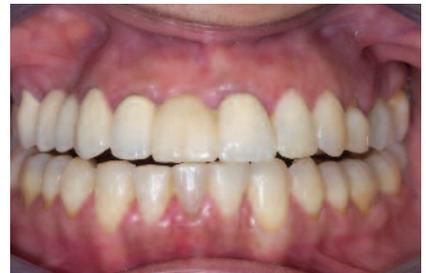
Figure 15: After lower fixed orthodontics, lower incisor was extracted.

- Fixed orthodontics
- Lingual retention.

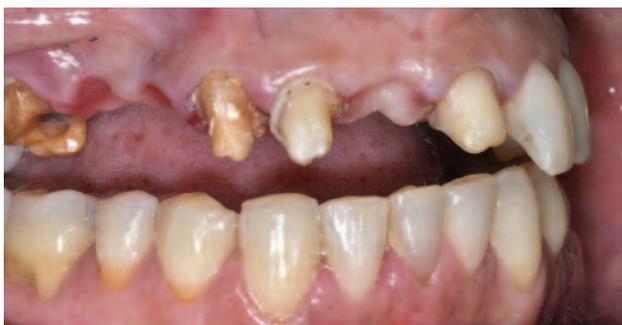
Figure 16: Removal of existing restorations.

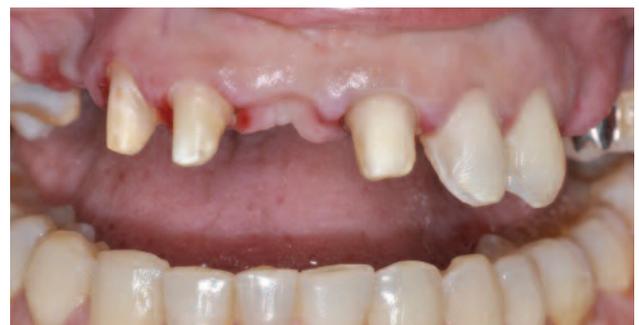
Figure 17: Refinement of the prepared teeth. Minimal veneer preparation on UL2 and UL3.

- Extraction UL4, UL5
- Implant placement UR4, UR5, UL4 all with Atlantis abutments
- E.max porcelain crowns UR6– UR3
- E.max Porcelain bridge UR2 – UL1
- E.max veneers UL2, UL3
- Porcelain fused to metal bridge UL4 implant – UL6 implant
- Both UR7 and UL7 unrestored.

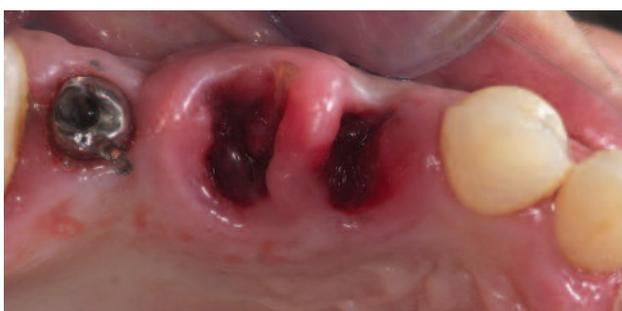
Figure 18: Extraction of hopeless teeth.

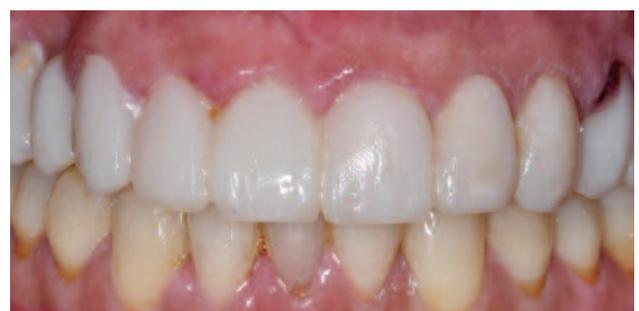
Figure 19: Provisional Luxatemp bisacryl restorations.

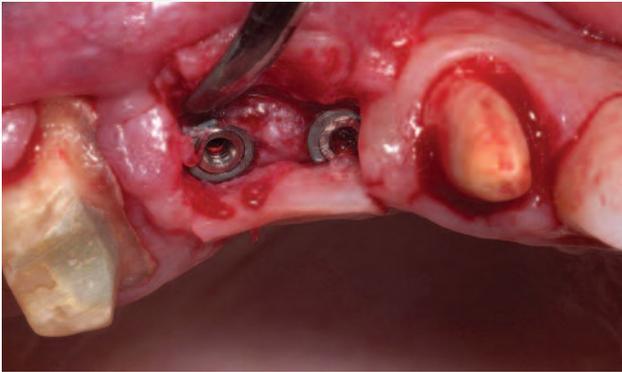
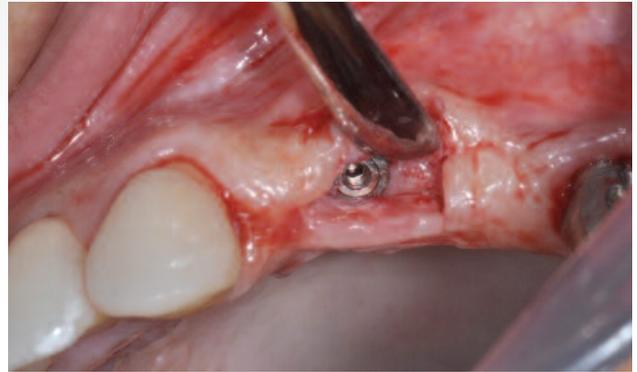
Figure 21a: Uncovering of implants four months after placement.

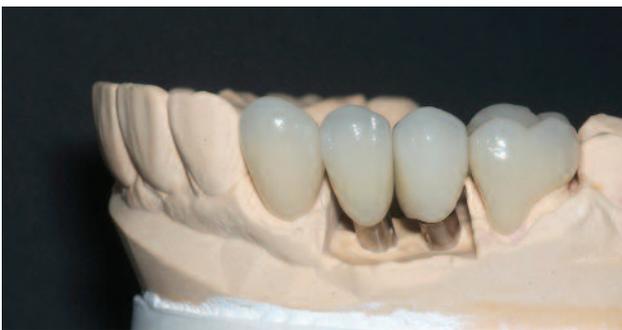
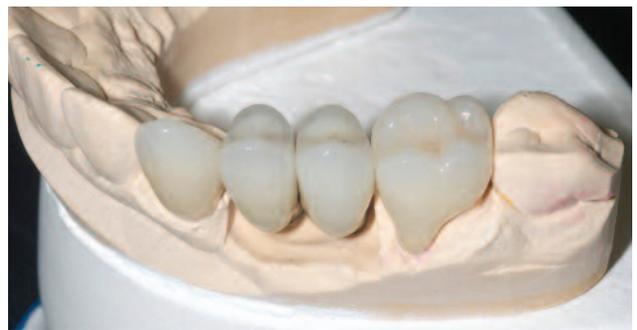
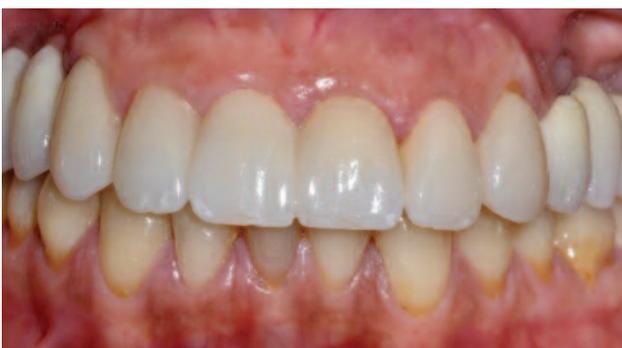
Figure 22a: Restoration of Ankylos implants with Atlantis abutments and E.max crowns.

Figure 22: Restoration of Ankylos implants with Atlantis abutments and E.max crowns.

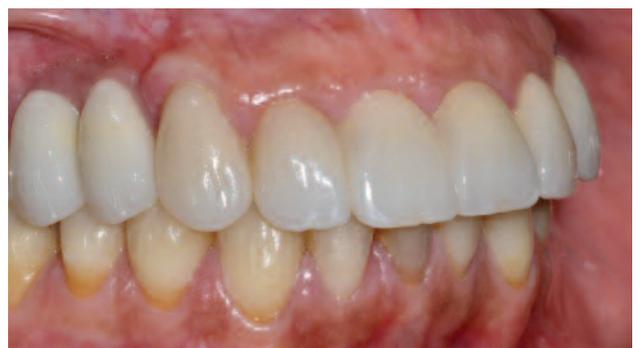
Figure 23: Fully restored and rehabilitated dentition.

- An improvement in OHI and gum health - from 58% bleeding score to 10%
- A reduction in pocket depth and BPE score
- A reduction of excessive pressure on the teeth
- Adaptive mobility within normal limits
- Improvement of guidance patterns
- Increased stability of bite
- Improvement of aesthetics.
