Simple chords of shades for harmonious restorations

Case 1: Anterior restorations using monochromatic & multi-shade techniques

Case 2: Posterior restoration using a cusp by cusp approach

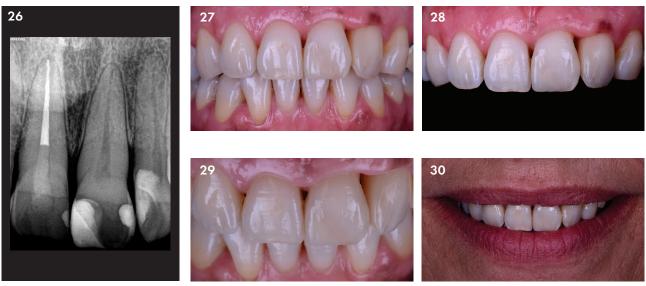
Fig. 26: Post-operative X-ray.

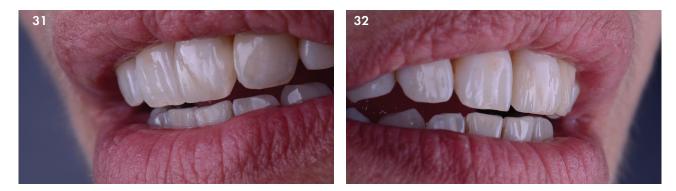
Fig. 27 to 32: Post-operative situation at one week.
