Masterclass in Clinical Practice Endodontics

The use of magnification, transillumination and methylene blue dye to determine the extent of structural cracks in teeth

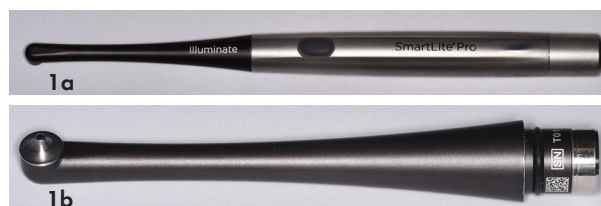
Figure 1. (a and b) The SmartLite Pro Transillumination Tip (Dentsply Sirona) is a diagnostic aid for the SmartLite Pro Curing Light (Dentsply Sirona) that helps visualize interproximal caries, evaluate cracked teeth and to illuminate endodontic access cavities when looking for missed canal systems.

Transillumination by aiming an LED light source perpendicular to the fracture plane at the cervical level of the tooth, is another important aid for identification of cracks. A crack that propagates into the dentine will cause a disruption in the light transmission.

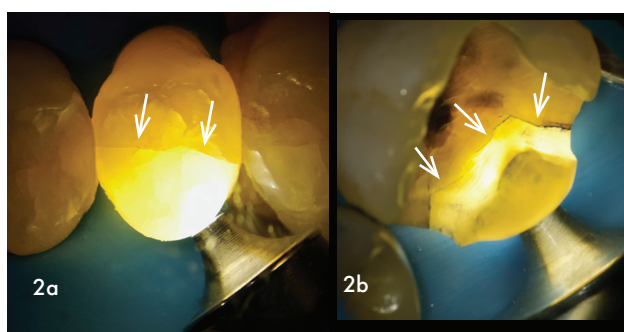
Figure 2.(a) Transillumination of a maxillary premolar with a suspected crack using the SmartLite Pro Transillumination Tip (Dentsply Sirona). Illumination from the palatal cusp showed evidence of mesial-distal crack in the tooth (arrows). Note that the crack blocked the light from adequately illuminating the buccal cusp; (b) Transillumination of the mesio-buccal cusp of a maxillary first molar outlining a cusp fracture (arrows) that was visible after removal of a previous amalgam restoration.

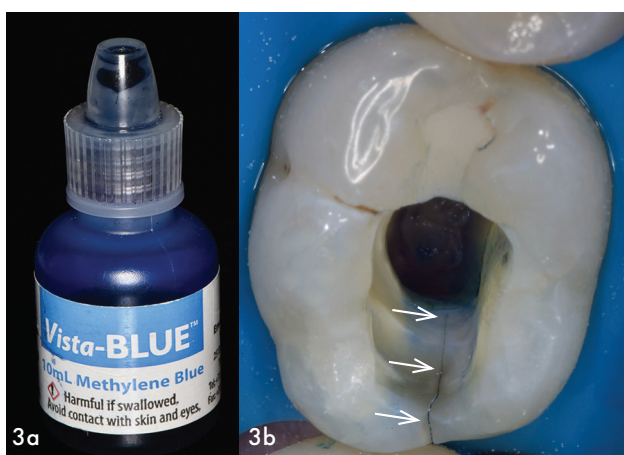
Figure 3.(a) Vista-Blue methylene blue dye (Vista Dental); (b) High magnification view through the DOM (X15) of the pulp chamber of a non-vital mandibular right first molar. After access cavity preparation a crack was noted on the distal marginal ridge. After staining the surface with methylene blue dye for 10 seconds it was rinsed with water and air-dried. Note the extent of the crack up to the pulp chamber floor (arrows).

Methylene blue dye is another option that can be used for identification of cracks in teeth (Figure 3). It helps to further determine the extent of the crack which is vital information to select the ideal treatment. Staining cracks with this dye often makes the difference between deciding to preserve the tooth or to extract. Methylene blue dye is superior to caries-indicator dyes as it pools much better and its dark blue colour optimises visibility. This allows for better documentation using photography as well as patient communication when discussing treatment options and long-term prognosis. Some negative aspects of using this dye is that it will stain plaque profusely as well as dentine surfaces previously exposed to sodium hypochlorite.

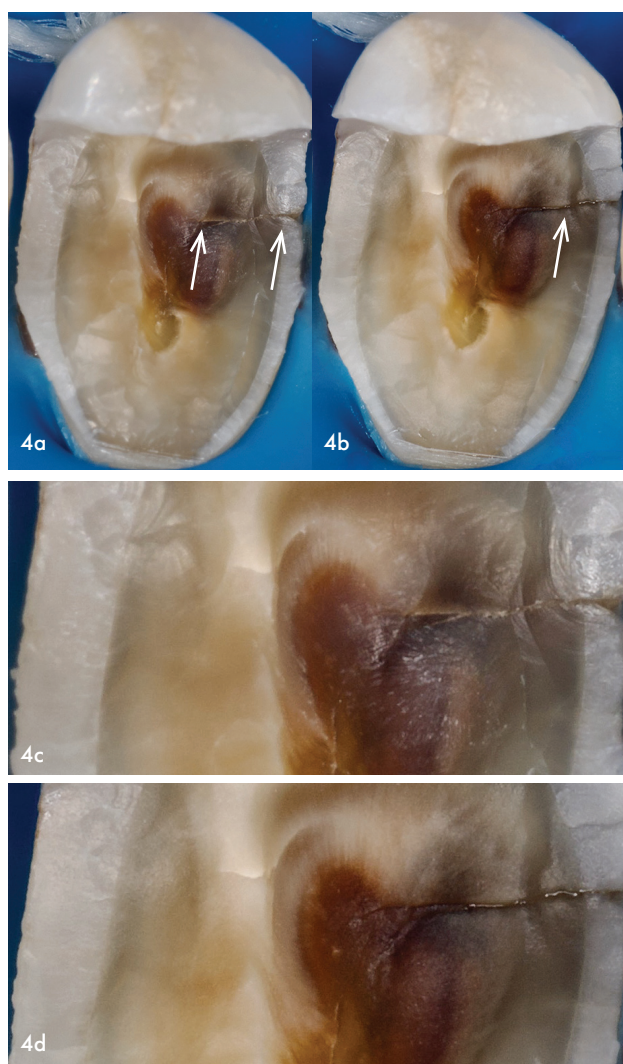
Figure 4.(a) High magnification view under the DOM (X12.5) of a right maxillary second premolar tooth after removal of a previous amalgam restoration that caused a buccal cusp fracture. There was evidence of a crack extending from the distal gingival margin up to an island of secondary dentine covering the roof of the pulp (arrows); (b) After sandblasting the surface with 29 micron aluminium oxide the biofilm was removed from the crack and crevicular fluid (arrow) was visible inside the crack indicating a structural crack; (c) 19X magnification view of the crack before sandblasting; (d) 19X magnification view of the crack after sandblasting.

with a rubber cup in conjunction with coarse pumice slurry or air polishing of the tooth surface with bicarbonate of soda or glycine powder in order to remove the biofilm prior to staining and examination under the DOM. Air polishing also has the ability to remove the biofilm in the cracks and this greatly improves the visualisation of the cracks especially with regards to depth, extent and fluid movement through the dentine crack.

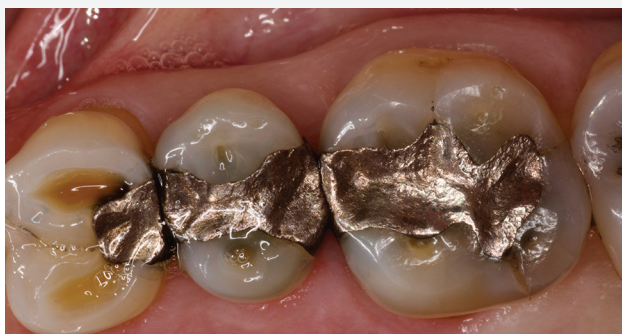
Figure 5 . Preoperative view of a 54-year-old male patient that reported with signs symptoms of irreversible pulpitis in his maxillary left first molar previously restored with a MO amalgam restoration.

A 54-year-old male reported with symptoms of irreversible pulpitis of his maxillary first left molar previously restored with a MO amalgam restoration (Figure 5). After air polishing the occlusal surface of the tooth with bicarbonate of soda, the occlusal surface was stained with methylene blue dye for 5 seconds and rinsed off with water and dried. Examination under magnification revealed two cracks on the distal marginal ridge and on the disto-palatal aspect of the tooth (Figure 6).

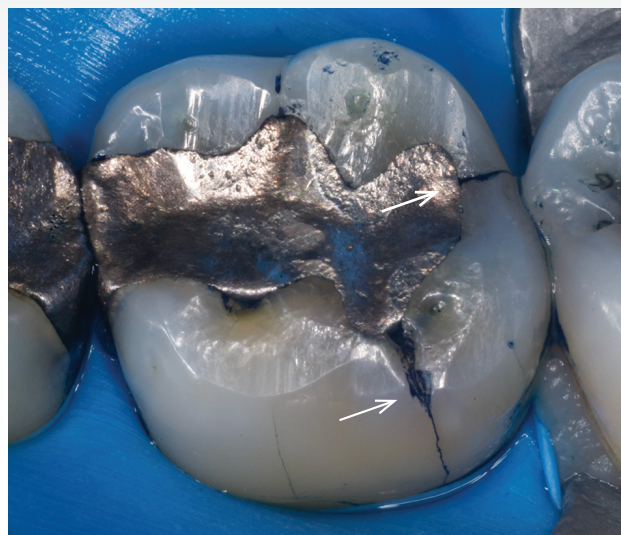
Figure 6. After air polishing the occlusal surface of the tooth with bicarbonate soda the occlusal surface was stained with methylene blue dye. Two cracks were confirmed. One on the distal marginal ridge and on the disto-palatal aspect of the tooth.

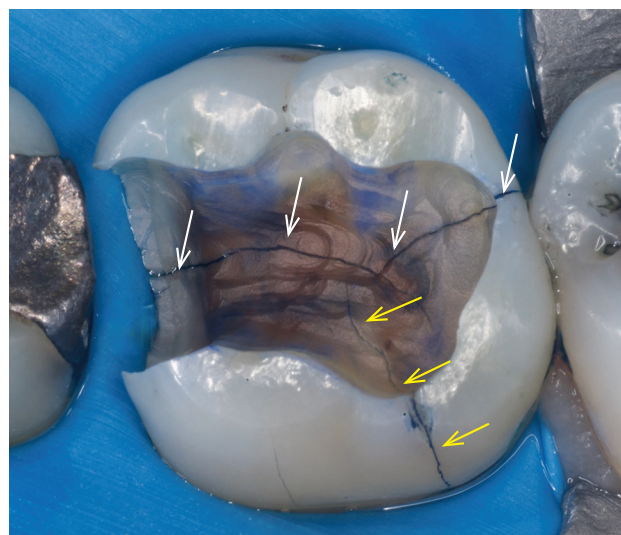
Figure 7. Occlusal view after removal of the amalgam restoration, air particle abrasion with 29 micron aluminium oxide and staining exposed dentine with methylene blue dye. Note the mesio-distal crack was visible extending from the mesial gingival margin, across the pulpal floor and ending over the distal marginal ridge (white arrows). A second crack from the disto-palatal aspect joining at an oblique angle with the mesio-distal crack was also evident (yellow arrows).

The amalgam restoration was removed and the cavity preparation surface cleaned with 29 micron aluminium oxide particle abrasion before staining the exposed dentine with methylene blue dye. A structural mesio-distal crack was visible extending from the mesial gingival margin, across the pulpal floor and ending over the distal marginal ridge. A second crack from the disto-palatal aspect joining at an oblique angle with the mesio-distal crack was also evident (Figure 7). The pulp chamber was opened, inflamed tissue removed, surfaces air abraded and the methylene blue dye reapplied. A high magnification view of the pulp chamber

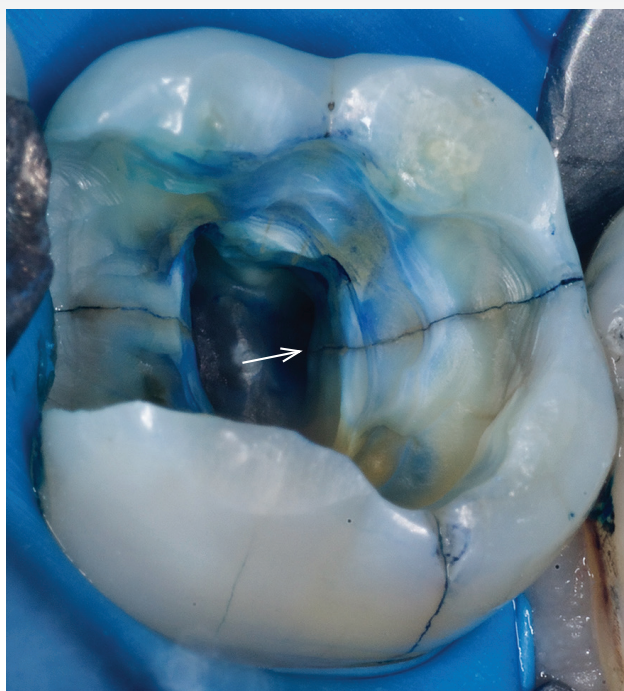
Figure 8. High magnification view of the distal aspect of the pulp chamber and reapplication of the methylene blue dye. Note the distal crack extends into the distal root canal system (arrow).

revealed that the distal crack extends past the pulp floor into the distal root canal system (Figure 8) and the mesial crack extended into the pulp floor right up to the MB2 canal orifice (Figure 9). Due to the nature and extend of these cracks it was decided to extract the tooth.

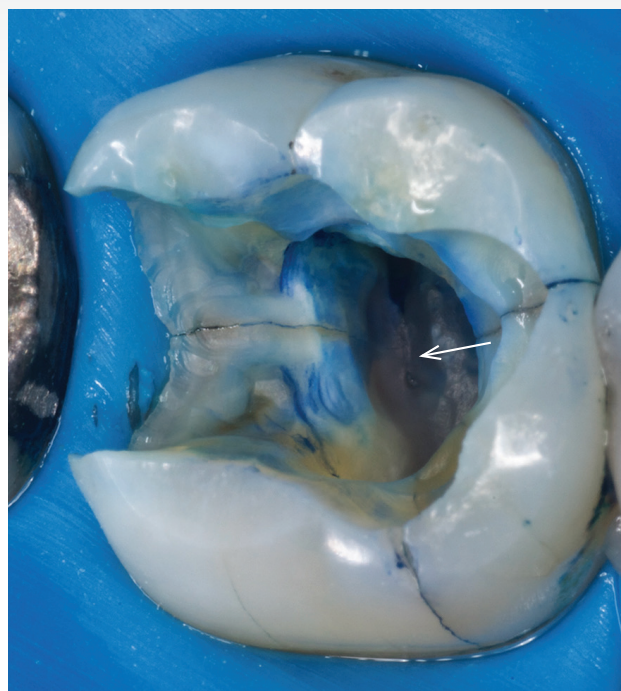
Figure 9. High magnification view of the mesial aspect of the pulp chamber. Note the distal crack extends into the pulp floor right up to the MB2 canal orifice.
