# Cusp replacement restoration on tooth 26

## About the case

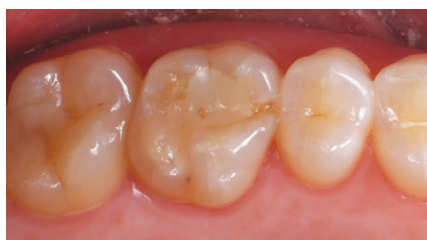
Fig 1: **Preoperative:** mesial fracture with a crack line through the mesiobuccal cusp on the existing restoration.

Upper left first molar (tooth 26). The patient presented with sensitivity and discomfort on biting on the upper left. On examination, the 26 showed a mesial fracture with a cracked mesiobuccal cusp, and the radiograph revealed secondary decay in the mesial area beneath the existing restoration.

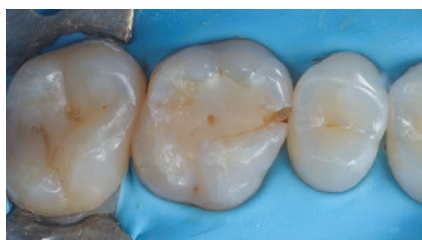
Fig 2: **Isolation:** sectional rubber dam placed for a clean, dry field.

- 1. Isolation** — The tooth was isolated with rubber dam for a clean, moisture-controlled field.
- 2. Caries removal & cusp reduction** — The old restoration was removed and the secondary decay fully excavated. The mesiobuccal cusp was reduced by ~1 mm to overlay and protect the cracked segment.  
*Key point: overlaying the compromised cusp reinforces it instead of leaving a crack to fail later.*

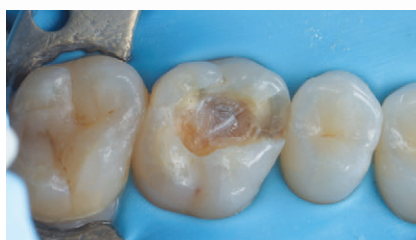
Fig 3: **Old restoration partially removed:** initial decay cleaned out.

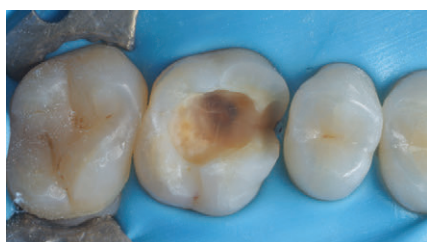
Fig 4: **All decay and unsupported structure removed:** MB cusp reduced 1 mm for a cusp overlay; mesial box shaped while chasing the crack line and assessing its extent.

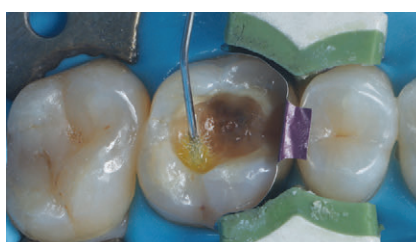
Fig 6: **Bonding:** universal adhesive (Tetric N-Bond) applied to enamel.

- 3. Surface prep & bonding** — The preparation was cleaned of all residual decay and then sandblasted with 50 µm aluminium oxide to create an optimal bonding surface, before being bonded with Tetric N-Bond..

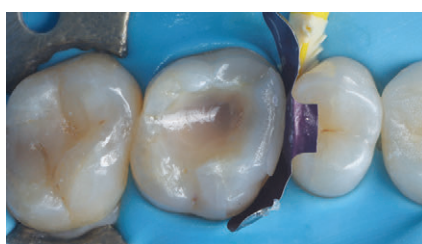
Fig 8: **Marginal ridge built:** with Tetric N-Plus — MB cusp intentionally left for later.

- 5. Mesial box — bulk flowable** — The mesial box was filled first with a bulk-fill flowable (Tetric N Power Flow 2).
- 6. Rebuild the marginal ridge** — The mesial marginal ridge was rebuilt and shaped with Tetric N-Plus to establish the ideal contact and ridge — only the marginal ridge at this stage, not the cusp.

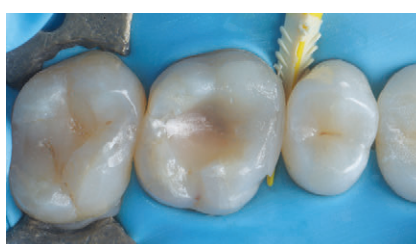
Fig 9: **MB cusp rebuilt:** with direct access after the ring was removed.

- 7. Rebuild the MB cusp separately** — With the ridge set, the ring was removed and the mesiobuccal cusp was accessed and rebuilt directly.  
*Key point: separating this step gives far better access and a more predictable cusp shape.*

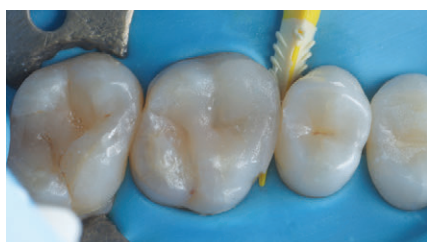
Fig 10: **Capping layer:** occlusal and lateral MB completed in a single layer of Tetric N-Plus, shaped with LM instruments.

- 8. Occlusal bulk** — The bulk of the occlusal defect was filled with the bulk-fill flowable (Tetric N Power Flow 2).
- 9. Capping layer & anatomy** — A final capping layer of Tetric N-Plus was carved with LM instruments (LM condenser and fissura) to sculpt ideal anatomy.

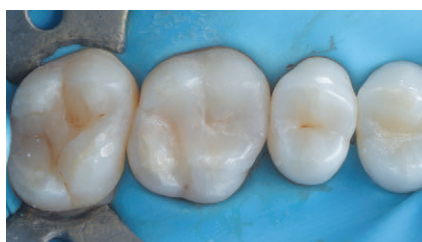
Fig 11: **Finished and cleaned**

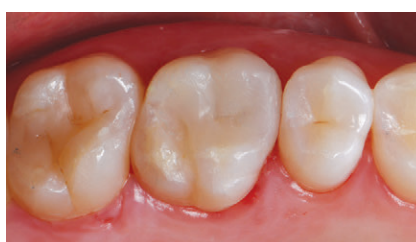
Fig 12: **Final result:** after occlusal check and final polish.

- 10. Finish** — Occlusion checked, finished and polished to a functional, natural-looking result. When the treatment was complete, the inlays integrated well into the natural environment.
