# Full arch reconstruction of the edentulous maxilla: from bone augmentation to final monolithic zirconia restoration

João Caramês<sup>1</sup>

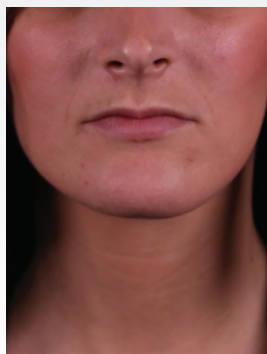
<sup>1</sup> Prof. Dr. João Caramês, DDS Full Professor and Chairman of the Oral Surgery and Implant Department, President of the Scientific Committee at Lisbon University Faculty of Dental Medicine (FMDUL). Principal Investigator on the Implantology research group at the Oral and Biomedical Research Unit of the Lisbon University Faculty of Dental Medicine (UICOB/FMDUL). Private practice, focused on Oral Surgery and Implant Dentistry, Lisbon, Portugal.

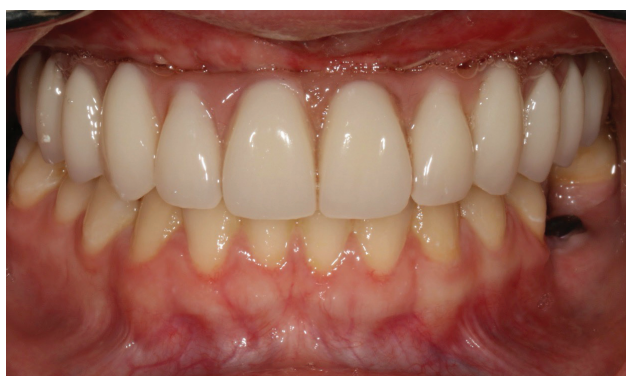
A temporary screw-retained prosthesis was delivered immediately, following the immediate loading protocol, to maintain function and esthetics during the healing phase (Fig.
