Biodentine™, a promising bioactive material for the preservation of pulp vitality in restorative dentistry

Case Report no.1

Case Report no.2

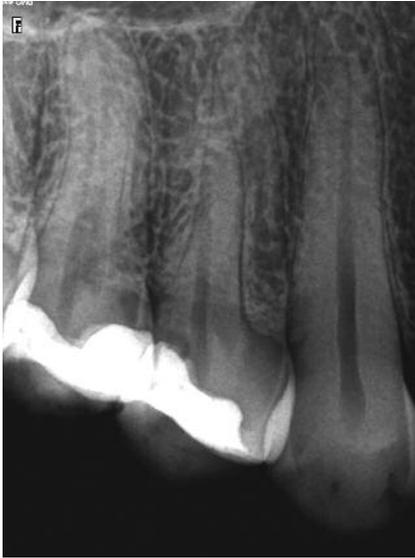
Figure 1: Preoperative radiograph showing recurrent caries below existing amalgam restorations in teeth # 14 and 15.

A 38 year-old female patient, with free medical history, came complaining of tooth sensitivity at the upper right maxilla, after consuming cold and hot beverages. Diagnostic assessment and radiographical examination revealed secondary carious lesions below existing amalgam restorations in teeth # 14 (distally) and # 15 (interproximally) (Fig. 1). Both teeth were tested positive on CO₂ snow sensitivity and negative on percussion. The patient was informed about the need of having the carious lesions treated and the amalgam fillings replaced.

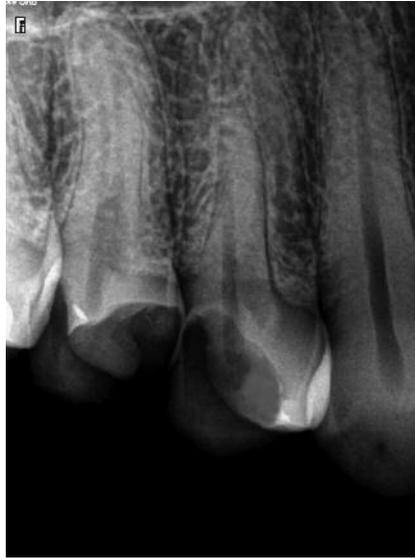
Figure 2: Radiograph taken after caries removal, showing close proximity of the cavity walls to the pulp, especially for tooth # 15.

After patient consent, local anesthesia was performed (Articaine HCL 4% and 1:200000 adrenaline, Ubistesin, 3M ESPE), the amalgam restorations were removed and the carious dentin was completely excavated (Fig. 2). At the proximal cavity area of tooth # 15 a very thin pulp facing layer of remaining dentin could be observed (Fig. 3).

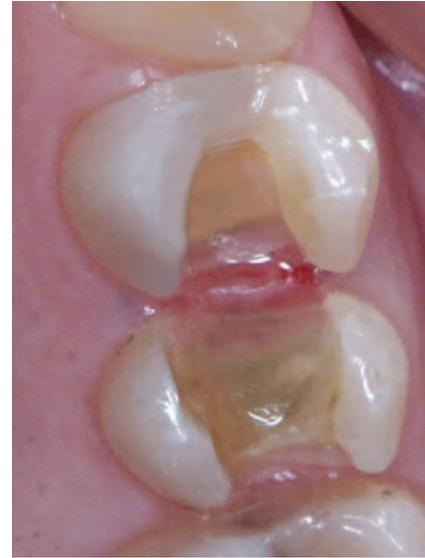
Figure 3: Clinical picture after caries removal.

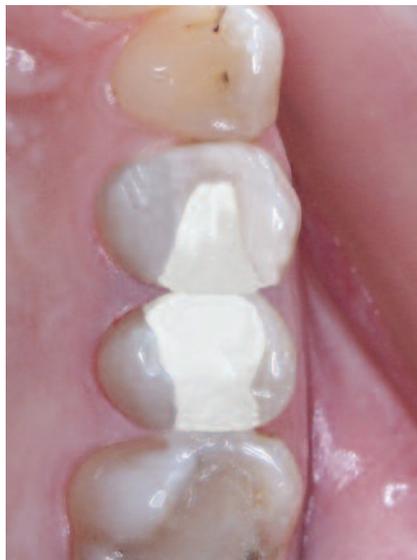
Figure 4: Biodentine™ was placed as a bulk material to restore both cavities and left in place for 6 weeks. The material has a smooth surface after setting.

Biodentine™ (Septodont) was chosen as a provisional filling material of the entire cavity of both teeth (Fig. 4, 5). The material was handled according to the manufacturer's instructions. This decision to use Biodentine™ was based on a previous history of unsuccessful outcome of indirect pulp capping after caries removal in teeth # 24 and 25 of the same patient, by using calcium hydroxide capped by a GIC as a cavity liner and final restoration with resin composites, which resulted to irreversible pulp inflammation 2 months after restoration. Biodentine™ was left in place for 6 weeks in order to ensure that pulp sensitivity would be eliminated while preserving pulp vitality (Fig. 6). The patient reported that she remained symptom free during the six week period, whereas both teeth were positive on CO2 snow sensitivity and negative on percussion. Biodentine™ was then partially removed to serve as a cavity liner (Fig. 7) and both teeth were restored with indirect composite restorations. Briefly, after final cavity preparation with Biodentine™ remaining as a dentin substitute, final impression was taken using a one-phase polyether material (Impregum, 3M ESPE) (Fig 8, 9). The teeth were restored with composite inlays (SR Adoro, Ivoclar Vivadent) that were cemented with a dual cure resin cement (Variolink II, Ivoclar Vivadent) (Fig. 10).

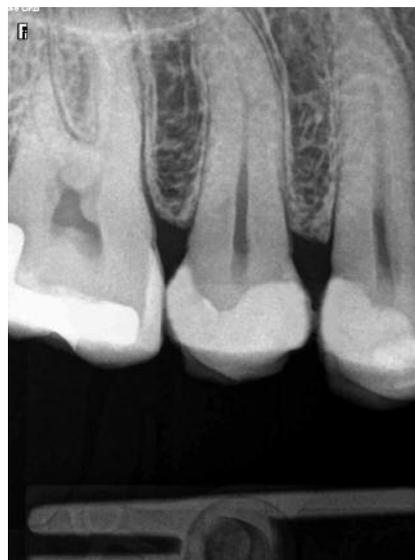
Figure 5: Radiograph after Biodentine™ placement.

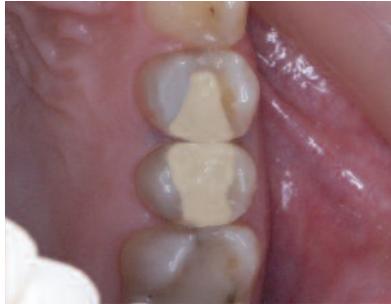
Figure 6: Biodentine™ restorations 6 weeks after placement. Marginal integrity of both restorations was fully preserved and no fractures were observed. A slight discoloration of both restorations could be recorded.

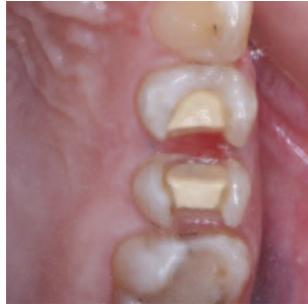
Figure 7: Biodentine™ was partially removed to serve as a dentin substitute.

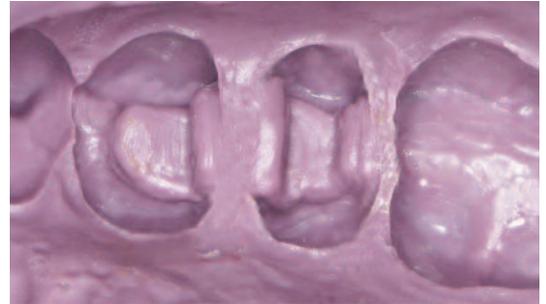
Figure 8: Final impression with one-phase polyether material.

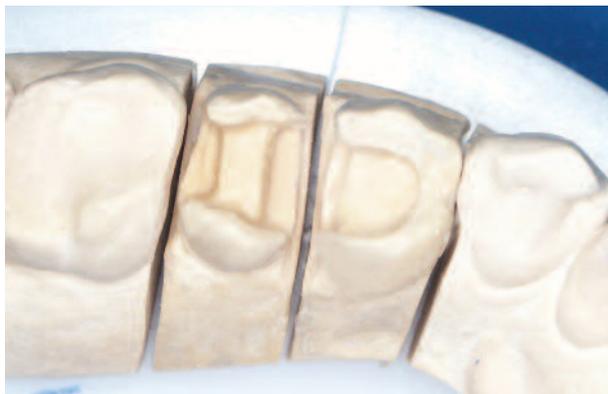
Figure 9: Final cast for the inlays build up with a laboratory composite.

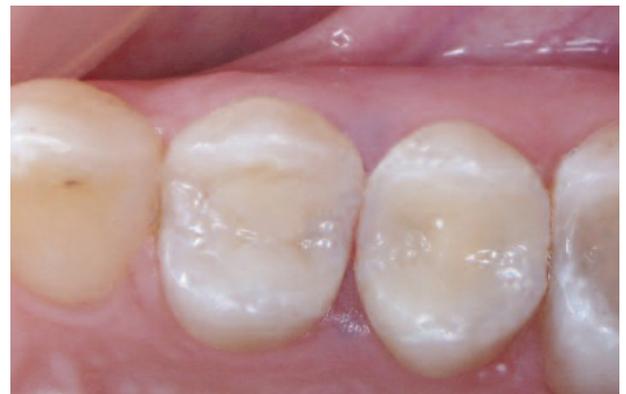
Figure 10: Final inlay restorations in place cemented with a dual cure resin cement.

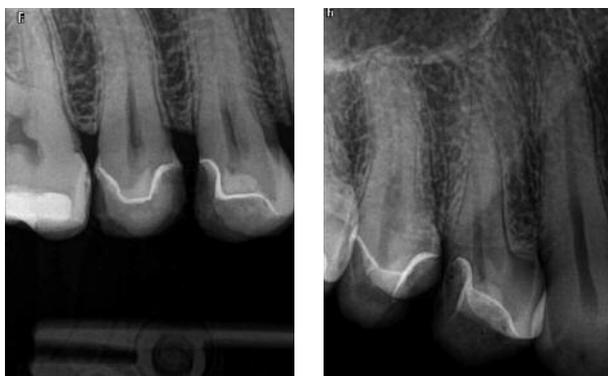
Figure 11: A, B Radiograph A. six months and B. 1 year posttreatment.

At the follow-up visit at 6 months and 1 year after treatment (Fig. 11 A, B) both teeth were free from any symptomatology and again tested positive for sensitivity and negative for percussion. Radiographical examination showed no signs of periapical pathology (Fig. 11 B).

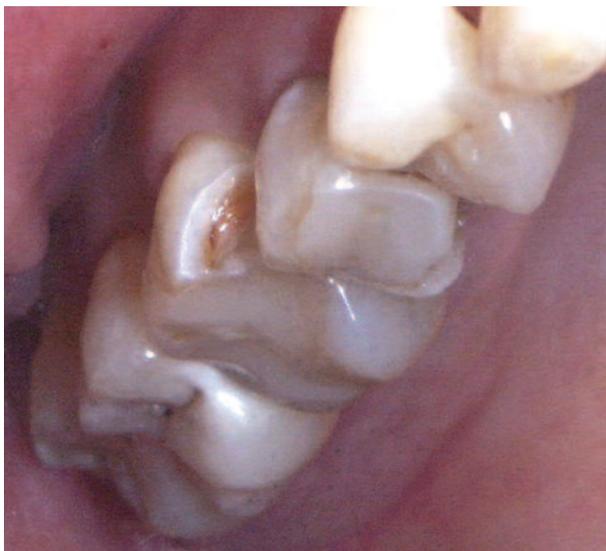
Figure 12: Preoperative clinical picture showing fracture of tooth # 26. Preoperative radiograph showing deep caries in teeth # 26 and 27 in close proximity to the pulp.

A 28 year-old female patient, with free medical history, came after fracture of her first upper left molar (# 26), which occurred during chewing (Fig. 12). Clinical and radiographical examination revealed deep caries at a very high proximity to the pulp in both upper molars (# 26 and # 27) (Fig. 13). Tooth # 26 had already a composite resin filling that was placed 2 years earlier.

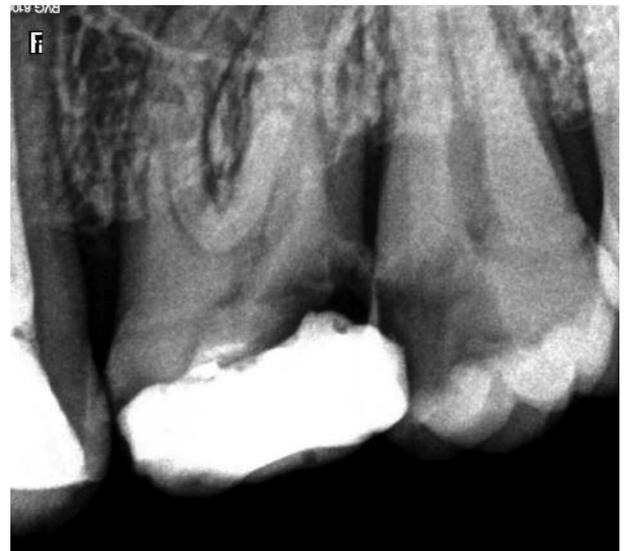
Figure 13: Preoperative radiograph.

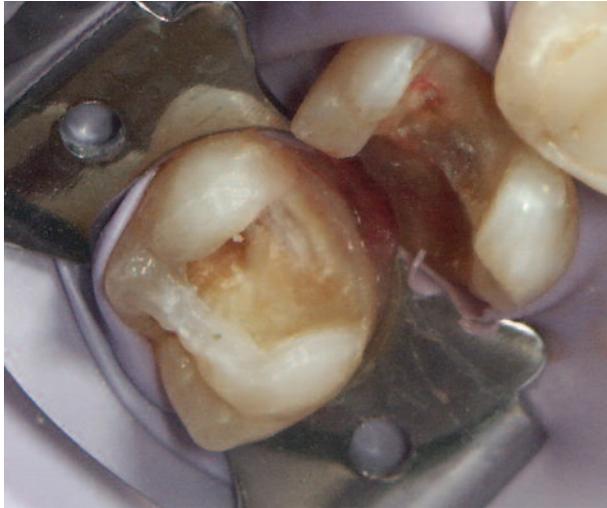
Figure 14: After caries removal the pulp was exposed iatrogenically in tooth # 26, whereas a very thin pulp facing layer of dentin could be observed in the distal area of 26, as well as the proximal area of 27.

Clinical examination also showed that both teeth were positive on CO2 snow sensitivity and negative on percussion. The patient did not mention any previous symptomatology derived from these teeth in her dental history. However, she mentioned that her two lower molars (# 36 and # 46) were endodontically treated due to deep caries that were symptom-free and therefore could not be diagnosed until they reached the pulp cavity. The patient was informed about the need of having the carious lesions treated and the possibility that an endodontic treatment would be required after caries removal. After patient consent, local anesthesia was performed (Articaine HCL 4% and 1:200000 adrenaline, Ubistesin, 3M ESPE) and a rubber dam was placed to avoid contamination with saliva in case a pulp exposure would occur. After excavation of the carious dentin, the pulp was exposed iatrogenically in tooth # 26, whereas a very thin pulp facing layer of dentin could be observed in the distal area of 26, as well as the proximal area of 27, both requiring indirect pulp capping (Fig. 14, 15). Clinically the pulp of the tooth # 26 at the exposure

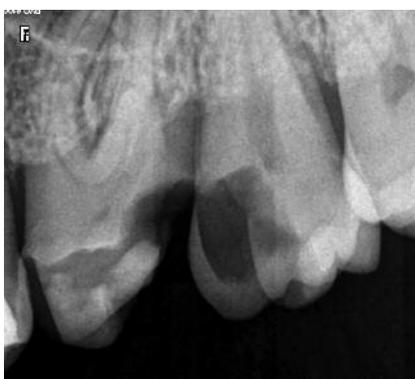
Figure 15: Radiograph after caries removal.

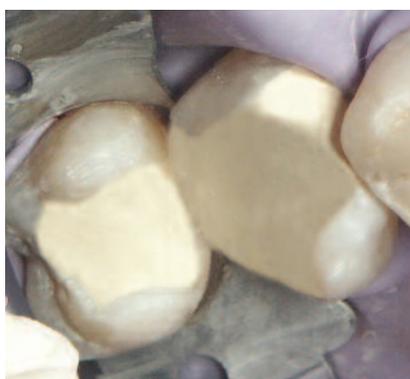
Figure 16: Biodentine™ was placed as a bulk material to restore both cavities and left in place for 6 weeks. A rubber dam was used to avoid bacterial contamination after pulp exposure.

site was vital without any major bleeding, so the maintenance of tooth vitality by direct pulp capping was decided upon. Cavity disinfection and control of the hemorrhage in tooth # 26 was performed with sodium hypochloride. Biodentine™ (Septodont) was chosen as a provisional filling material of the entire cavity of both teeth (Fig. 16). The material was handled according to the manufacturer's instructions. Biodentine™ was left in place for 6 weeks after which the patient came to receive her final restorative treatment (Fig. 17). During this period of 6 weeks the patient was symptom-free, whereas both teeth remained positive on CO2 snow sensitivity and negative on percussion. Biodentine™ was then partially removed in

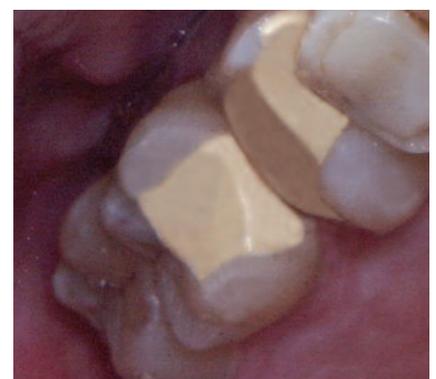
Figure 17: Biodentine™ restorations after 6 weeks of placement. Marginal integrity of both restorations was fully preserved and no fractures were observed.

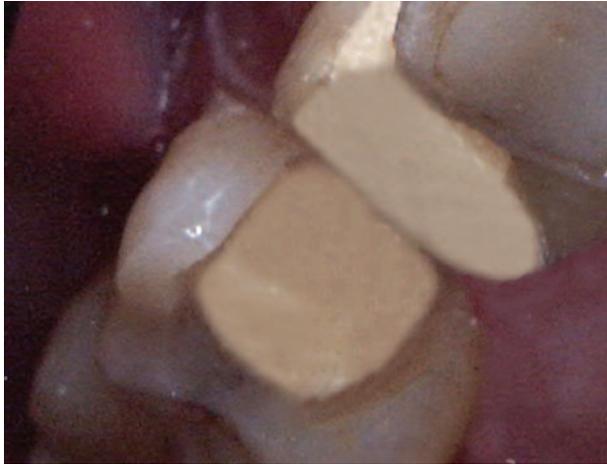
Figure 18: In tooth # 27 Biodentine™ was then partially removed and kept as a base/dentin substitute that was capped by a direct composite resin filling (Tetric EvoCeram, Ivoclar-Vivadent). Tooth # 26 was prepared for full coverage and Biodentine™ remained as an abutment build-up material.

tooth # 27 and kept as a base/dentin substitute that was capped by a direct composite resin filling (Tetric EvoCeram, Ivoclar-Vivadent), following normal procedures (acid etching of the cavity with phosphoric acid and application of single step adhesive of the same company) (Fig. 18, 19). Tooth # 26, on the other hand was prepared for a full coverage metal-ceramic crown due to the significant loss of dental hard tissues after caries removal. The tooth was prepared without removing Biodentine™ that remained and served as an abutment core build-up material (Fig 18). The final metal-ceramic crown was cemented with a conventional GIC (Fuji I, GC) (Fig. 19). At the follow-up visit after 6 months both teeth were free from any symptomatology and again tested positive for sensitivity and negative for percussion. Radiographical examination showed no signs of periapical pathology (Fig. 20).

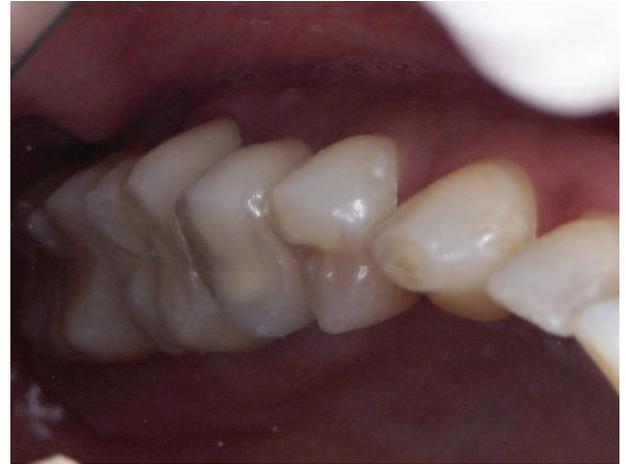
Figure 19: Post-operative clinical picture with a direct resin composite filling in tooth # 27 and a metal ceramic crown in tooth # 26.

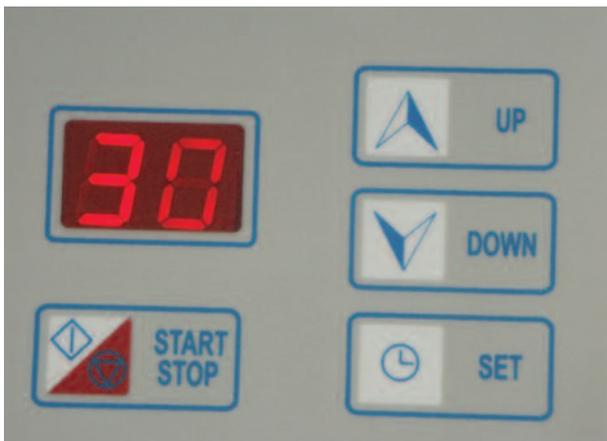
Figure 21, 22, 23: The material should be handled according to the manufacturer's instructions. It is important to add exactly 5 drops of liquid into the powder capsule and allow it to mix at a speed of 4000 – 4200 rotations/min for 30 seconds.

Compared to conventionally used pulp capping materials, such as calcium hydroxide, Biodentine™ presents significantly higher mechanical properties which are very similar to those of dentin (elastic modulus of 22 GPa, compressive strength of 220 MPa and microhardness of 60 VHN)¹⁴. This allows the preservation of the material as a base underneath resin fillings or even its use as a core-build up material in vital abutment teeth. Moreover, the ability of the material to create a firm bond with the underlying dentin substrate is highly required for core buildup materials, to ensure the preservation of the abutment integrity and therefore to lower the risk for crown or bridges detachment. Future studies are, however, required to evaluate the behavior of Biodentine™ as a core build-up material of vital abutment teeth in long-span fixed partial dentures, especially in teeth that serve as terminal abutments for such restorations that are normally subjected to higher masticatory forces. Although the handling properties of the material present some difficulties, this can be easily overcome by strict compliance to the manufacturer's instructions. It is important to add exactly 5 drops of liquid into the powder capsule and allow it to mix at a speed of 4000 - 4200 rotations/min for 30 seconds (Fig. 21-23). In case a lower amount of liquid is added the material is very dry and brittle, whereas a higher amount of liquid will give

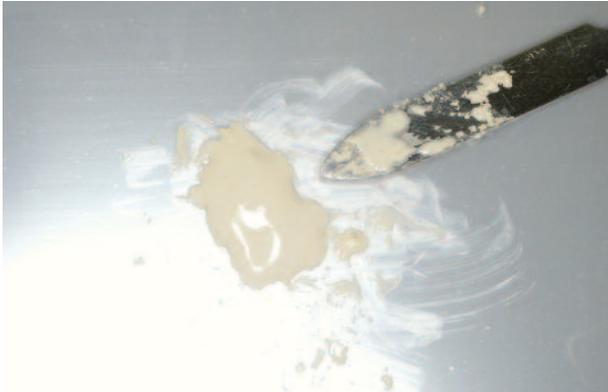
Figure 24: Correctly mixed material must have a creamy consistency.

the material a runny consistency making its handling very difficult. Correctly mixed material must have a creamy consistency (Fig. 24). It is also important to allow Biodentine™ to set for at least 12 min before matrix band and wedge removal (Fig. 25), otherwise the risk of material fracture is very high. Biodentine™ should not come in contact with liquids during its setting and for this reason application of a rubber dam is mandatory whenever possible. Moreover, the material should be applied into the cavity with light pressure, avoiding excessive carving of the restoration during its setting, because this may disturb its crystalline structure and lead to loss of marginal integrity or fracture.

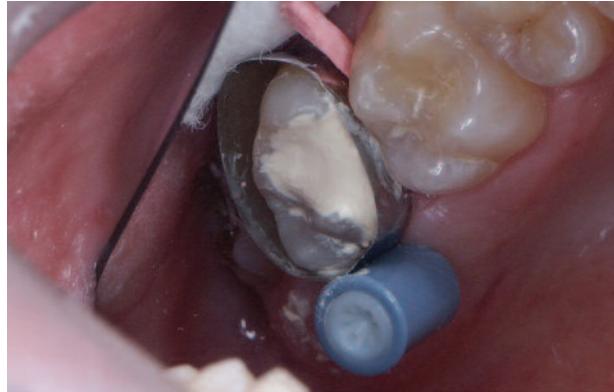
Figure 25: It is important to allow Biodentine™ to set for 12-15 min before matrix band and wedge removal.
