All- ceramic crowns on endodontically treated central incisors

Jan Hajtó,¹ Stefan Frei²

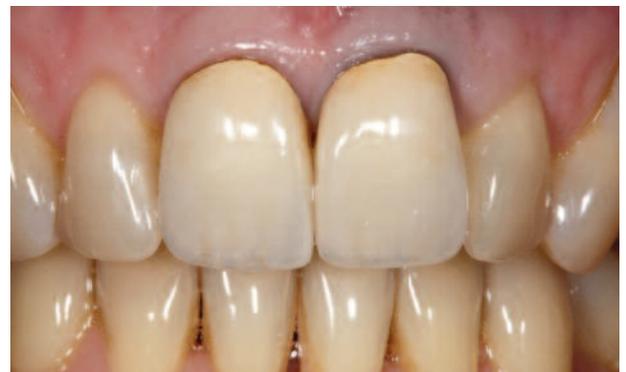
Figure 1: Preoperative situation: existing metal-ceramic crowns on teeth 11 and 21. In addition to the dark crown margins, the bluish discoloured gingiva on tooth 21 caused dissatisfaction.

A 40-year-old female patient required a functional overhaul of her dentition, including an increase in the vertical dimension. In addition, the two existing metal-ceramic crowns on the central incisors were in need of replacement. The patient was bothered about the clearly visible dark areas beneath the crown margins. The gingival tissues looked slightly bluish on the cervical side of the crowns, which was an indication of discoloured underlying tooth structure (Figure 1). An X-ray examination revealed an inadequate root canal filling on tooth 21.

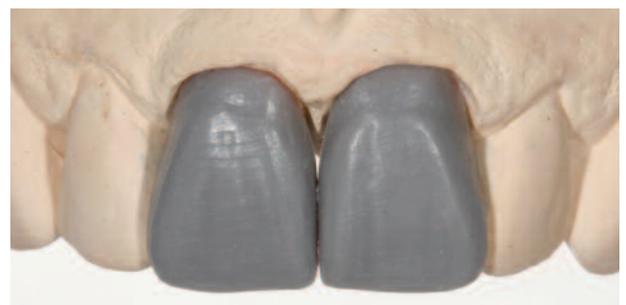
Figure 2: In the wax-up we established a crown shape that was characteristic for the patient and created an optical distraction from the slightly flawed gingival esthetics.

Tooth 11 had not previously been treated endodontically, yet it did not show any signs of sensitivity when it was exposed to vitality testing. Since the central incisors play an essential part in the esthetic appearance of the anterior region, even straightforward cases like this necessitate a careful approach to planning. Creating a wax-up in the run-up to implementing the restoration is required even, or especially, for cases that involve only one or two incisal crowns. In the present case, the existing crowns did not match the characteristics of the patient well. Our aim was to find a more expressive and daring shape to optically distract from the shortcomings of the gingival esthetics. The central papilla in particular was somewhat too short. We therefore decided to use a triangular shape for the crowns (Figure. 2).

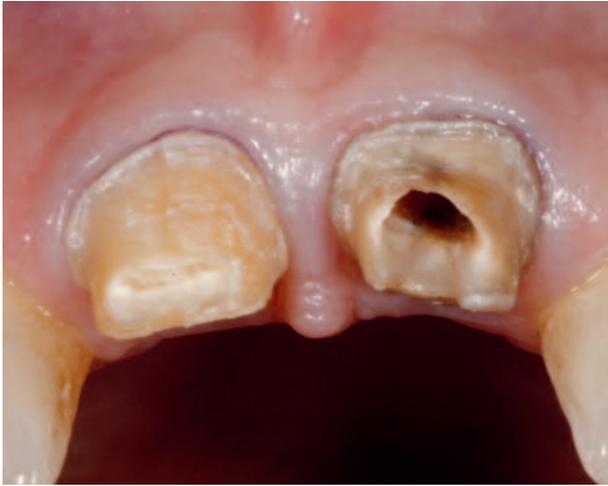
Figure 3: Situation after removal of the crowns, cleaning of the remaining tooth structure and post extraction on tooth 21.

amend this position. As a result, tooth 11 showed long standing damage to the pulp cavity with a symptomless necrotic pulp, which required endodontic treatment. Both root canal systems were discoloured to different extents (Figure 3). Such discolouration can usually be easily brightened up by internal bleaching. However, if this step is performed, a tight root canal filling is indispensable to protect the periapical tissue from contact with the bleaching agent. Tooth 11 was endodontically treated and the existing root canal filling of tooth 21 was revised. Subsequently, both root canals were obturated with liquid gutta percha (Figures 4 and 5).

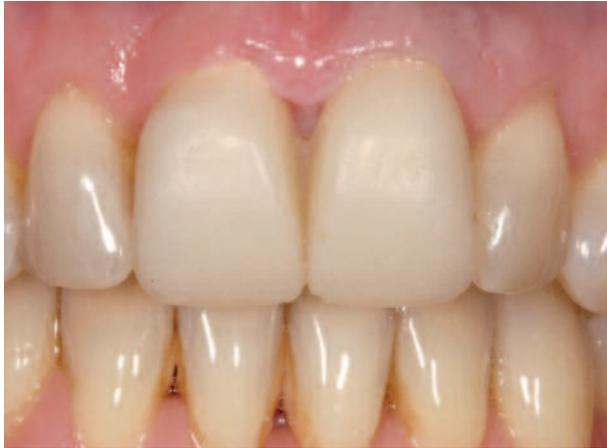
Figure 5: Direct temporary. The shape still resembled that of the previous crowns.

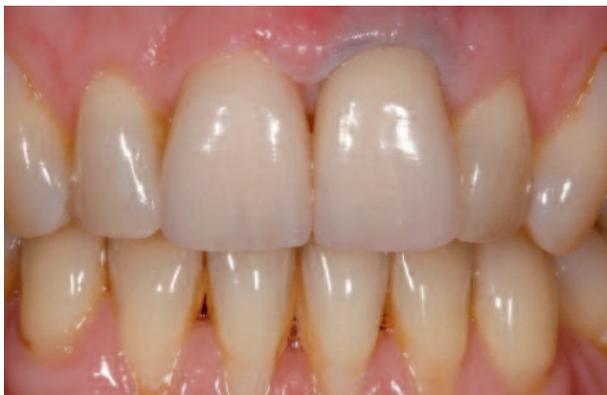
Figure 7: The lab-fabricated temporaries at the try-in. A dark retraction cord is shining through the gingival margin of tooth 21.

If possible, the lab-fabricated temporaries are not splinted. The patient was satisfied with the provisional result, as shown in Figure 7. However, it turned out that

these crowns were slightly too long, resulting in premature contacts during extreme protrusive movements. This inconvenience was easily eliminated on the temporaries before the final crowns were fabricated.

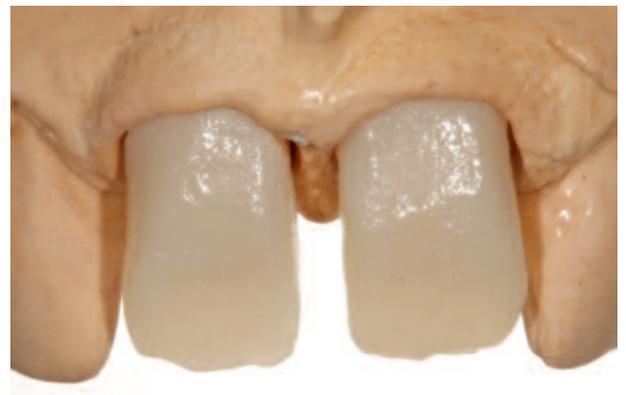
Figure 8: The frameworks were fitted on the model and adjusted. After wash firing and individual characterization (Essence materials), they were prepared for the application of the veneering ceramic.

of the framework were designed as large as possible using the highstrength lithium disilicate glass-ceramic (Figure 8).

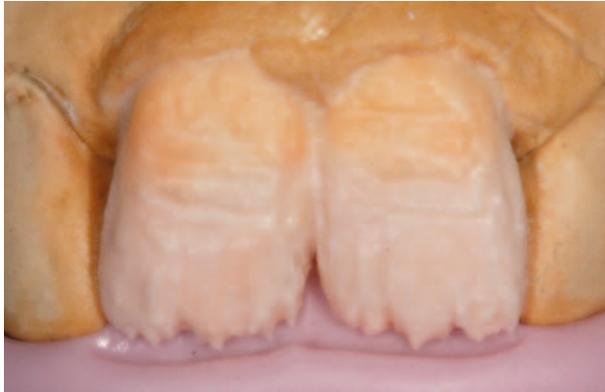
Figure 9: Dentin layering (Dentin A2 and A3).

The dentin body was built up with ceramic materials of various intensities using a palatal matrix as an auxiliary (Figure 9). Opalescent incisal materials were used to extend the core and characterizations were applied with mamelon materials (MM yellow, MM light). The shape was completed with Incisal and Opal Effect materials (TI 1, OE1, OE2).

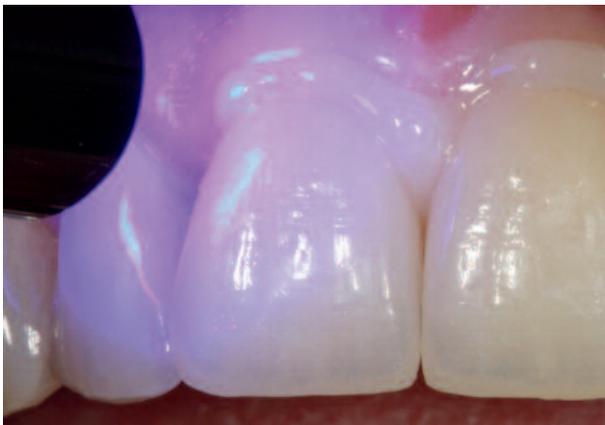
Figure 11: The restorations were polymerized from all sides for a few seconds to facilitate the removal of surplus material.

Multilink Automix was applied in a homogeneous, bubble-free layer directly into the crown by means of a mixing tip. After the crown had been seated, the excess material was polymerized for a few seconds (Figure 11) and effectively removed (Figure 12). Multilink Automix is a self-curing material that offers the option of light-curing to speed up the polymerization process in conjunction

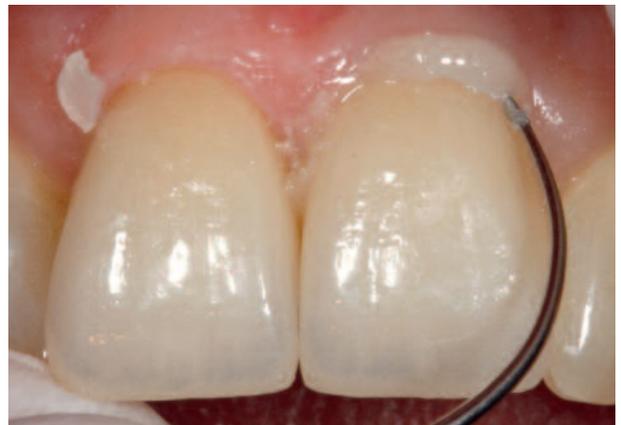
Figure 12: Excess removal with a pointed probe.

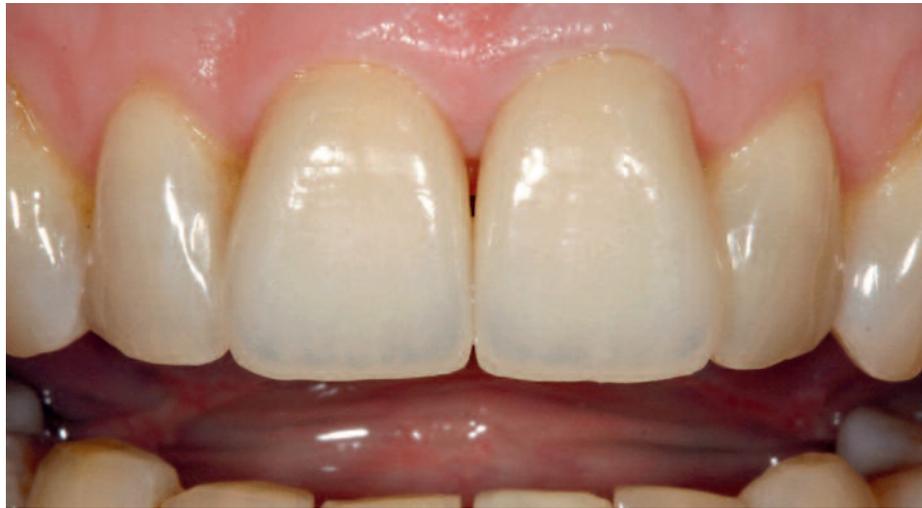
Figure 13: *The treatment result at the check-up. The dark shadow above tooth 21 has completely disappeared.*
