Predictable complex composite restoration

Clinical Case

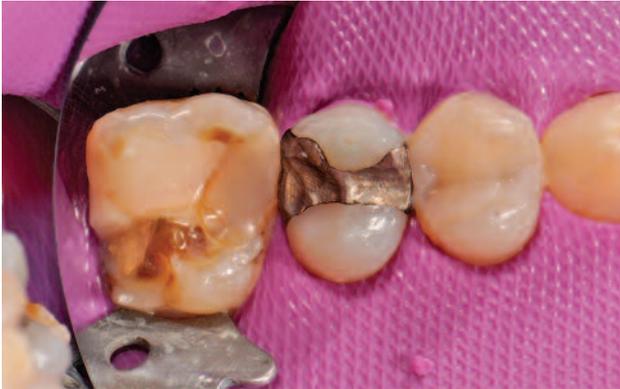
Figure 1: Pre-operative situation: multiple "patch" restorations with massive leakage and deep recurrent caries pulpally.

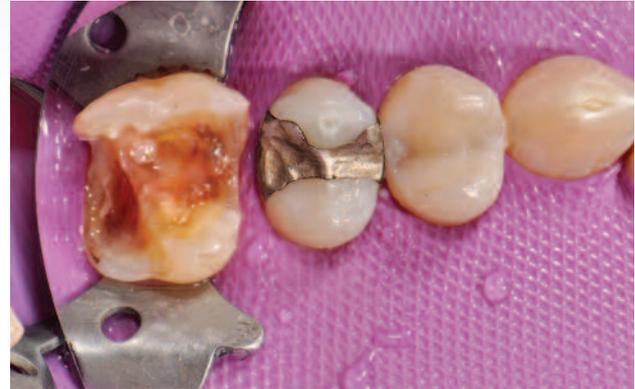
Figure 2: Intraoperative view during excavation of caries.

Following administration of local anaesthesia, the 2nd quadrant was isolated with a 12A rubber dam clamp and a non-latex rubber dam. The WedgeGuard (pink) was inserted, and the preparation completed. Caries was removed using Caries Detector Dye (Kuraray) as a guide along with tactile feedback. The preparation was finished by bevelling the enamel 15 degrees on the residual buccal wall to increase surface area for bonding. An Omnimatrix (Ultradent) was fitted, with a WaveWedge placed mesial to tooth 26 to seal the margin. It is important to understand the function of the

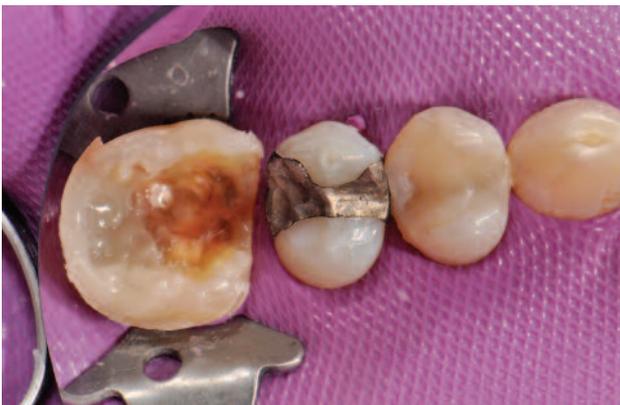
Figure 3: Construction of the distal marginal ridge and restoration of the proximal box simultaneously.

Tooth 26 was etched with 33% H₃PO₄ (aq) before application of Optibond Solo Plus (Kerr Corp.), air-thinned for 10 seconds and light-cured. The distal marginal ridge was built up incrementally using Grandio (VOCO) and the Omnimatrix removed. The Wave-Wedge (pink) was left in place to protect the papilla as the SuperCurve Blue (5.5mm)

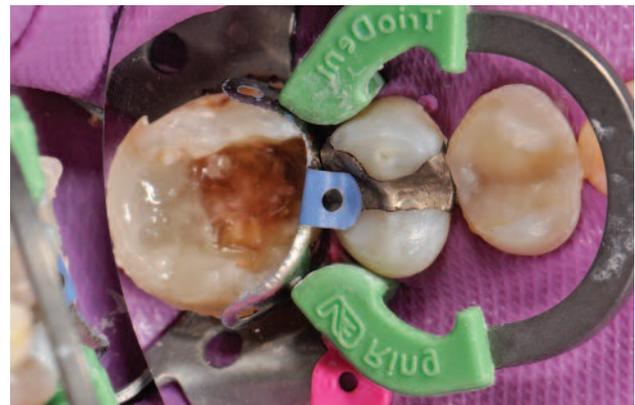
Figure 4: To ensure a solid mesial interdental contact and accurate reproduction of emergence profile, the Triodent V3 matrix system and Wave Wedge was paired with a SuperCurve matrix band.

matrix was slid into position. The V3 ring (Green Universal) was used in this molar case for predictable contact strength and morphology. The mesial marginal ridge was also constructed using incremental placement of Grandio. The V3 sectional apparatus were removed and the occlusal aspect restored after confirmation of mesial contact strength. Individual lobes were fashioned incrementally taking C-Factor stresses into account. Small lobe-specific increments allowed for a minimization and optimization of an already-low polymerization contraction figure (1.61%). Final polishing was completed using Dimanto (Voco), a single-stage ultra-high shine polishing system specific to Grandio.

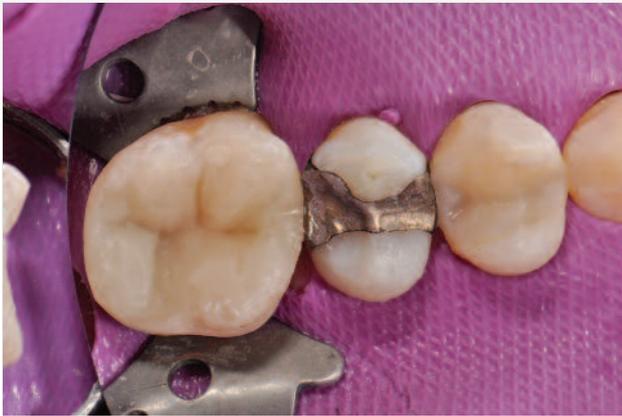
Figure 5: Post-contoured, pre-finished view of 26.

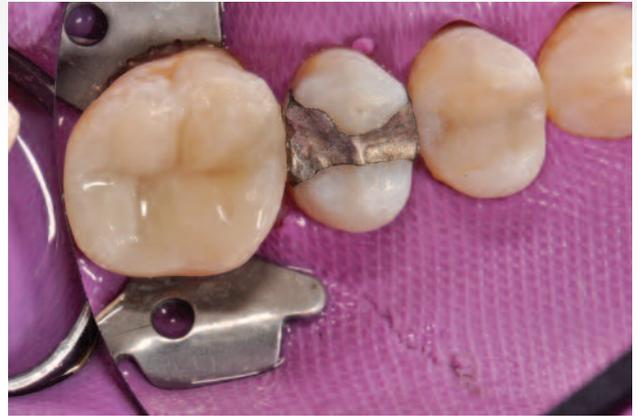
Figure 6: Post-finishing and polishing, before occlusal checks.

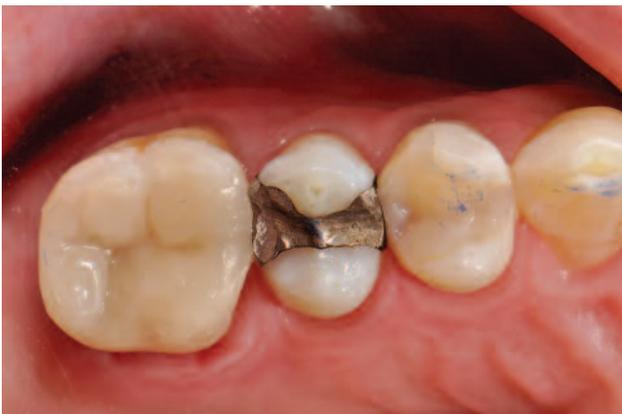
Figure 7: Immediate post-operative situation after occlusal fine-tuning.

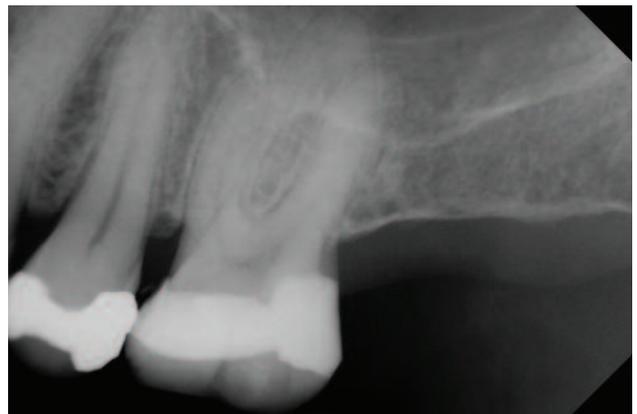
Figure 8: Immediate post-operative periapical radiograph showing complete removal of caries, well sealed margins and impressive radioopacity from Grandio.
