Composite resin – the material of choice

Gabriel Krastl¹

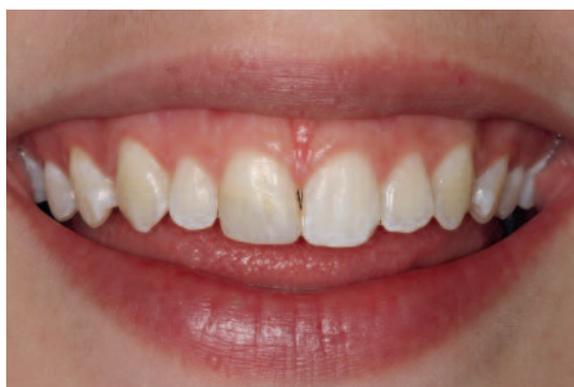
The clinical examination showed that the teeth were free of caries and in overall good condition in accordance with the patient's age. The patient clearly practiced excellent oral hygiene (Figure 1). Compared with the adjacent teeth, the natural part of tooth 11 looked yellowish and the composite build-up appeared greyish and translucent. With the exception of tooth 11, all the teeth reacted to the sensitivity test. The probing depth of the

Figure 1: The preoperative situation shows that tooth 11 has been restored rather unattractively.

As discussed with the patient, root canal treatment was planned for tooth 11. Furthermore, subsequent internal bleaching of the tooth was proposed, in preparation for the new composite build-up.

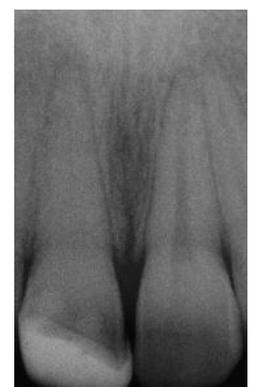
gingival sulcus measured less than three millimetres. Tooth 11 showed minimal percussion sensitivity. The periapical X-ray revealed traces of an apical lesion (Figure 2). The root canal seemed to be extensively calcified.

Figure 2: X-ray showing apical periodontitis in tooth 11.

The oral cavity was isolated with a rubber dam before the root canal was opened. The canal was difficult to locate, despite the use of an operating microscope. Nevertheless, it was found at a depth of 13 millimetres. The root canal was prepared and a calcium hydroxide medicated filling placed for two weeks. Subsequently, the root canal was filled with thermoplastic gutta-percha points and sealed. The cervical structure of tooth 11 was internally bleached with sodium perborate until the tooth structure acquired the shade of the adjacent tooth.

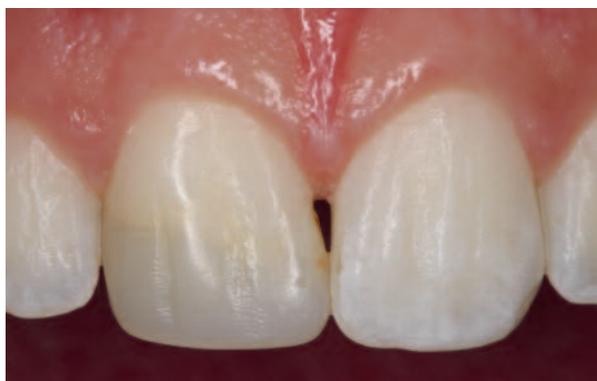
Figure 3: Close-up of teeth 11 and 21.

A close look at the two central incisors showed that the teeth were slightly asymmetrical (Figure 3), that is, the crown of tooth 11 looked somewhat wider. When the patient was questioned about this finding, she confirmed that she had had a median diastema, which was closed when the restorative work was done after her accident.

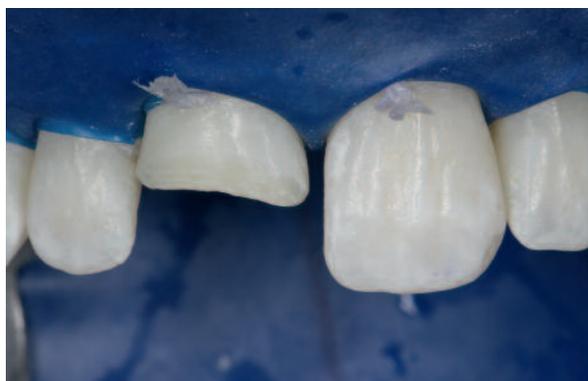
Figure 4: The old filling has been removed and tooth 11 has been prepared.

The old composite resin restoration was removed with rotating instruments. Furthermore, the enamel margins were beveled. A wide area was prepared in the labial region in particular (approx 2 mm) to ensure the invisibility of the final restoration margin (Figure 4). A rubber dam was placed in the anterior teeth (up to the first premolar) to establish a full view of the treatment field. Ligatures helped to completely isolate the anterior teeth requiring treatment and to displace the rubber dam towards the gingival margin. A three-step system including phosphoric acid etching (eg Syntac® Classic) was used for the adhesive pretreatment of the tooth structure. In order to make the two anterior teeth look symmetrical and to close the diastema, the mesial region of tooth 21 had to be widened a little with enamel material.

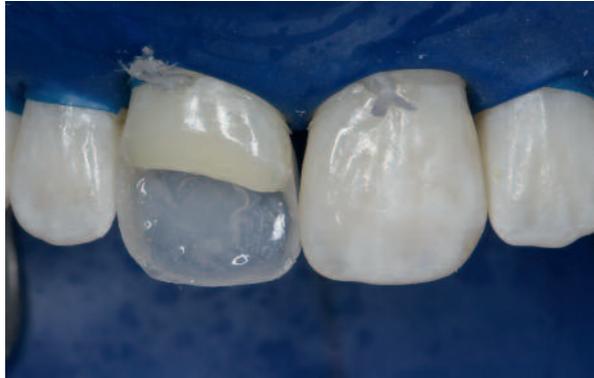
Figure 5: After the adhesive pretreatment the palatal “enamel shell” is created.

The restoration was initially polymerized from the labial aspect. Next, the silicone matrix was carefully removed and the built up composite resin was polymerized from the palatal aspect. Small amounts of excess in the palatal and proximal areas were easy to remove with a scalpel (Size 12). The palatal surface prepared in this way produced the desired width in the incisal area. Nevertheless, the proximal part of the restoration did not make contact with the neighbouring tooth at this stage. The chosen matrix technique has a decisive influence on the creation of the most natural-looking proximal contours possible. As the mesial and distal portions of the defect were located superingivally in the present case, transparent matrices were used, which were held in place with wooden wedges. The proximal wall was built up with utmost precision. After the matrix and wedges were removed, the thin composite layer significantly enhanced the appearance of the incisal, palatal and proximal contours of the tooth (Figure 5).

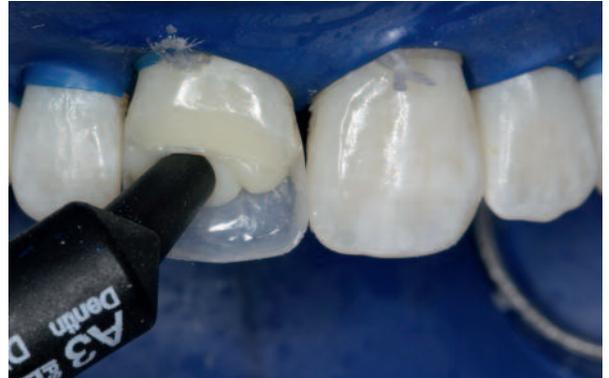
Figure 6: The dentin core is deliberately built up generously.

The subsequent layers were placed with opaque dentin material (IPS Empress® Direct Dentin, A3). The dentin core was built up (Figure 6). In comparison with natural teeth, this part of the tooth was larger. As a result, the space available for the enamel coating was very limited. It seemed to make good sense to cover the enamel bevel with dentin material as well.

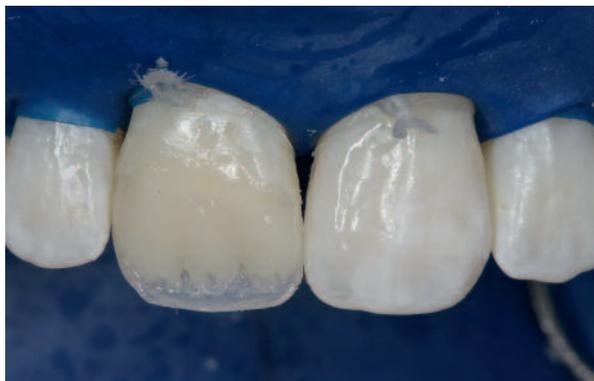
Figure 7: The built up dentin core provides only very little space for the enamel material.

This measure prevents the restoration margin from becoming visible as a grey line. Towards the incisal part the dimensions and the morphology of the dentin core were determined by the neighbouring and contralateral teeth. In the present case, mamelon structures were created. In the incisal area, enough space was provided for the translucent enamel materials (Figure 7). Each increment was cured for 20 seconds using a bluephase® LED light.

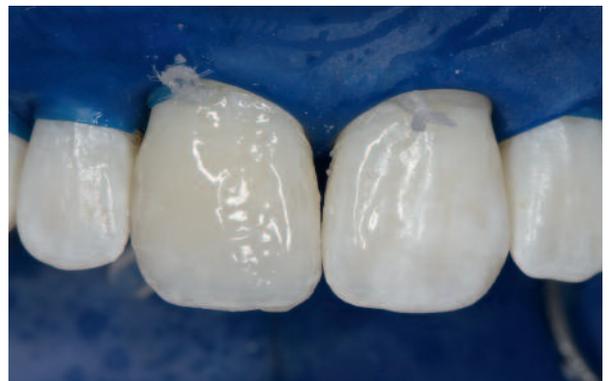
Figure 8: The restoration is ready for polishing after it has been characterized with translucent and white-opaque materials and sculpted.

The restoration was completed by applying a last thin enamel layer (IPS Empress® Direct Enamel A2) on the labial side (Figure 8).

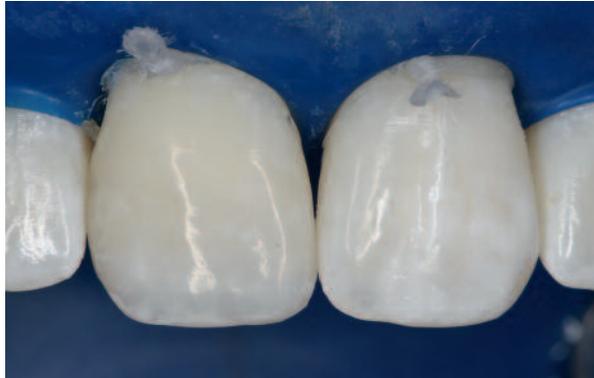
Figure 9: After polishing: A natural-looking surface lustre and a fine morphological structure was produced with the suitable polishing technique.

with flexible discs. In labial areas, these instruments must be used with great care to prevent the destruction of the morphology and the accidental removal of enamel material. Concave areas in the buccal surface were deepened in places with silicone polishers. High-gloss polishing was done with silicon-carbide impregnated brushes (Astrobrush®) (Figure 9).

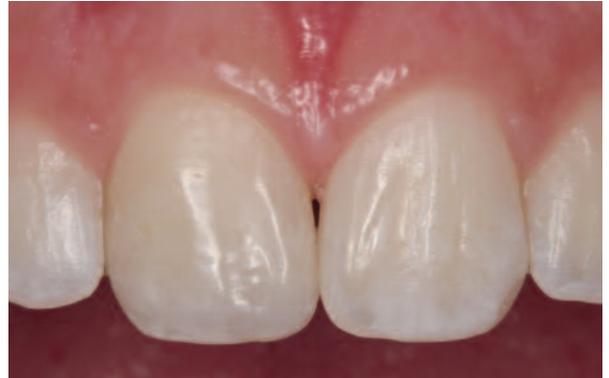
Figure 10: Four weeks later, the follow-up examination showed a normal clinical situation.

Four weeks after the treatment ended, the clinical situation looked healthy. The restoration in tooth 11 was virtually invisible. Symmetry has been restored to the anterior dentition (Figure 10). In addition, the radiological follow-up exam did not show any irregularities (Figure 11). The patient was free from any complaints and highly satisfied with the overall result (Figure 12).

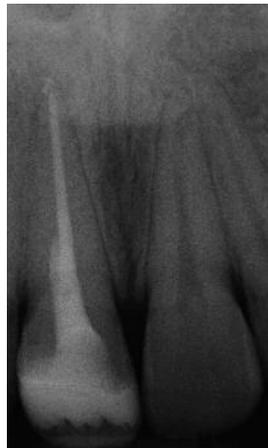
Figure 11: The final X-ray showing the root canal filling and composite restoration.
