Rehabilitation of an atrophic maxilla with Straumann® Bone Level implants and Straumann® BoneCeramic

Background

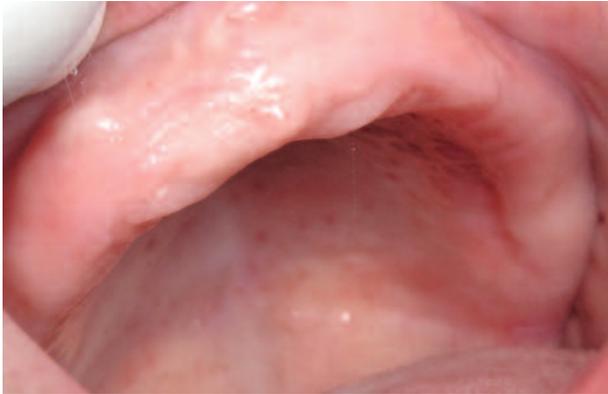
Figure 1.

Clinical examination revealed the patient had had an edentulous maxilla (Figure 1) for over 20 years, treated with

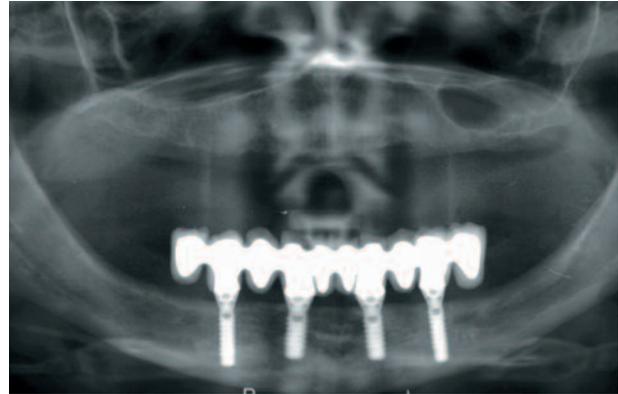
Figure 2.

a full denture, a thin gingival biotype in the second quadrant, and an implant screw-retained metal-ceramic prosthesis in the mandible. Radiographic examination with a panoramic x-ray (Figure 2) and a cone-beam CT (Figures 3, 4) scan revealed an atrophic edentulous maxilla, in both horizontal and vertical dimensions. Using the SAC Assessment Tool (ITI) to aid in making clinical decisions, this case was considered to be “complex” both in terms of the surgical and restorative aspects.

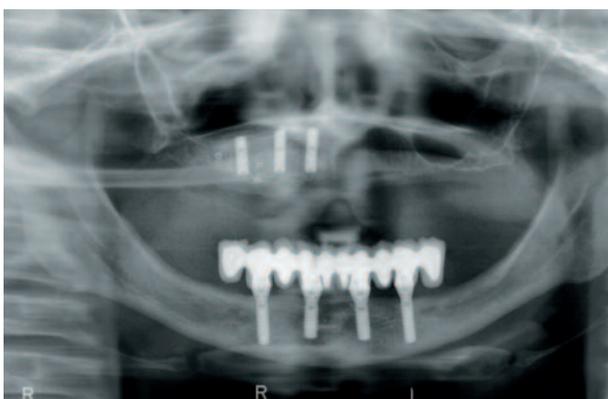
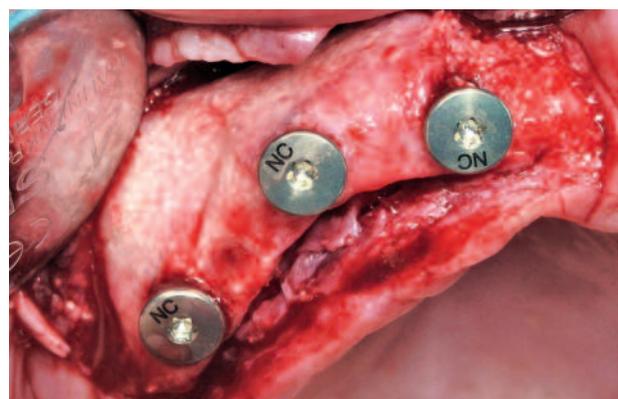
implants had to be inserted through the buccal wall. Six months after the implant surgery, the titanium-reinforced membrane was removed, and the implants were exposed (Figures 5, 6).

concurrent GBR using Straumann® BoneCeramic. A regenerative, titanium-reinforced membrane was also placed (11, 13 and 15) laterally (buccal) due to the residual size of the alveolar crest. The residual crest was so thin that the

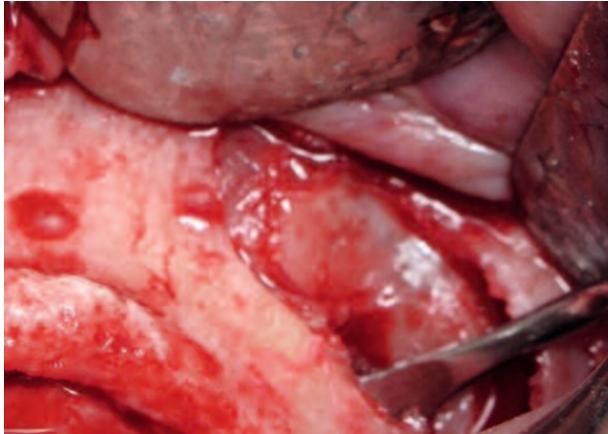
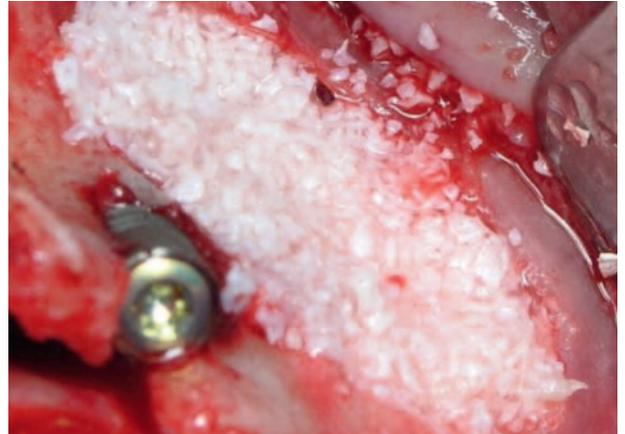
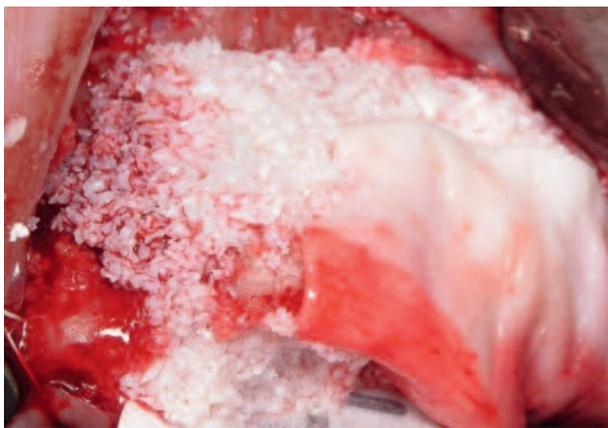
Two months after the surgery in the first quadrant, a sinus lift procedure was performed in the second quadrant with concurrent implant placement (Straumann® NC Bone Level \varnothing 3.3 mm, 12 mm, SLActive on 21 and 23; Straumann® RC Bone Level, \varnothing 4.1 mm, 10 mm, SLActive® on 26) along with GBR using Straumann® BoneCeramic, a collagen membrane and regenerative titanium-reinforced

membrane (Figures 7 – 9).

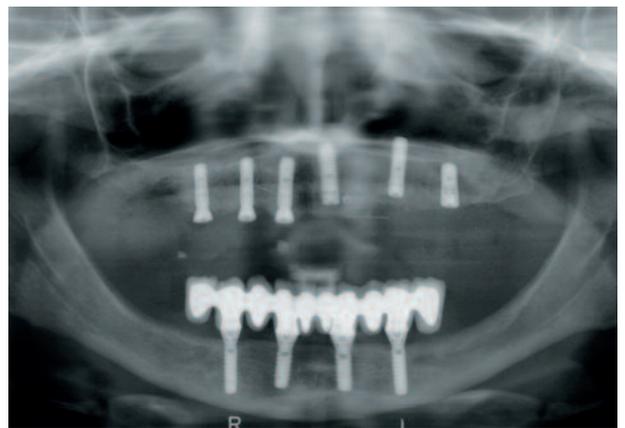
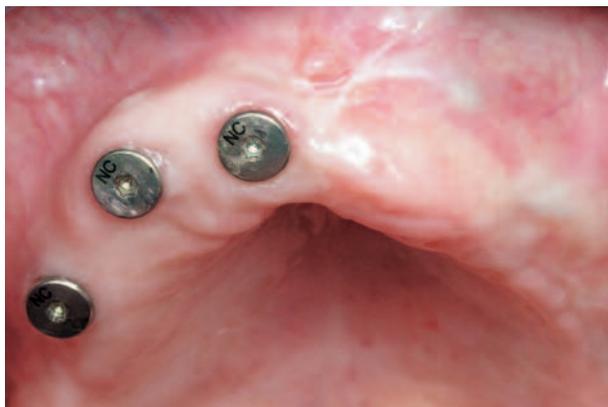
Six months after implant placement in the second quadrant (Figures 10, 11), the titanium-reinforced membrane was removed and the implants were exposed (Figures 12, 13). During the same surgery, a connective tissue graft was removed from the palate and sutured into the second quadrant in order to increase the thickness of a thin gingiva (Figure 14).

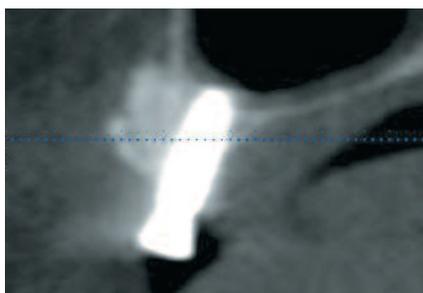
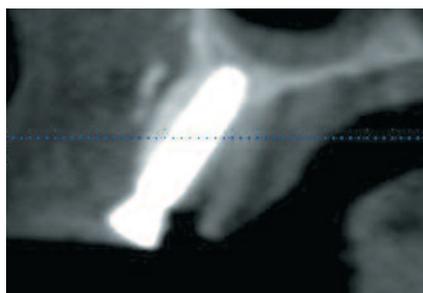
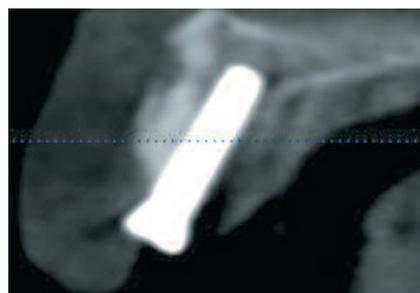
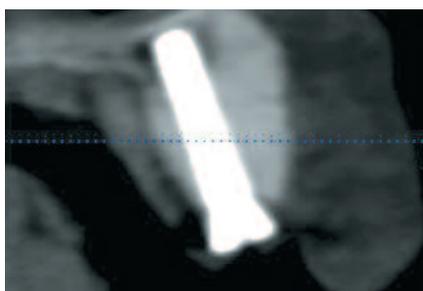
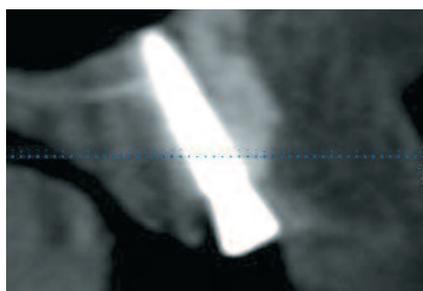
A new CBCT scan was performed to evaluate the stability of the bone augmentation and sinus lift procedures (Figures 15 – 20). The augmented bone, achieved using Straumann® Bone Ceramic, exhibits a lighter gray tone. All of the implants are completely surrounded by bone. The outcome of the sinus lift procedure with augmented bone surrounding implant 26 is clearly visible (Figure 20).

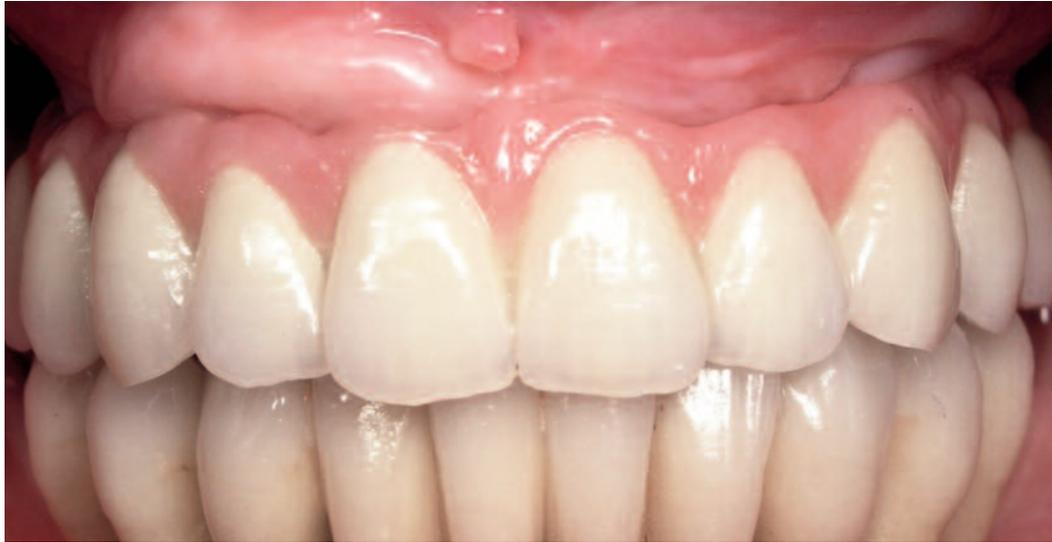
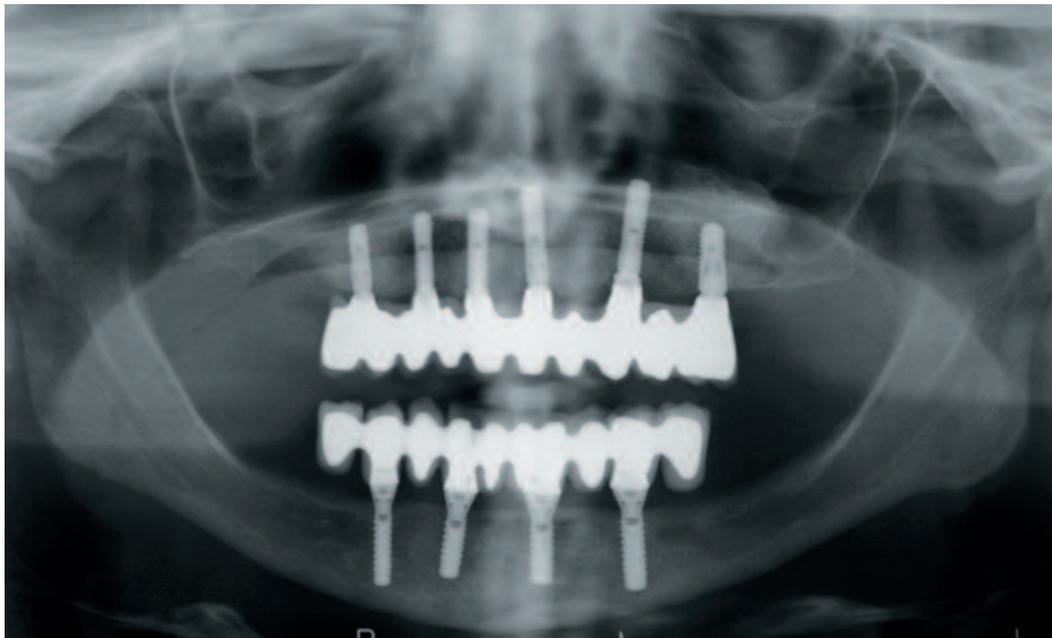
The insertion of the metal-ceramic full-arch was possible one year after the first surgical procedure. Due to the vertical discrepancy, gum ceramics were used (Figures 21, 22). The periapical radiographs (Figures 23 – 25) illustrate the perfect crossfit connection and stability of the hard tissues around the Straumann® Bone Level implants. In this case, the restoration of an atrophic maxilla with Straumann® Bone Level implants, together with GBR using Straumann® BoneCeramic has proven a reliable solution with outstanding stability of both hard and soft tissues, as was shown by the one-year follow-up.
