Immediate placement of a new fully tapered tissue level implant

Mario Rocuzzo¹

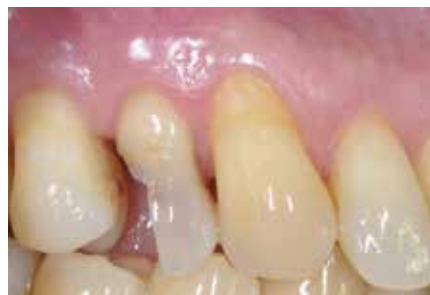
Figure 1.

In September 2019, a 53-year-old non-smoking male patient came for a consultation after the fracture of his maxillary right first premolar (Fig. 1). The patient presented with minimal periodontal problems, including multiple gingival recessions. The radiographic image confirmed the presence of a large periapical radiolucent area and some distal interproximal bone loss (Fig. 2). A thorough examination was carried out and revealed caries into the root and involvement of the distal furcation (Fig. 3). Upon clinical examination, the amount of healthy dentine was considered insufficient for a stump preparation for a conventional crown.

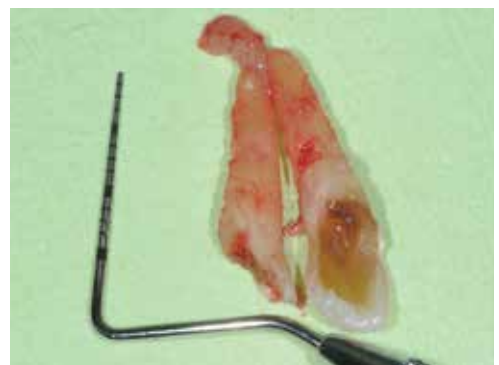
Figure 4.

In order to minimise the trauma during treatment, a careful separation of the tooth into two parts was carried out before extracting both roots (Fig. 4). No incisions were made, in order to reduce the risk of soft-tissue dehiscence. Before implant insertion, meticulous cleaning and careful curettage/debridement was carried out. The dimensions of the socket were measured by means of a periodontal probe (Fig. 5). A TLX SP, RT, SLActive®, Roxolid® 3.75x12.00mm implant (Straumann Institut) was placed according to the manufacturer's instructions. The implant was inserted using the handpiece in a self-tapping fashion, and a high primary stability was achieved (Figs. 6 & 7). The implant was positioned according to the International Team for Implantology philosophy of "as shallow as possible, as deep as necessary", the SLActive® surface margin placed at bone level. The use of a reduced-diameter implant allowed the presence of more bone around the implant for greater long-term success. The implant was placed slightly on the palatal side of the alveolar bone crest, leaving sufficient space buccally (Fig. 8).

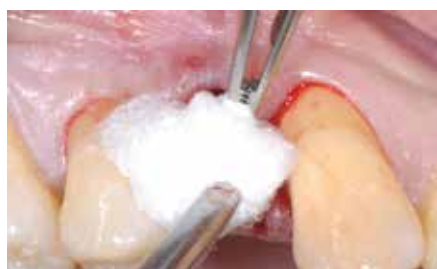
Figure 9.

A flexible composite cone composed of synthetic granules and porcine collagen fibres (collacone® max, botiss biomaterials) was inserted into the buccal portion of the socket to reduce bone remodelling and possible soft-tissue recession (Fig. 9). The mesial papilla was fixed with a 4/0 Vicryl® suture (Fig. 10). The postoperative radiograph confirmed the good positioning of the implant in the vertical dimension (Fig. 11). The patient was instructed not to traumatise the area, to brush very carefully and to rinse with a 0.12% chlorhexidine digluconate solution for one minute three times a day for the same period. The suture was kept in place for one week (Fig. 12). The patient was seen once a

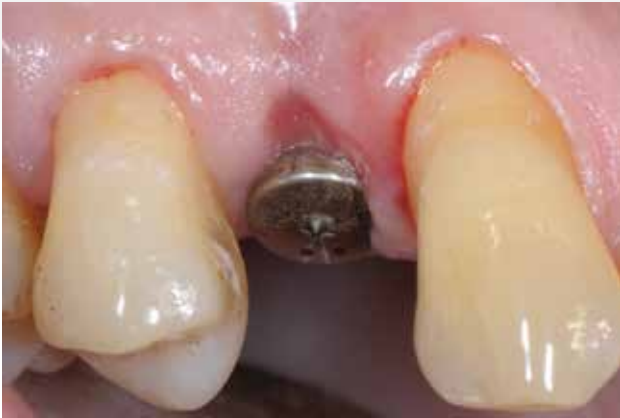
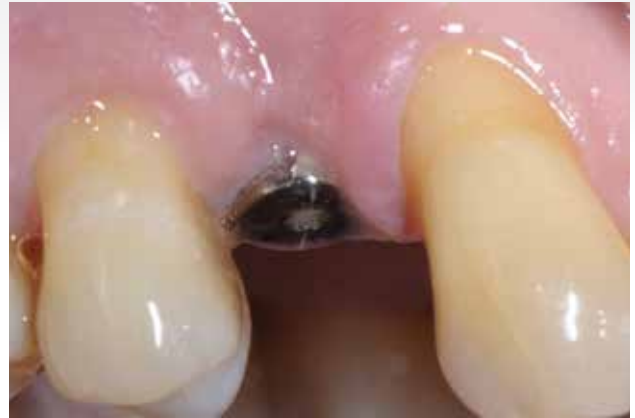
week for the first month to monitor healing, which proceeded with no complications (Figs. 13 & 14). The patient was then instructed on proper brushing in order to have adequate plaque control without injuring the soft tissue.

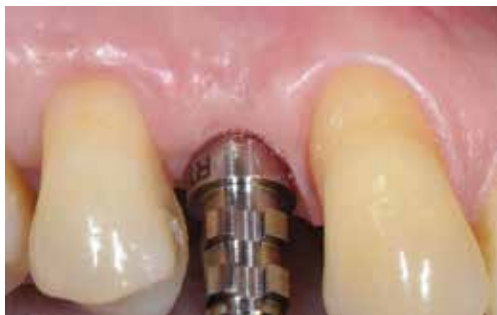
Figure 15.

Six weeks after surgery, the peri-implant mucosa appeared to be free from inflammation and had an optimal contour (Fig. 15). After soft-tissue maturation, an impression was taken, and a provisional crown was

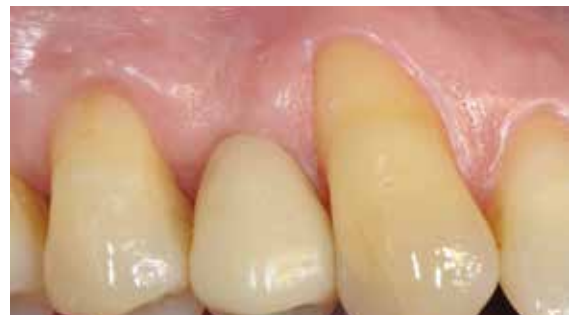
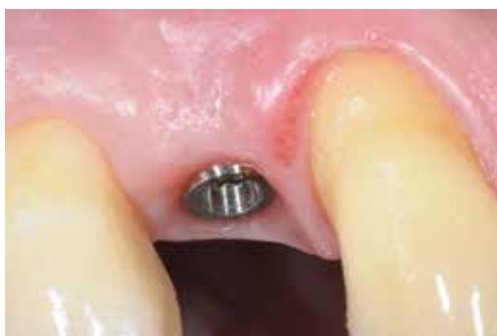
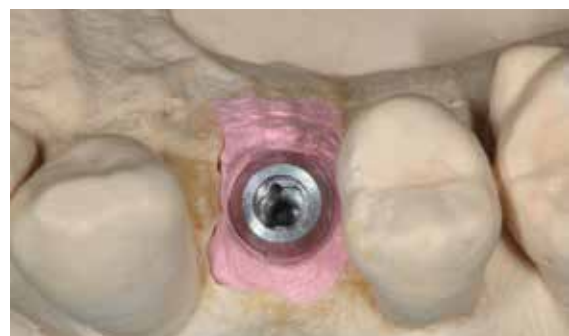
delivered (Figs. 16–18). The provisional crown was kept in place for three months in order to facilitate soft-tissue maturation for an ideal final aesthetic restoration. Before the delivery of the definitive metal–ceramic crown, the peri-implant soft tissue was checked with a probe, and the probing depths were found to be physiological (Fig. 19). The patient was asked to follow an individualised supportive periodontal therapy programme for an appropriate clinical and radiographic follow-up.
