Masterclass in Clinical Practice

Salvaging an incorrectly placed implant in a cost- effective way

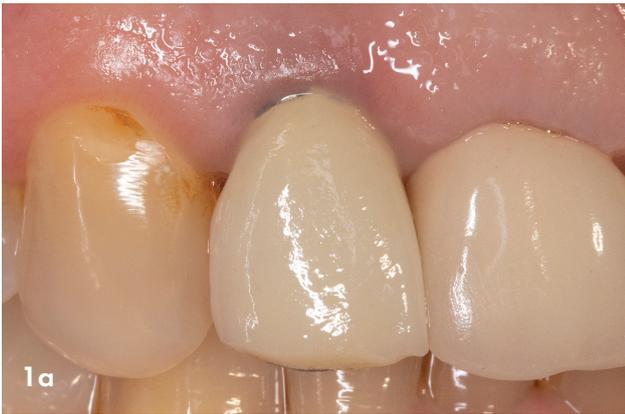
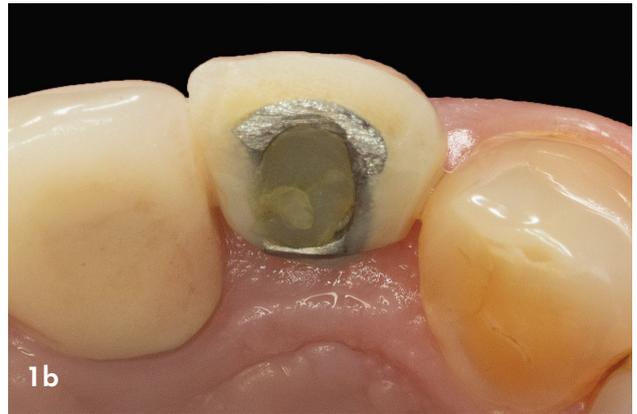
The 12 crown incisal edge seemed to have been trimmed down intra-orally, exposing the abutment. The abutment was also visible at the gingival margin (Figures 1 a and b). An intra-oral radiograph confirmed the suspicion that the crown had not seated properly (Figure 2). After removal it was established that the implant was an external hex, placed in a position requiring an angled abutment. Even with an angled abutment the crown would still be cement retained which in this case would still not be the preferred option. The implant was however placed incorrectly, with the hex orientated in such a manner that the angled abutment could not be used in the correct orientation. On placing the abutment to engage the hex properly, it was clear that the crown was now rotated (Figure 3).

Figure 1 a and b: Metal showing at incisal edge as well as gingival margin. Crown also more buccal than ideal.

Consultation with the dental technician followed, who suggested that a Dynamic Abutment® (Dynamic Abutment Solutions, Spain) be used to correct this with a new crown rather than remove the implant and start all over. Removing the implant and replacing it with a new one would have been a very costly and lengthy treatment with multiple procedures, including bone augmentation. In order to assess the status of the implant as a possible cause of her pain, a healing abutment was placed for 4 weeks (figure 4). She experienced no pain during this period and the decision was made to proceed with a new crown. The Dynamic Abutment was slightly narrower than the original creating more space for soft tissue to protect the bone crest. The Dynamic Abutment system allows angulation correction of up to 28 degrees. The incorrectly placed implant could therefore be properly restored with a lab cemented screw retained crown, with palatal screw access.

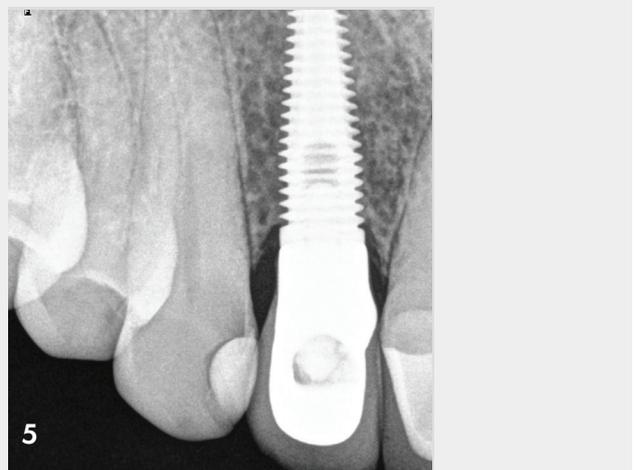
It was seated properly (Figure 5) with the screw access from palatal made possible by the unique driver and screw configuration. The palatal screw access was sealed with composite, completing the treatment (Figure 6a and 6b).
