Masterclass in Clinical Practice

Salvaging an incorrectly placed implant in a cost-effective way

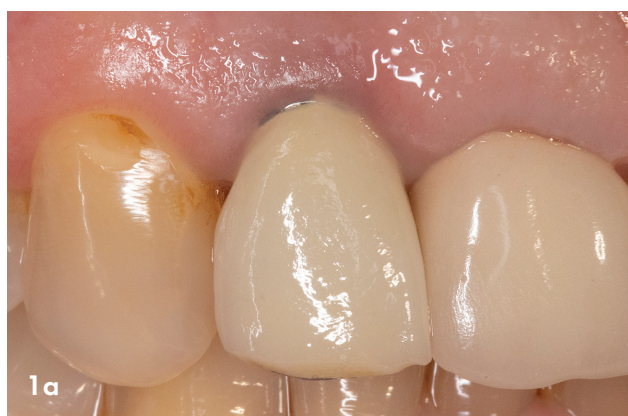
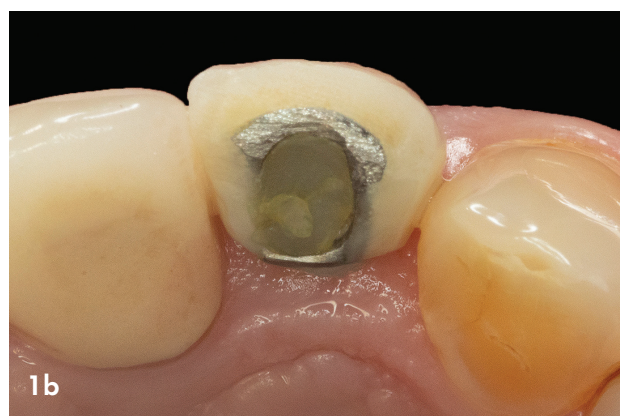
The 12 crown incisal edge seemed to have been trimmed down intra-orally, exposing the abutment. The abutment was also visible at the gingival margin (Figures 1 a and b). An intra-oral radiograph confirmed the suspicion that the crown had not seated properly (Figure 2). After removal it was established that the implant was an external hex, placed in a position requiring an angled abutment. Even with an angled abutment the crown would still be cement retained which in this case would still not be the preferred option. The implant was however placed incorrectly, with the hex orientated in such a manner that the angled abutment could not be used in the correct orientation. On placing the abutment to engage the hex properly, it was clear that the crown was now rotated (Figure 3).

Figure 1 a and b: Metal showing at incisal edge as well as gingival margin. Crown also more buccal than ideal.

Consultation with the dental technician followed, who suggested that a Dynamic Abutment® (Dynamic Abutment Solutions, Spain) be used to correct this with a new crown rather than remove the implant and start all over. Removing the implant and replacing it with a new one would have been a very costly and lengthy treatment with multiple procedures, including bone augmentation. In order to assess the status of the implant as a possible cause of her pain, a healing abutment was placed for 4 weeks (figure 4). She experienced no pain during this period and the decision was made to proceed with a new crown. The Dynamic Abutment was slightly narrower than the original creating more space for soft tissue to protect the bone crest. The Dynamic Abutment system allows angulation correction of up to 28 degrees. The incorrectly placed implant could be therefore be properly restored with a lab cemented screw retained crown, with palatal screw access.

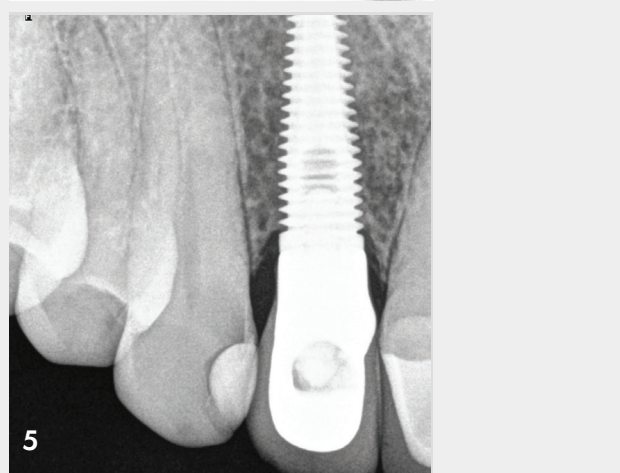
It was seated properly (Figure 5) with the screw access from palatal made possible by the unique driver and screw configuration. The palatal screw access was sealed with composite, completing the treatment (Figure 6a and 6b).
