Immediate implant placement and loading in a lower first molar – 1 Year follow up

Case Report

The following case report describes a successful immediate implant placement in a Lower First Molar with Straumann® TLX® and immediately functionally restored, with 1 year follow up.

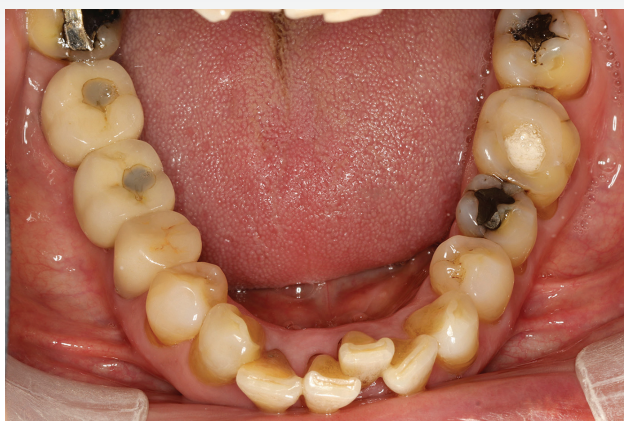
Fig. 1: Intra Oral occlusal view

After careful assessment of the patient's anatomical conditions through panoramic radiograph and CBCT scan (Figures 1, 2 and 3), it was possible to verify ideal interradicular bone availability allowing the following treatment planning:

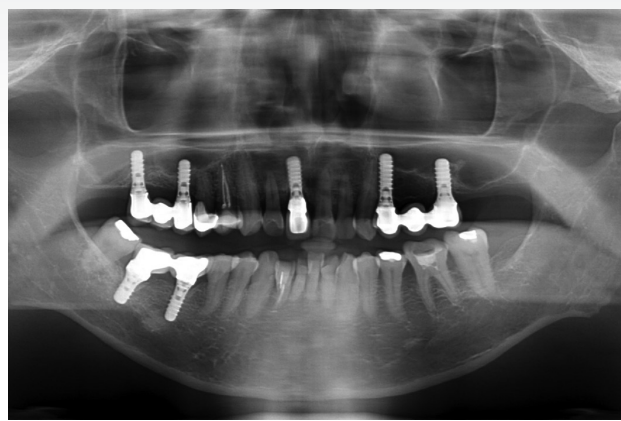
Fig. 2: Panoramic radiograph

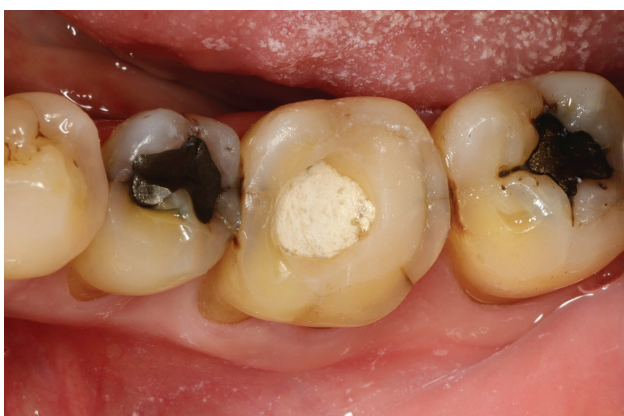
Fig. 3: Tooth #36 initial situation

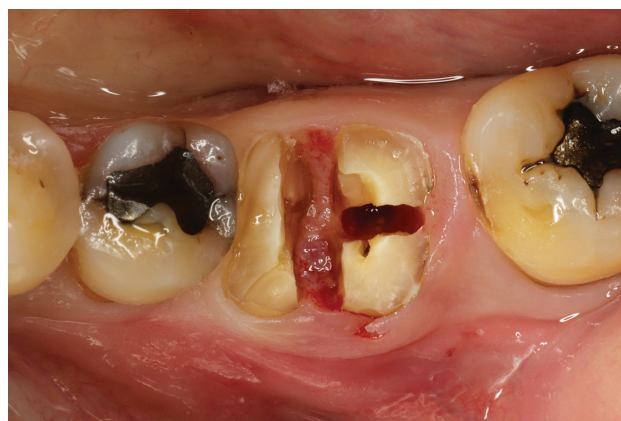
Fig. 4: Roots splitting for minimally traumatic extraction

To maintain the gingival and surrounding walls as preserved as possible, a flapless minimally traumatic approach to the extraction was chosen by splitting the roots in different directions (Figure 4). Extra precautions were made not to inflict any trauma, even by the suction device on the papilla and any surrounding soft tissue. A simple orthodontic elastic is placed around the adjacent teeth to delimitate the buccal and lingual red zone margins that should not be encroached upon.

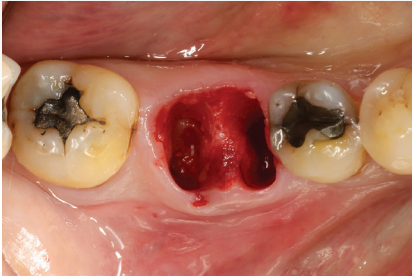
Fig. 5: Socket dimensions preserved

It was possible to verify solid interradicular bone availability (Fig. 05) extending further the limits of the root apices

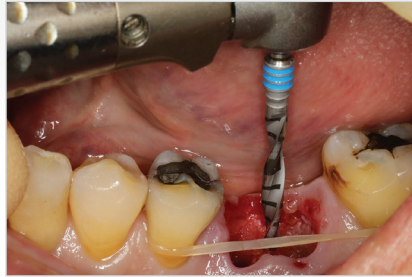
Fig. 6: Osteotomy with drill Ø 2.2mm

800 rpm, followed by the Ø2.2mm and Ø2.8mm drills (Fig. 06 to 10). The implant was placed with the use of ratchet and torque control reaching the desired final position with 50Ncm torque value (Figs.11, 12 and 13). The sockets are then augmented with bovine derived bone substitute impregnated with α -PRF finalized by sutures to keep the α -PRF application immobile, with a 3mm healing abutment in position (Figs. 14, 15, 16 and 17).

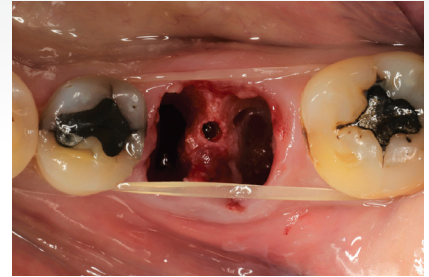
Fig. 7: Centrally oriented osteotomy

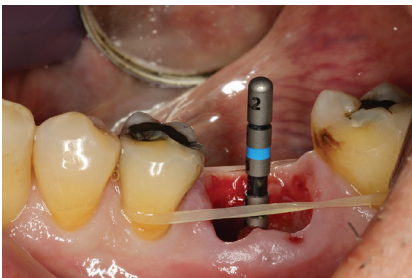
Fig. 8: Ø 2.2mm alignment confirming three-dimensional position

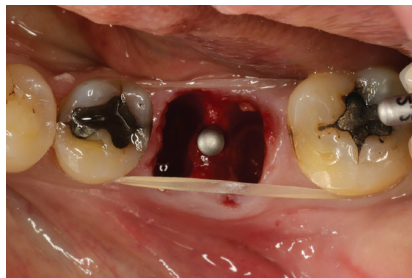
Fig. 9: TØ 2.2mm alignment confirming three-dimensional position

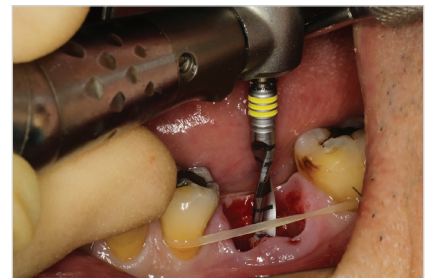
Fig. 10: Osteotomy with Ø 2.8mm drill

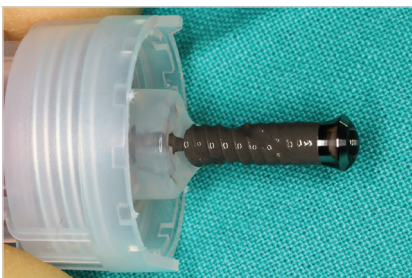
Fig. 11: Ø 3.75 x 12mm TLX Implant ready for pick up on the vial cap

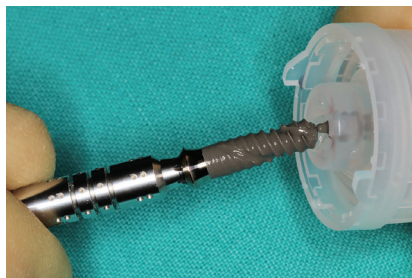
Fig. 12: Direct implant pick up with insertion driver

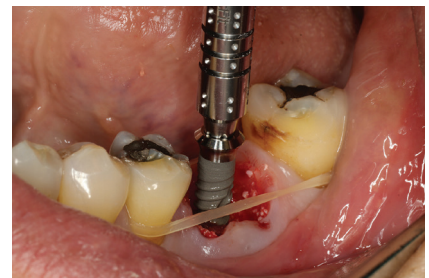
Fig. 13: TLX Implant insertion

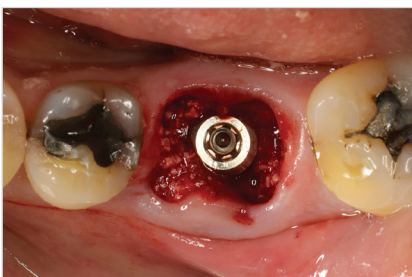
Fig. 14: Implant in final position with bone augmentation

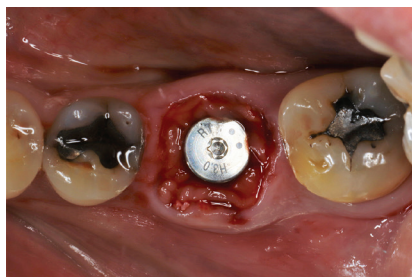
Fig. 15: Implant in final position with L-PRF protecting the bone substitute granules

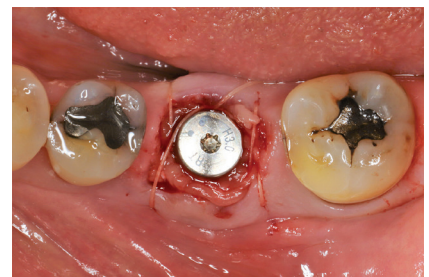
Fig. 16: Sutures to stabilize the biomaterials in place.

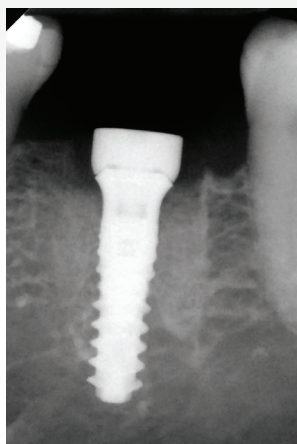
Fig. 17: Periapical radiograph after implant placement

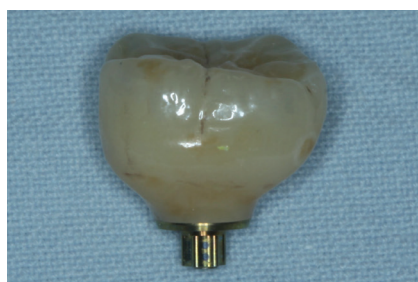
Fig. 18: Temporary crown

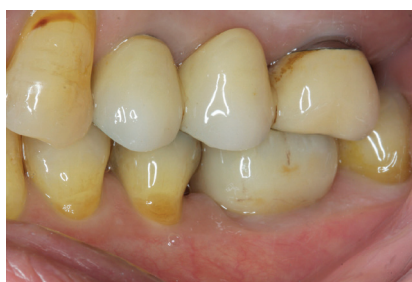
Fig. 19: Temporary crown immediately seated

The patient was sent to the prosthodontist and the immediate restoration technical work followed a digital workflow that included an intraoral scanner DW (IOS; TRIOS Pod, 3Shape, Copenhagen, Denmark) and CAD/CAM processing using Straumann CARES® Digital Solutions (Dental Wings, Montreal, Canada). A PMMA crown was milled and cemented to a prefabricated titanium abutment (Variobase®, Institute Straumann AG, Basel, Switzerland) (Fig. 18). A few hours later the patient was leaving the office with an immediate implant placed and functional provisional screw-retained restoration (Fig. 19 and 20).

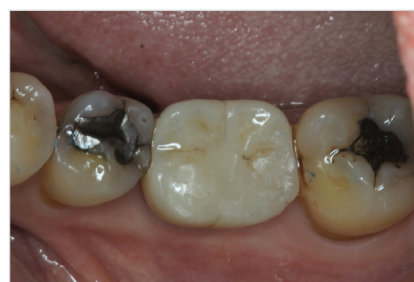
Fig. 20: Temporary crown immediately seated

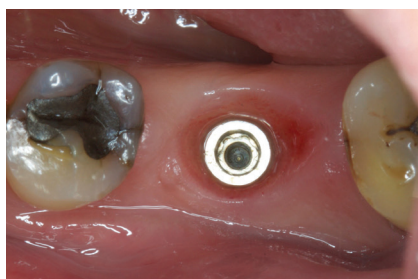
Fig. 21: Gingival healing ready to initiate final crown

Upon the patient's return the final crown was initiated by another intra oral scanning to copy all the gingival contours after healing time (Figs. 21 and 22). A full monolithic zirconia crown was milled and cemented to a Variobase® 5mm x AH 6mm and properly seated with occlusal and contact points

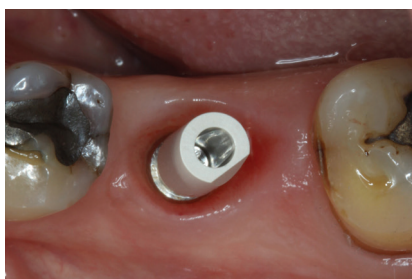
Fig. 22: Scan body in position for digital impression

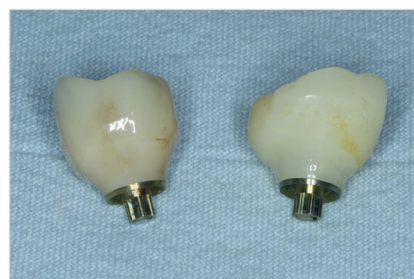
Fig. 23: Temporary crown removed and monolithic Zirconia crown ready for insertion

checked. The screw access was properly closed with Teflon tape and light curing composite (Fig 23).

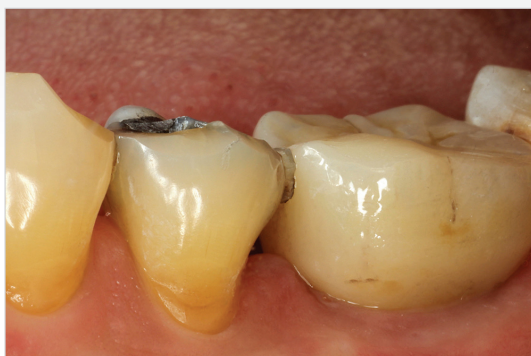
Fig. 24: Final result – lateral view

From a clinical perspective the immediate placement and function was very well indicated as it can be verified through the gingival margins and health; and bone levels throughout the healing phase, final and 1 year follow up pictures. (Figs. 24 to 29).

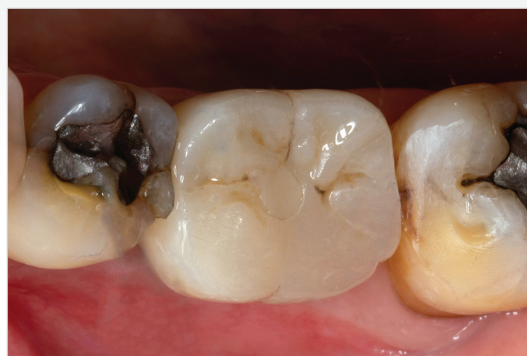
Fig. 25: Final result – Occlusal view

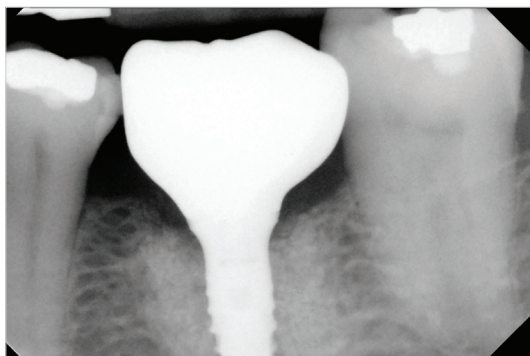
Fig. 26: Final outcome radiograph

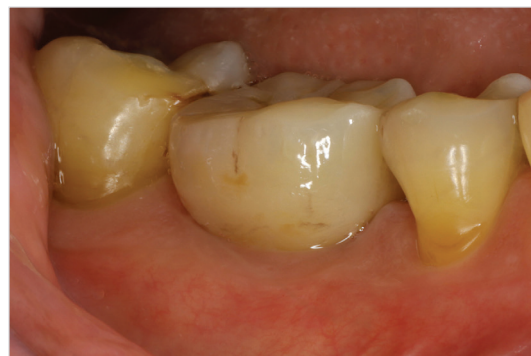
Fig. 27: TLX 1 Year follow up clinical outcome

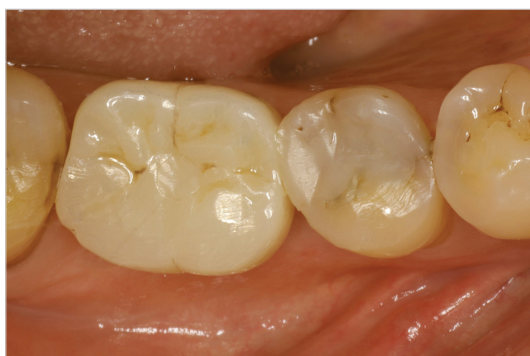
Fig. 28: TLX 1 Year follow up clinical outcome

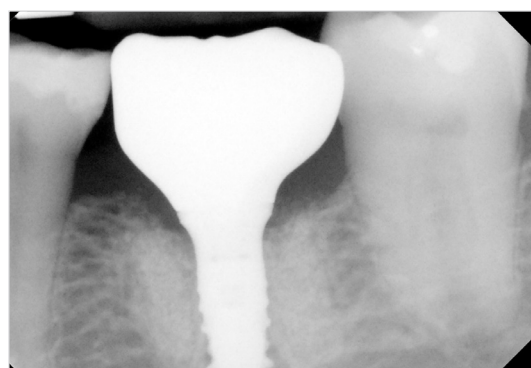
Fig. 29: 1 Year follow up radiograph show stable peri-implant stability.
