# Deep white dyschromia

Although resin infiltration techniques are not the first choice for treating most molar incisor hypomineralisation (MIH) lesions, many patients refuse to have their teeth drilled, while seeking for a solution to this aesthetic issue.

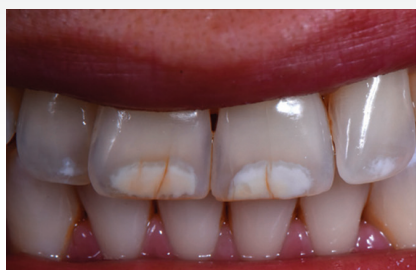
Figure 1: Teeth with severe discolouration

A 46-year-old patient came to my practice asking me to solve her aesthetic problem (Figure 1). Whenever I have to treat white spots on dark teeth, or when I approach treatments with a high aesthetic impact, I usually recommend bleaching to improve the base we work on.

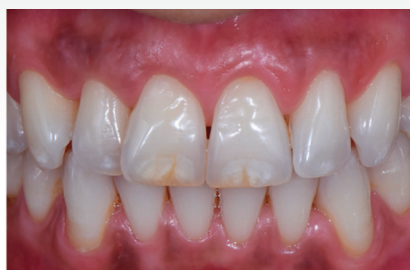
Figure 2: White spots after whitening

After three weeks' whitening for four hours a day, and after an additional 20 days wait, the teeth were ready for treatment of the discolourations (Figure 2).

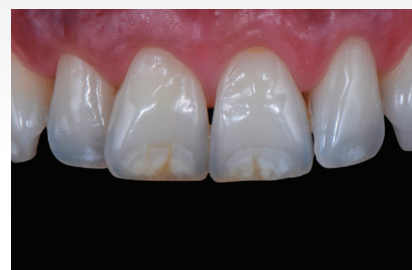
Figure 3: Discolourations after tooth whitening

The white portion of the spots had faded but the orange portion was still evident (Figure 3). I used the K-Lite (Smileline), which allowed me to understand the actual depth of the stain due to MIH (Figure 4).

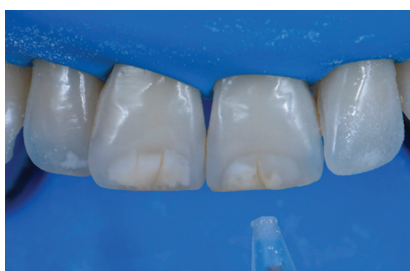
Figure 5: Sandblasting discolourations

Although MIH is not the ideal condition to apply resin infiltration, I tried to apply this minimally invasive approach, but the position of the spot in the thickness of the enamel forced me to sandblast before letting the etching work (Figure 5).

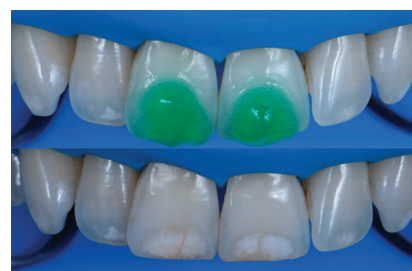
Figure 6: Etching of white spots for infiltration

Because of the depth of the lesions, I knew from the start that I would have to repeat the cycle several times. Using Icon Dry after each erosion, I simulated the action of the infiltrant resin. The dyschromia was still evident after the first cycle (Figures 6 and 7) so I repeated the etching step (Figure 8). Figure 9 shows the third cycle.

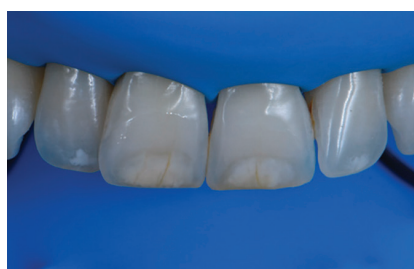
Figure 7: Previsualisation of infiltration outcome

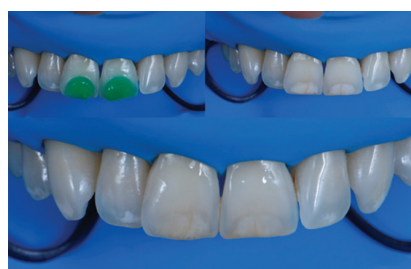
Figure 8: Second cycle of etching for infiltration
