CLINICAL

Successful treatment of peri-implantitis using a dental implant cleaning system: A 2-year follow-up

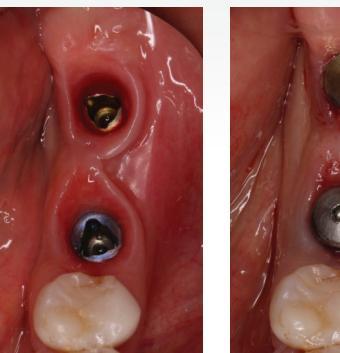
Fig. 1: Conservative treatment and prosthesis removed.

We started with conservative treatment, removing the prosthesis and installing healing abutments (Figs. 1,2). Nonsurgical mechanical treatment was carried out using regular ultrasonic instruments and an air flow device. This was followed by irrigation using CHX 0.12% and metronidazole 5mg/ml and a solution of local antibiotic and hyaluronic acid. An X-ray was taken of the implants in positions #36 and #37 after the healing abutments were screwed in place (Fig. 3).

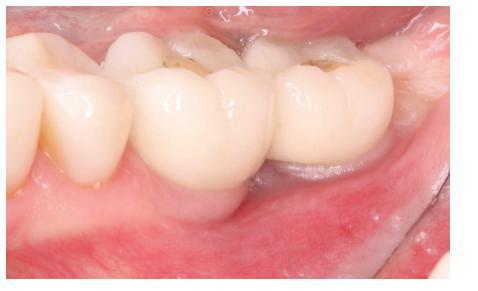
Fig. 4: Clinical re-evaluation before the surgery.

Right before the surgery, a re-evaluation was carried out (Figs. 4,5)

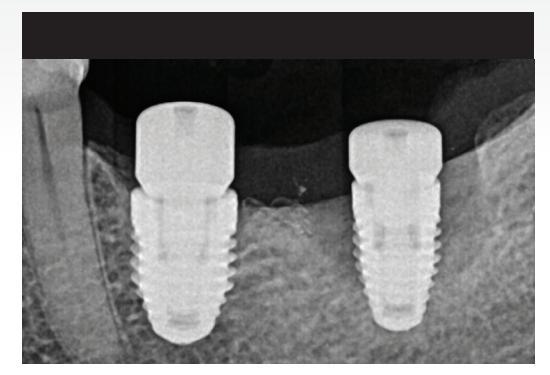
Fig. 3: X-ray of the implants in positions #36 and #37.

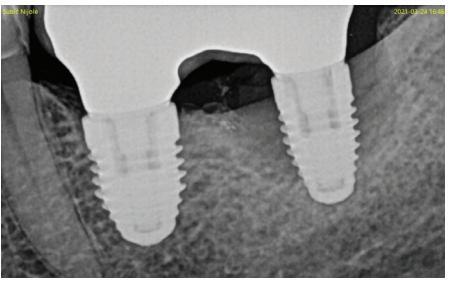
Fig. 5: X-ray taken before the surgery.

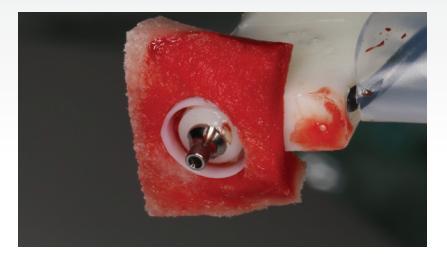
Fig. 7: Sponge on the GalvoSurge[®] Spray Head to ensure that the cleaning solution is kept in maximum contact with the treated implant.

Gentle pressure was applied to the Spray Head throughout the cleaning process. The sponge on the Spray Head is designed to hold the cleaning solution in maximum contact with the treated implant (Fig. 7).

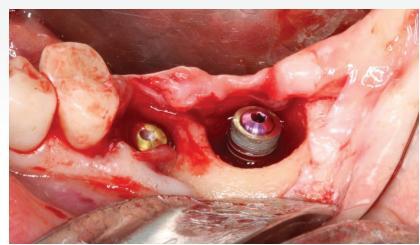
Fig. 8: Clean implant surface after electrolytic cleaning with GalvoSurge®.

The presence of hydrogen bubbles during the cleaning demonstrated the correct application of GalvoSurge[®]. Over a 2-minute cleaning period, these bubbles form underneath the biofilm and subsequently raise the biofilm from the implant surface. Consequently, the implant is thoroughly cleaned.

After ensuring the implant surface was clean, the closure caps were inserted (Figs. 8,9), and the guided bone regeneration (GBR) process began. A Straumann[®] Membrane Flex was secured in place using pins (Fig. 10).

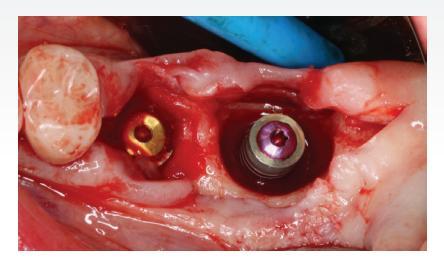
Fig. 9: Closure caps inserted.

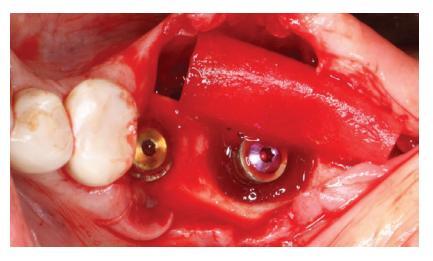
Fig. 10: Straumann[®] Membrane Flex secured in place.

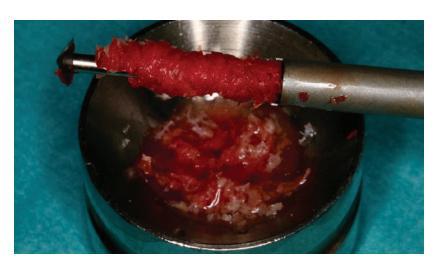
Fig. 11: Autogenous bone chips collected and mixed with botiss maxgraft[®] granules.

Autogenous bone chips were collected and mixed with botiss maxgraft[®] granules (Fig. 11).

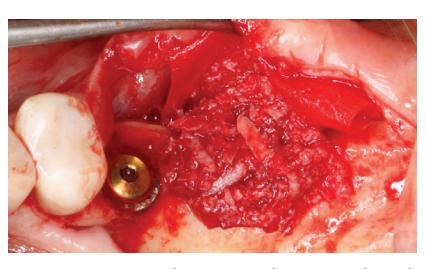
Fig. 12: Bone chip granules mixed with PRF.

The bone chip granules were mixed with PRF and placed on the defect (Fig. 12). Using pins, the Straumann[®] Membrane Flex was closed for soft tissue support and graft containment (Fig. 13).

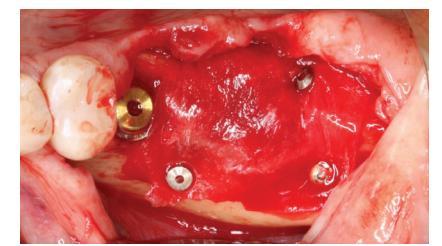
Fig. 13: Straumann[®] Membrane Flex closed using pins for soft tissue support and graft containment.

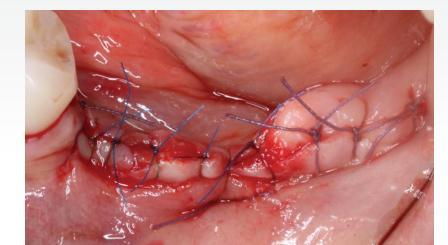
Fig 14: Suturing performed.

Suturing was performed using 4/0 Vicryl and 6/0 Prolene sutures. Additionally, oral hygiene instructions were provided (Fig. 14). Ten days later, the patient returned to have the stitches removed and the wound evaluated. The woundhealing process was uneventful (Fig. 15).

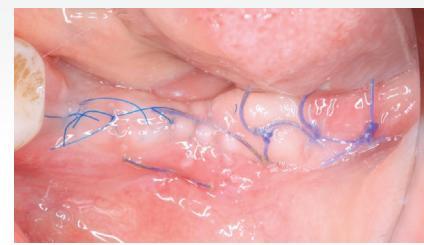
Fig. 15: Ten days later: clinical situation before stitch removal.

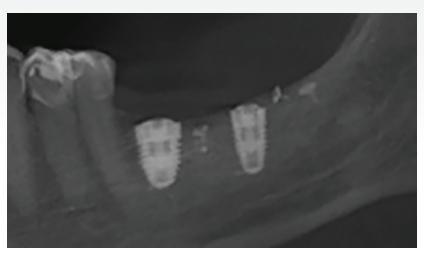
Fig. 16: Optimal bone level around the implants after 6 months.

After a healing time of 6 months, a control CT scan was performed. Optimal bone level was observed around the implants (Figs. 16,17). A flap was raised to remove the rest of the excess bone from the healing abutment (Figs. 18,19). To close the incision, we utilized 4/0 Vicryl and 6/0 Prolene sutures, ensuring a secure and effective closure. Next, the

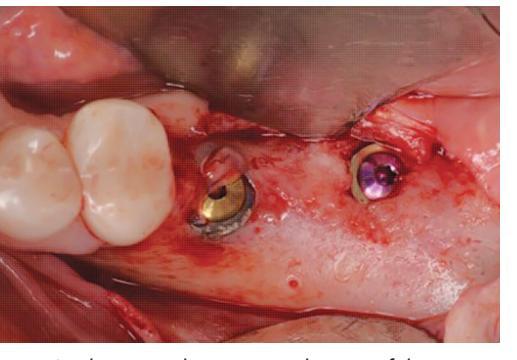
Fig. 18: Flap raised to remove the rest of the excess bone from the healing abutment.

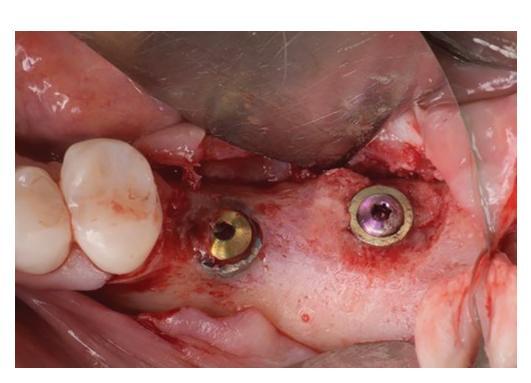
Fig. 19: Situation after removal of the excess bone from the healing abutment.

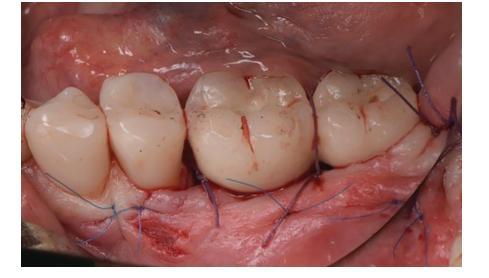
Fig. 20: Prosthetic back in its designated position.

prosthetic was carefully screwed back into its designated position (Fig. 20).

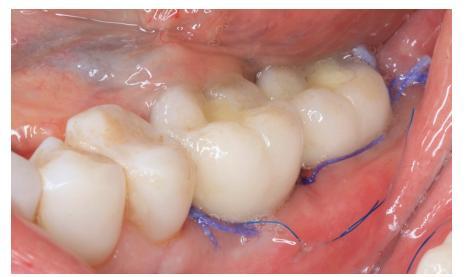
Fig. 21: Ten days later: situation at the followup visit.

Ten days later, the patient returned for a follow-up visit, where we conducted a thorough evaluation of the treatment area. During this visit, the patient's sutures were carefully removed, and a radiograph was taken to assess the progress and healing of the treated area. The patient expressed satisfaction with the outcome, indicating a successful and positive response to the procedure (Fig. 21).

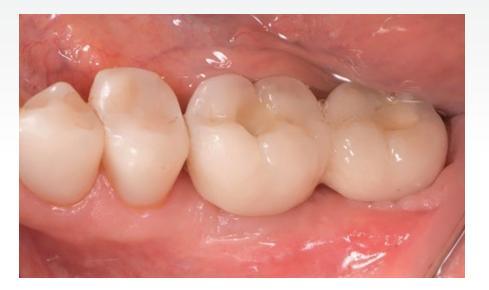
Fig. 22: Clinical situation at the follow-up visit in 2021.

During the follow-up visits in 2021 (Figs. 22,23), 2022 (Fig. 24), and 2023 (Fig. 25), no biological or radiographic

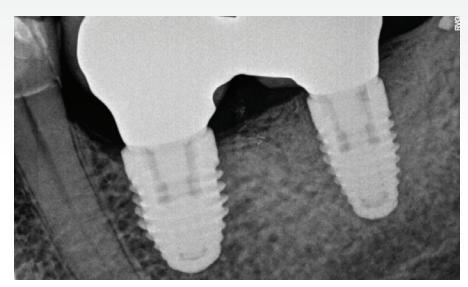
Fig. 23: No radiographic complication at the follow-up visit in 2021.

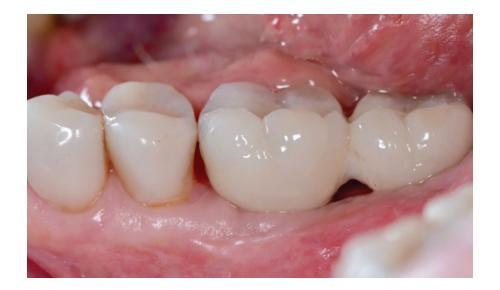
Fig. 24: Stable result at the follow-up visit in 2022.

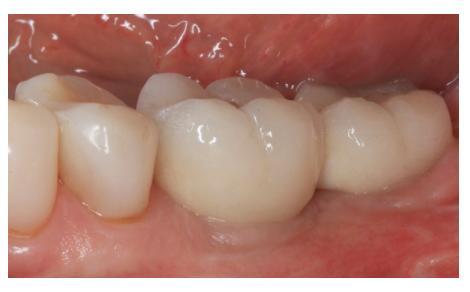
Fig. 25: Stable result at the follow-up visit in 2023, no biological complication noticed.
