Advanced restorative techniques and the full mouth reconstruction: the use of gold copings in bridgework

Paul Tipton¹

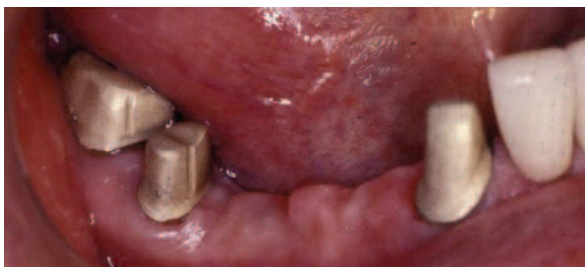
Figure 2: Sandblasted gold copings cemented in place with zinc phosphate.

The gold coping is a thin crown, 0.7mm thick, that is waxed directly onto the dies and usually cast in yellow gold. They are made parallel to each other and can be

sandblasted by the technician for extra retention (Figures 1 to 3) (Newburg, 1978). The margins are polished, however, as they will be exposed in the mouth. These copings are permanently cemented over the remaining abutment teeth with a traditional hard cement, such as zinc phosphate. The long span bridgework is then made in the conventional manner and cemented over the gold copings with a softer cement such as zinc oxide and eugenol such as 'Temp-bond' (Kerr). Should excess stress be transferred to the cement lute then one or more of the soft cement lutes will preferentially fail.

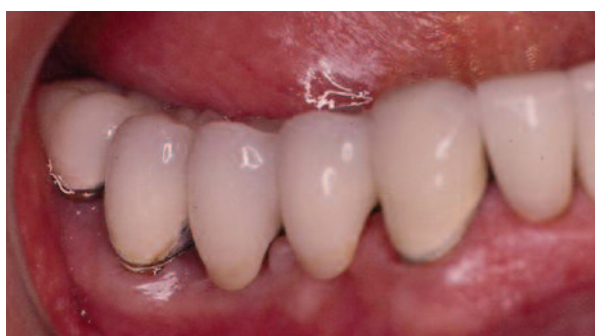
Figure 3: Three-quarter gold crown as a minor retainer in mandible.

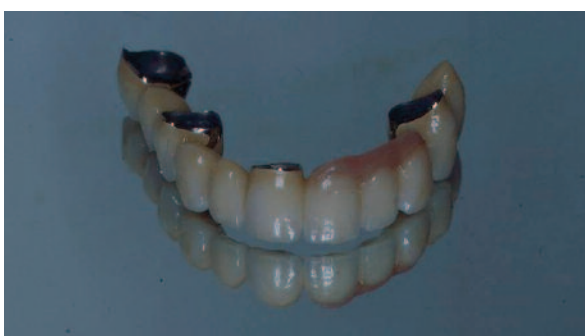
Figure 4: Full arch bridgework.

One or more screws can also be incorporated into the restoration so that when the cement lute fails the bridgework does not fall out of the mouth but is retained by the screws. This gives the patient added confidence in their restoration (Figures 4 to 6) and is especially useful in the upper jaw. Careful preparation techniques are required for this type of retention as the screw could (in certain situations) pull the coping off the tooth, leading to an increased risk of caries.

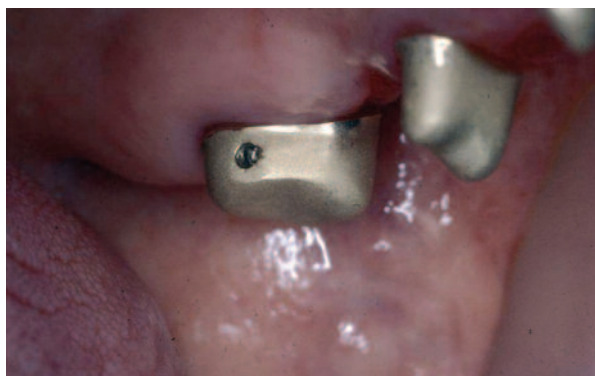
Figure 5: Screw block placed in the posterior gold coping.

The screws are usually placed into the end abutments, which require special tooth preparation. The end abutment is prepared so that it is tilting distally, allowing for a distal path of insertion of the coping. Bridgework usually unseats

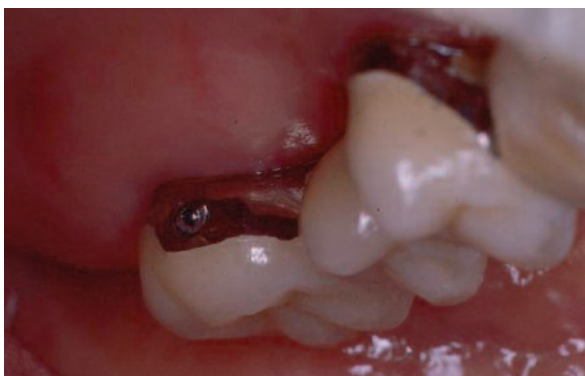
Figure 6: Bridgework screwed into the gold copings.

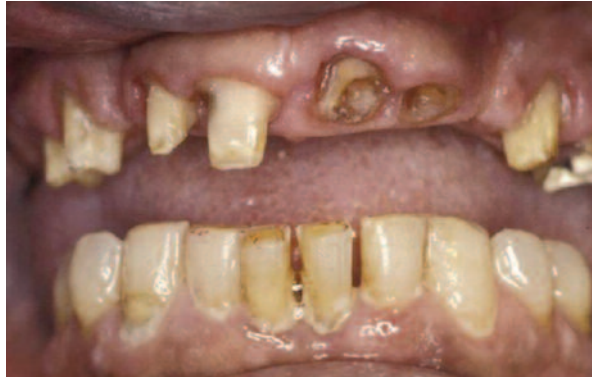
Figure 7: Combined complex perio/endo case.

In this manner, periodontal maintenance is more easily achieved, root fillings and cast posts and cores can be fabricated without drilling through the superstructure and teeth can be removed, roots resected and the bridge modified prior to re-cementation (Figures 7 to 11).

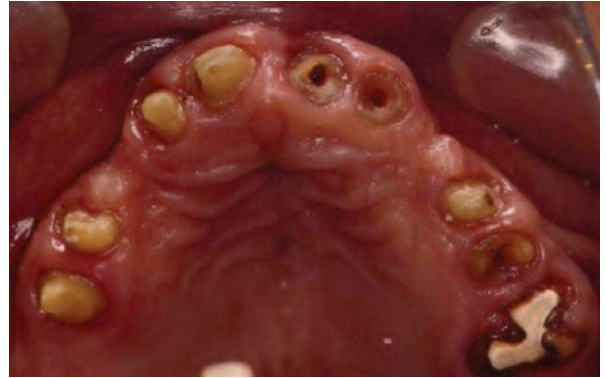
Figure 8: Occlusal view showing remaining compromised abutments.

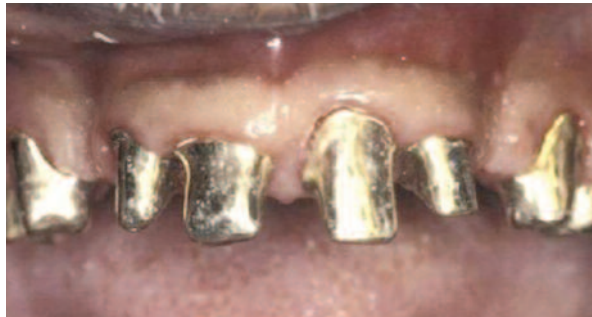
Figure 9: Gold copings cemented in place with zinc phosphate.

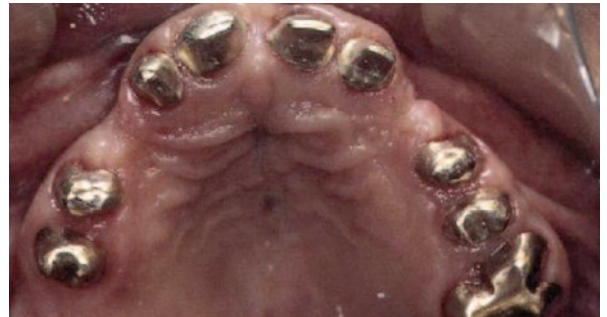
Figure 10: Occlusal view.

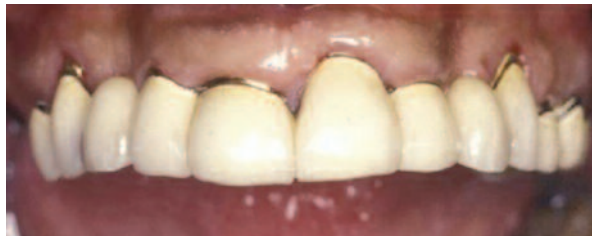
Figure 11: Full arch bridgework cemented onto copings with Temp-bond as long-term provisional prior to definitive implant treatment.

incomplete seal and seat is less detrimental (Faucher, 1983). This type of bridge is often used as an interim prosthesis while implants are placed around the tooth abutments to take the patient from a tooth-supported bridge to an implant-supported bridge without the need for a removable prosthesis.

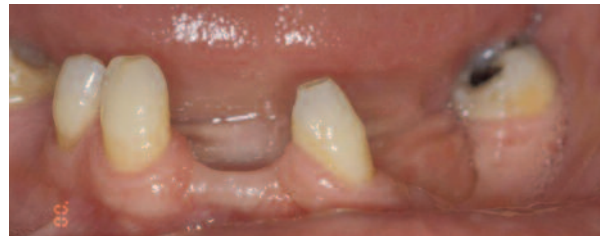
Figure 12: Patient presents with multiple tooth loss.

Aesthetics can be compromised by this type of bridge because – as previously mentioned – extra tooth preparation is required (which may not always be possible) and there are also two finish lines. Although advantageous in an aesthetic restoration (Figures 12 to 23), it may not always be possible to keep both of these metal margins

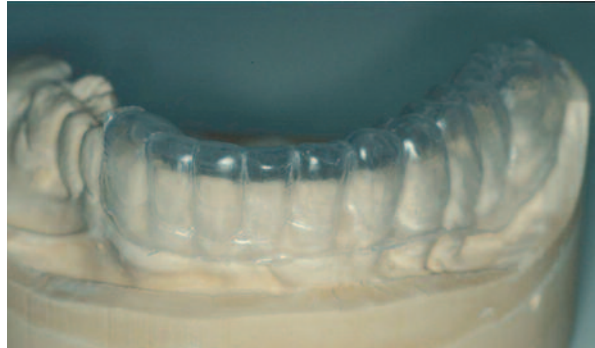
Figure 14: Tooth preparation guide.

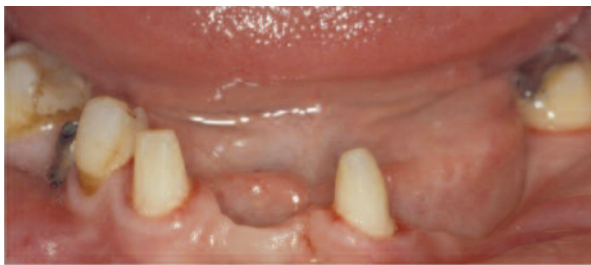
Figure 15: Preparation of the three teeth for the coping bridge.

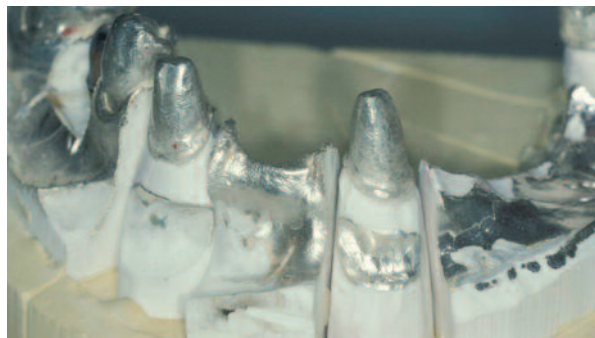
Figure 16: Silver dies anterior view.

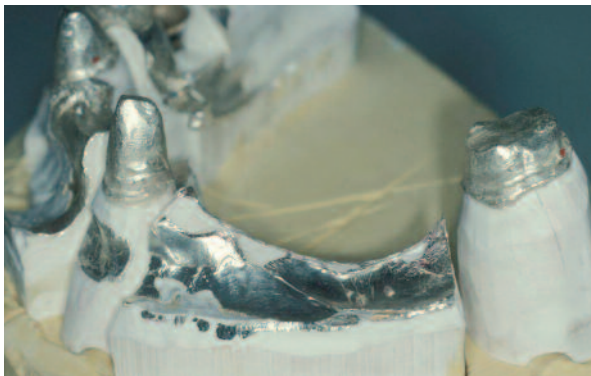
Figure 17: Silver dies left hand side view.

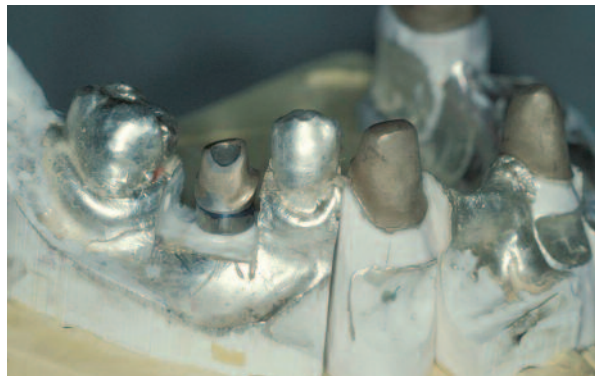
Figure 18: Coping and implant abutments right hand side view.

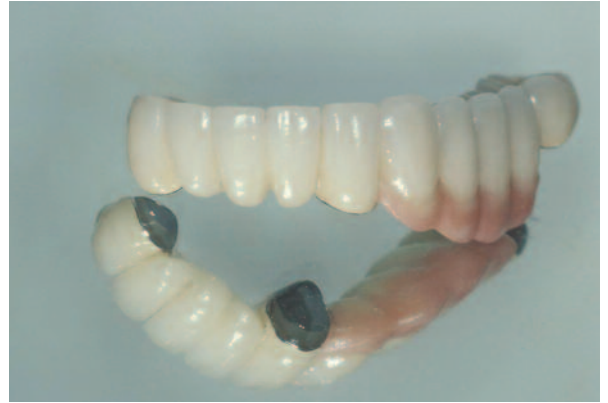
Figure 20: Completed bridge - anterior view.

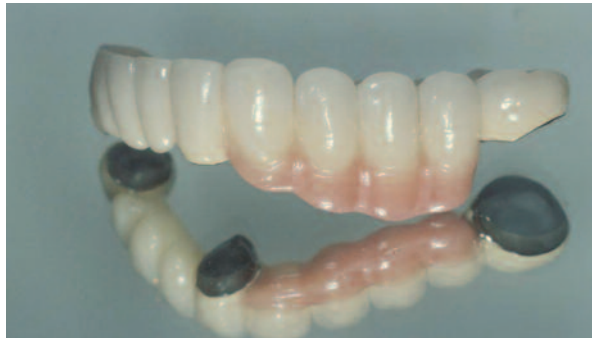
Figure 21: Completed bridge - left hand side view.

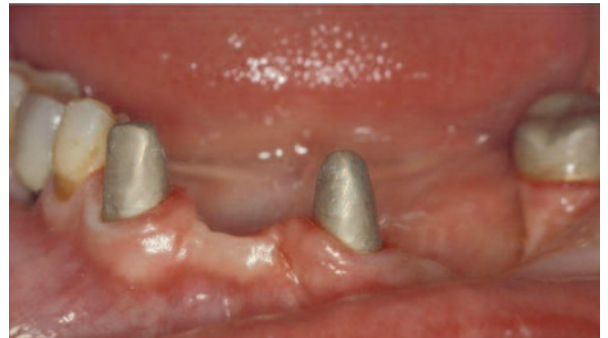
Figure 22: Copings cemented in the mouth - phosphate cement.

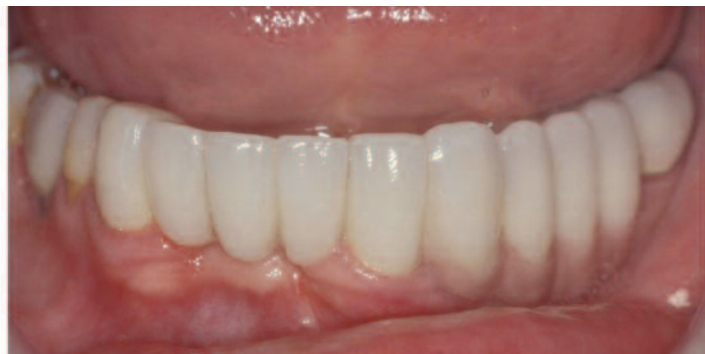
Figure 23: Bridge cemented over the copings with 'soft cement'.
