# A new bioactive cement for direct pulp capping

Till Dammaschke<sup>1</sup>

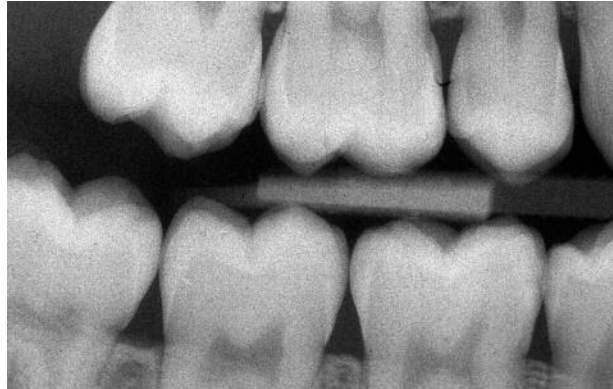
*Figure 1: Bitewing film of quadrants 1 and 4 of a patient aged 18 years at the time. Note the proximal carious lesion on tooth 15 distally. The patient did not show up at the scheduled appointment for filling.*

Four years ago a male patient, then 18 years old, came for a routine check-up. Bitewing films recorded during the diagnostic assessment showed signs of an approximal carious lesion distally on tooth 15 (Figure 1). The patient was informed about the need to have the carious lesion treated, but failed to keep the scheduled appointment. At age 22 he returned, complaining of discomfort of tooth 15 on contact with cold food, drinks and air apparently caused by a buccal enamel fracture of the tooth. On examination, a deep approximal carious lesion was found distally. The tooth was tested positive on CO<sub>2</sub> snow sensitivity and negative on percussion. After thorough information of the patient, an anesthetic (Septanest, 1 ml; Septodont, St. Maur-des-Fossés, France) was injected for terminal anesthesia and a rubber dam was put in place. Following cavity preparation the carious dentin was completely excavated. In the process the pulp cavity was exposed iatrogenically at two sites (Figure 2). Clinically the pulp tissue was vital without any major bleeding, so that maintenance of tooth vitality by direct pulp

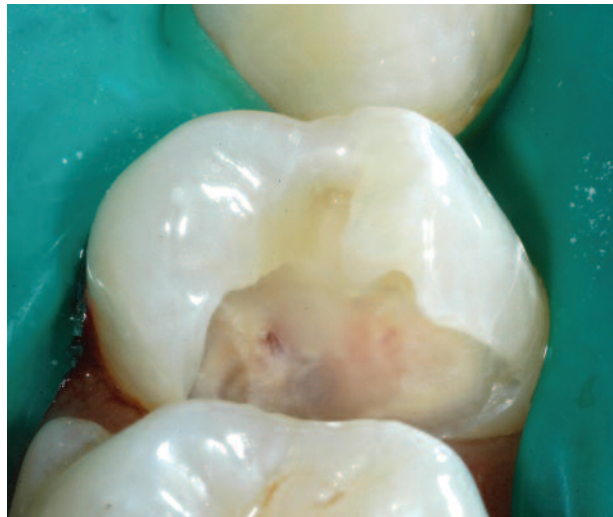
*Figure 2: When the patient returned 4 years later, iatrogenic pulp exposure occurred at two sites during complete caries excavation.*

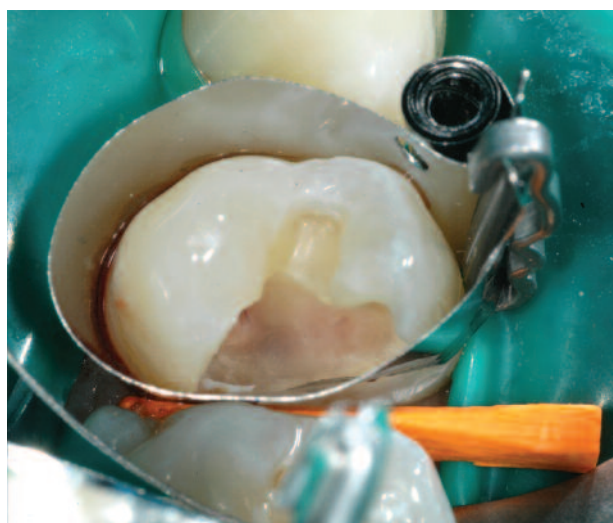
*Figure 3: For filling the cavity and for direct capping with Biodentine™ (Septodont; St. Maur-des-Fossés, France) a matrix band (AutoMatrix; Dentsply-Caulk, Milford, DE, USA) and wedges were put in place.*

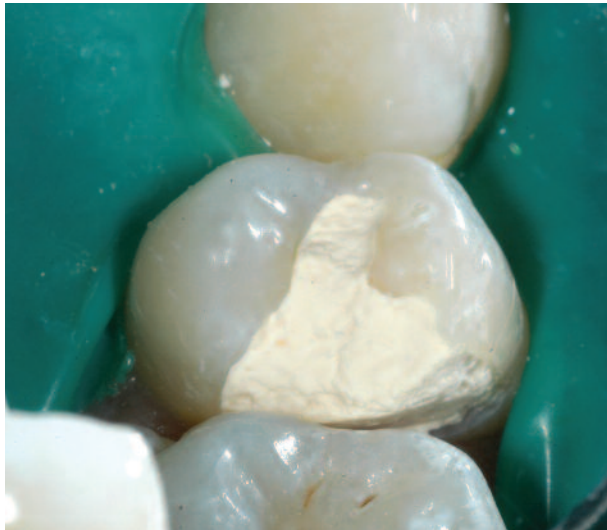
**Figure 4:** Biodentine™ was applied to the cavity with cement pluggers using light pressure. Carving instruments were used for occlusal adjustment. Biodentine™ should not be prepared with rotating instruments and should not come into contact with water.

Of note, Biodentine™ fillings were found to show marginal material loss at the follow-up visit after 3 months. This may be attributable to incorrect handling. During occlusal adjustment, Biodentine™ should not be prepared with rotating instruments and should not come into contact with water. It should rather be applied into the cavity with cement pluggers using light pressure, and carving instruments should be used for occlusal adjustment. Subsequent polishing of the Biodentine™ filling should be omitted. Excessive pressure or exaggerated trimming and polishing may disrupt the crystalline structure of Biodentine™ with resultant loss of material strength.

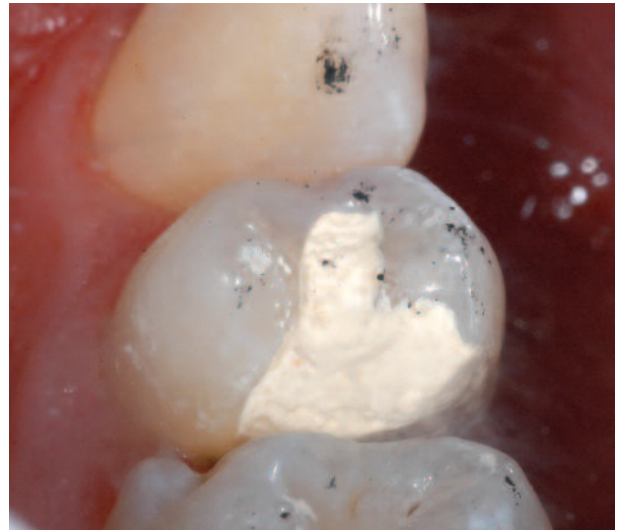
**Figure 5:** After allowing 12 to 15 minutes for Biodentine™ to set the bite was checked. Subsequent polishing of the Biodentine™ filling should be omitted.

capping was decided upon. NaOCl (2.5%) was applied for hemostasis, clearing and disinfecting the cavity. Biodentine™ (Septodont, St. Maur-des-Fossés, France) was chosen for direct pulp capping. Mixed as recommended by the manufacturer, Biodentine™ was applied to the exposed pulp tissue for direct capping and for temporary restoration. After placing a matrix band (AutoMatrix; Dentsply-Caulk, Milford, DE, USA), (Figure 3), the entire cavity was filled with the bioactive cement (Figure 4). About twelve minutes after mixing, when the Biodentine™ had set, occlusion was checked (Figure 5). At the follow-up visit 4 days after direct capping the patient reported some increased cold and warm

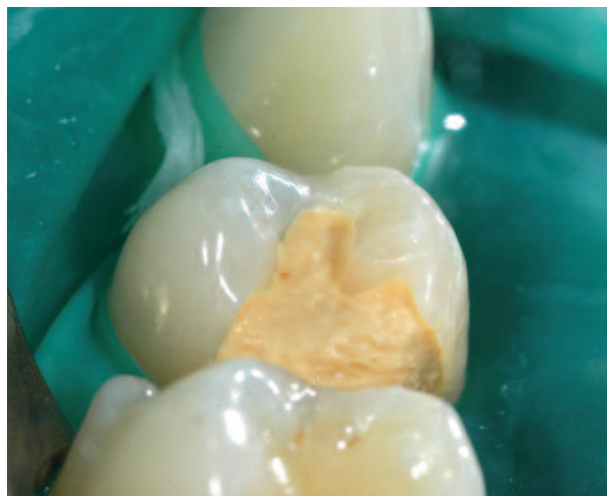
**Figure 6:** Three months later the patient returned to have the cavity definitively filled with composite. At this visit the Biodentine™ filling showed marginal material loss.

Three months after direct capping he returned to have the Biodentine™ filling (Figure 6) partially removed and covered by a composite filling to replace enamel. The symptoms he had originally reported had completely disappeared within a very short time. Tooth 15 was clinically normal and tested positive for sensitivity and negative for percussion. An anesthetic (Septanest, 1 ml; Septodont, St. Maur-des-Fossés, France) was injected for terminal anesthesia and a rubber dam was placed. The Biodentine™ filling was reduced and kept as a base/dentin substitute (Figure 7) and a matrix band as well as wedges (Composi-Tight 3D; Garrison, Spring Lake,

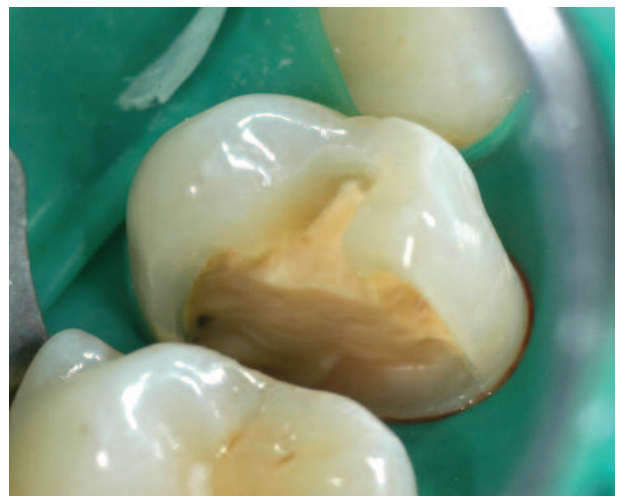
**Figure 7:** Biodentine™ reduced to a base/dentin substitute level.

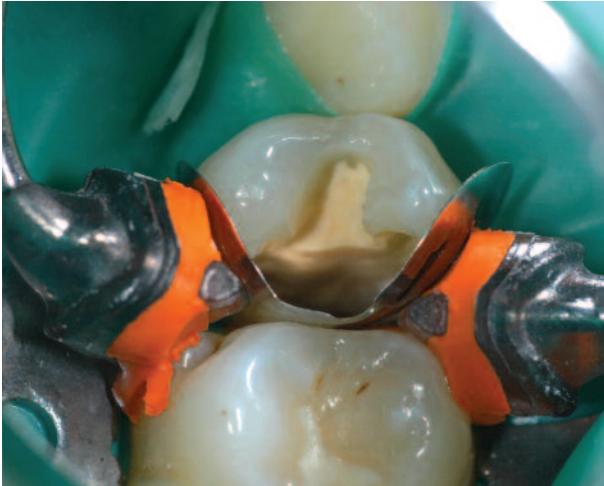
**Figure 8:** Before restoring the cavity with composite a matrix band (Composi-Tight 3D; Garrison, Spring Lake, MI, USA) and wedges were put in place.

MI, USA) were applied (Figure 8). Then the entire cavity was etched with phosphoric acid, and a dentin adhesive (Optibond FL; Kerr, Orange, CA, USA) and a composite (Grandio; VOCO, Cuxhaven, Germany) were applied (Figures 9 and 10). At the follow-up visit 6 months after direct capping, tooth 15 was clinically normal and again tested positive for sensitivity and negative for percussion. The dental film recorded at that time did not show any pathological findings apically (Figure 11).

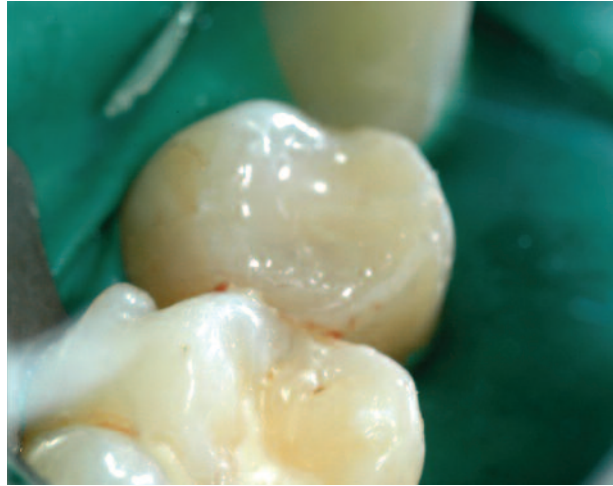
**Figure 9:** Cavity filled with composite (Grandio; VOCO, Cuxhaven, Germany).

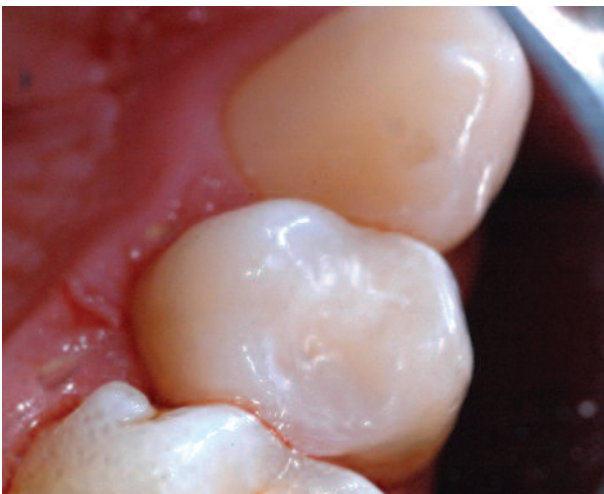
**Figure 10:** Finalized and polished composite filling.

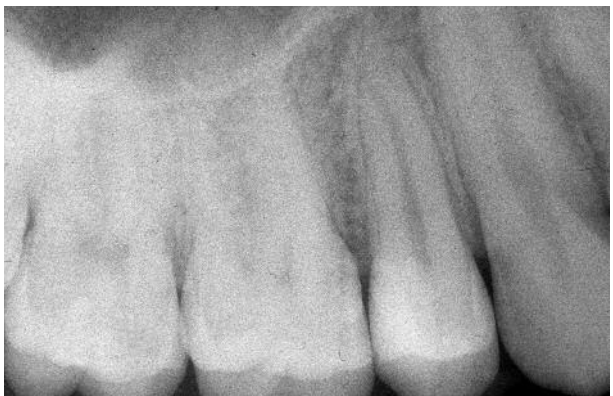
**Figure 11:** The dental film recorded 6 months after direct capping does not show any pathological findings apical of tooth 15.
