Restoration of teeth using lithium disilicate glass-ceramics in a patient with Dentinogenesis Imperfecta

Daniel Edelhoff¹, Oliver Brix² and Josef Schweiger¹

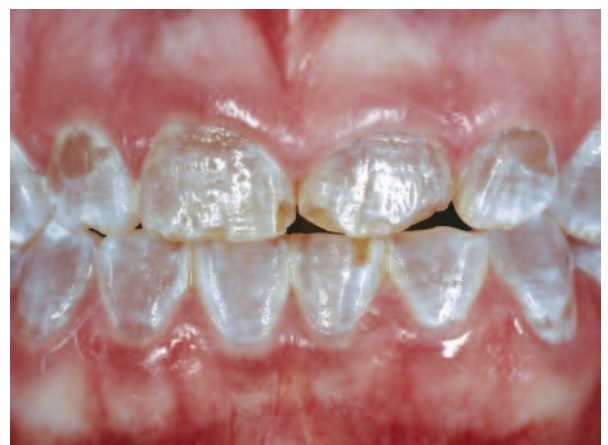
Fig. 1 Preoperative situation: Serious esthetic damage was caused by significant discoloration and unbalanced proportions of dental tissue as a result of the condition known as dentinogenesis imperfecta.

A 16-year-old patient presented to the practice in the company of his parents and expressed the wish to transform the appearance of his severely discoloured and deformed teeth. He reported no pain, but complained about the negative influence that the teeth had on his social life (Figs 1, 2a and 2b). On the basis of the examination and the patient history dentinogenesis imperfecta type II was diagnosed. In many cases, the teeth

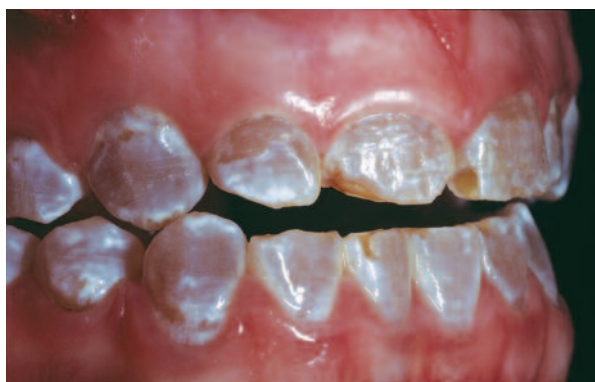
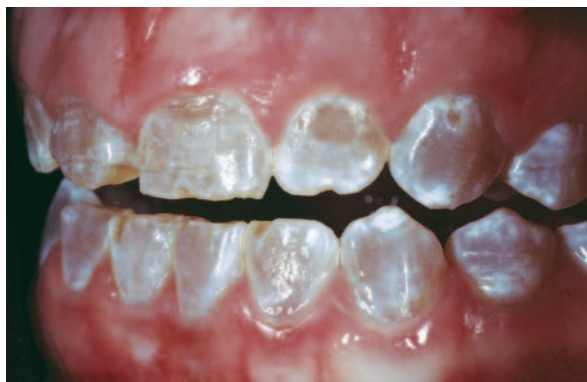
Figs 2a and 2b Preoperative situation: The severe damage of the dentition also affected the function of the teeth.

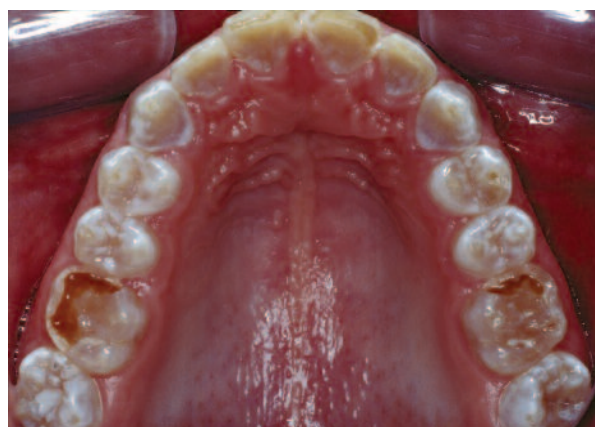
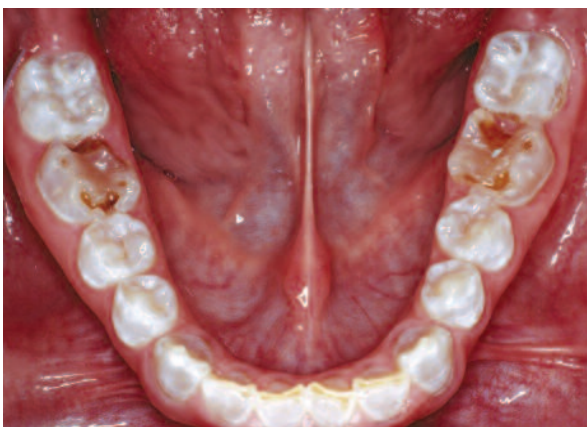
Figs 3a and 3b Preoperative situation: View of the upper and lower jaw. The first molars of both jaws in particular show a high degree of destruction due to enamel cracking.

Before the teeth were permanently treated, fillings were placed in teeth 16, 26, 36 and 46 (Tetric EvoFlow / Ceram, Syntac) (Figs 3a and b). Due to the deformation of the dentin, the bond to dental enamel was considerably impaired in many areas. Against this background and because of the extreme discolouration of the dentin,

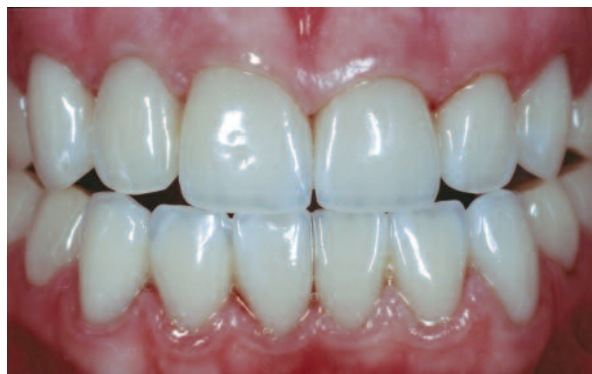
Fig. 4 Long-term temporaries made of high-performance polymers. Long-term temporaries fabricated according to an analytical wax-up using CAD/CAM techniques were splinted in segments (3-4 units) and placed with glass ionomer cement. The long-term temporaries helped the patient quite considerably in evaluating the esthetics and function of the proposed restoration.

The first temporaries were fabricated chairside with the help of the multiple-use diagnostic matrix and a Bis-GMA-based temporary material (C&B Provilink). After the soft tissue had healed sufficiently, precision impressions were taken of both jaws. These impressions together with the facebow and the records of the maxillomandibular relationship were delivered to the dental laboratory. On the basis of the scans of analytical wax-ups, the long-term temporaries were milled from a high-performance polymer using CAD/CAM techniques. Due to the weak retention of the short abutment teeth, the long-term temporary crowns were splinted in segments of 3 to 4 units and cemented with glass ionomer cement (Fig. 4). This approach was taken in order to avoid premature loss of retention due to the short abutment teeth and to ensure adequate density of the long-term temporaries over a period of 12 months in situ. During this time, small tissue adjustments were made and crown 21 was lengthened with minimally invasive surgical methods.

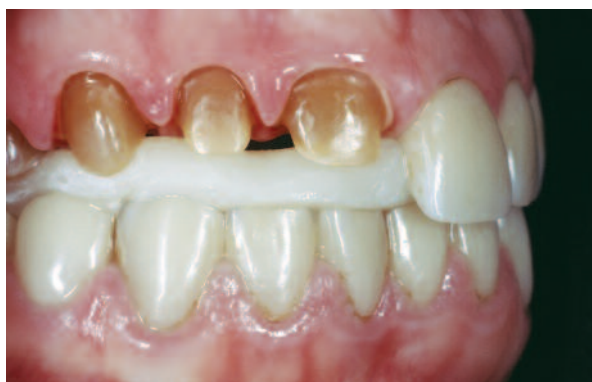
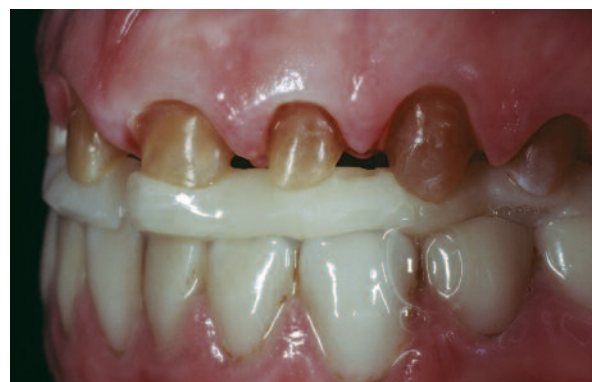
Figs 5a and 5b Determination of the maxillomandibular relationship. The long-term temporaries of one quadrant were removed to fabricate the permanent crowns. The maxillomandibular relationship was determined with a Bis-GMA-based temporary restorative material. This record was subsequently used as a reference for establishing the maxillomandibular relationship in the second quadrant.

After the smooth evaluation phase of the long-term temporaries, the permanent restorations were introduced. In a first step, the permanent maxillary restorations were fabricated. For this purpose, the temporaries in one half of the jaw were removed, the prepared teeth were finished and the maxillomandibular relationship was determined with a Bis-GMA-based provisional restorative (C&B Provilink) (Fig. 5a). This record subsequently served as the

reference for the determination of the maxillomandibular relationship in the second quadrant (Fig. 5b). Next, precision impressions were taken for the fabrication of the permanent glass-ceramic crown units. During the period up to the incorporation of the permanent crowns, chairside-fabricated temporaries were used. After the placement of the glass-ceramic CAD/CAM restorations in the upper jaw, the single-tooth restorations were accordingly placed in the lower jaw (Figs 6a, 6b and 6c).

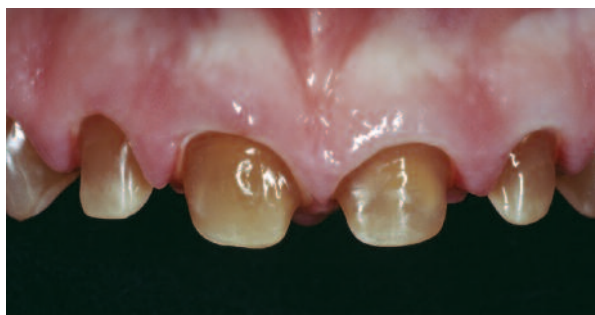
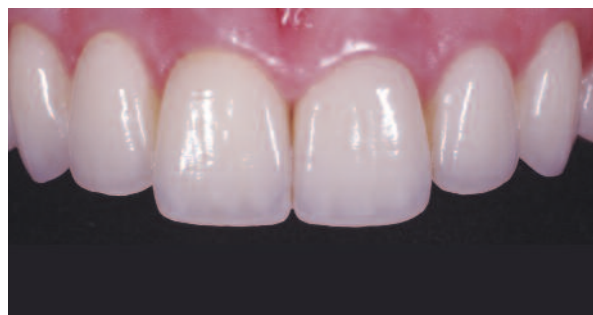
Figs 6a and 6b. Seating of the anterior teeth made of lithium disilicate ceramic.

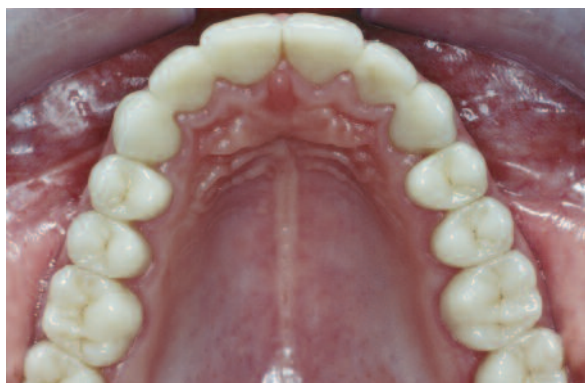
Fig. 7a View of the IPS e.max Press restorations in the upper jaw after adhesive cementation. Due to the very short abutment teeth, the anterior restorations were splinted in units of three. The posterior teeth were splinted in units of two.

In preparation for the permanent placement of the restorations, the inner surfaces of the glass-ceramic restorations were etched with hydrofluoric acid gel (< 5% IPS Ceramic Etching Gel) for 20 seconds and subsequently silanized (Monobond-S). Subsequently, the dentin adhesive system Syntac was applied to the prepared teeth. The restorations were cemented with the Variolink II system (dual-curing, low-viscosity, shade Base A1/110). The material was permanently cured with a high-performance polymerization light (bluephase G2 with > 1000 mW/cm²) (Figs 7a and 7b, 8).

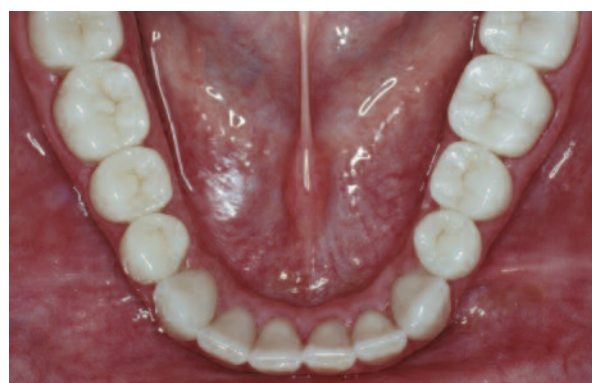
Fig. 7b View of the IPS e.max Press restorations in the lower jaw after adhesive cementation. The crowns did not have to be splinted in the lower jaw. Single-tooth restorations were used exclusively.

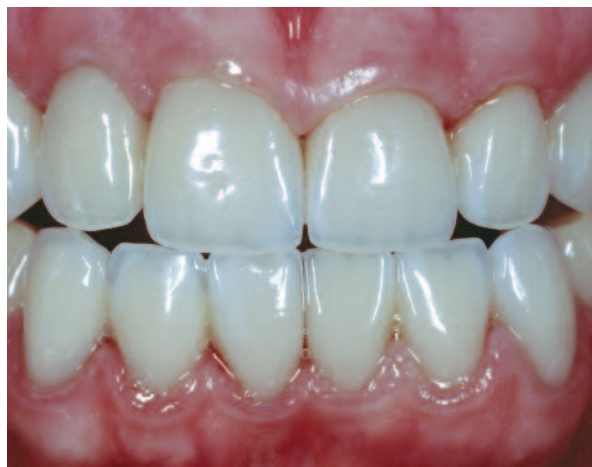
Fig. 8 Postoperative situation. Dynamic occlusion after the placement of the permanent restorations. The dimensions of the upper anterior teeth now correspond to the young age of the patient.

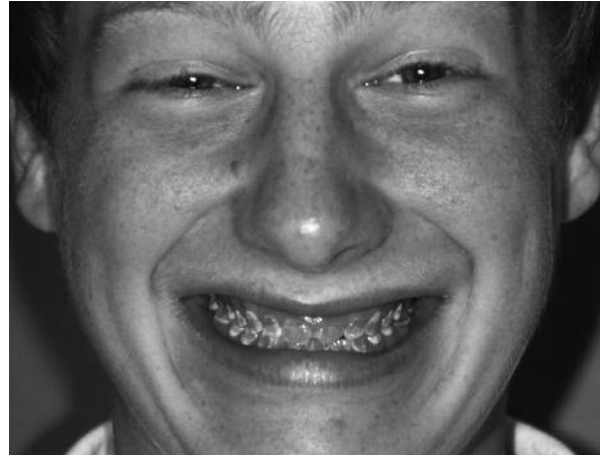
9a: At the beginning of the treatment, the 16-year-old patient hardly had a reason to smile due to his dental anomalies.

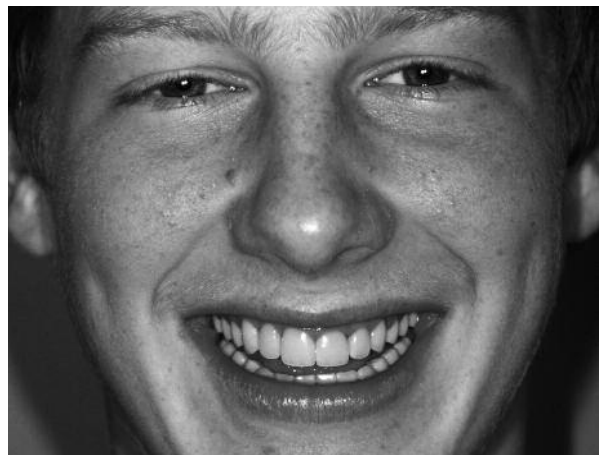
9b: A considerable improvement compared with the preoperative situation was achieved with the provisionals created with CAD/CAM techniques according to the analytical wax-up.

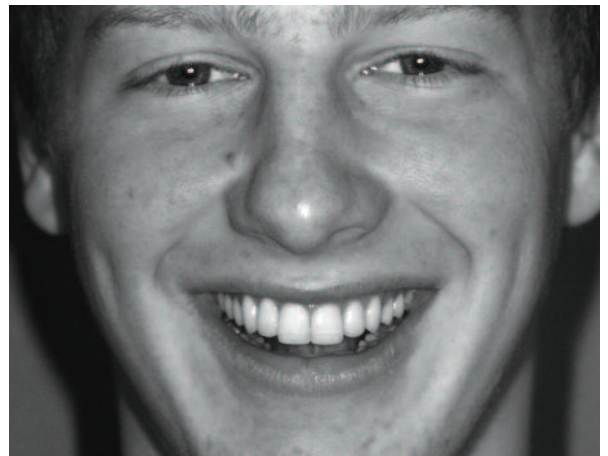
9c: Situation after the placement of the 28 crowns made of IPS e.max Press. The stained teeth have been successfully masked and an esthetic and functionally effective result has been achieved.

was delighted with the result in terms of both esthetics and function (Figs 9a to 9c).
