A skilful combination of CAD/CAM and manual work

Aiham Farah¹ and Anas Aloum²

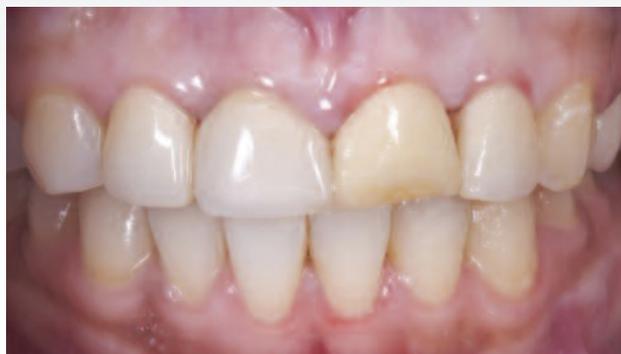
Figure 2: Preoperative oral situation with periodontitis, discoloured restorations and devitalized teeth. Inadequate esthetic characteristics of the individual teeth and inharmonious smile line.

A 29-year-old female patient consulted the practice with the wish to have a natural beautiful smile. She was dissatisfied with her upper anterior restorations and the appearance of the surrounding soft tissue. She wished for a functional and esthetic solution (Fig. 1). Photographs of the oral situation were taken during medical history-taking and the patient's expectations were discussed. The intraoral examination revealed severe discolouration, devitalized teeth and poor esthetics. In addition to an inappropriate shade, the upper anterior crowns and veneers were out of proportion, causing an inharmonious smile line (Fig. 2). An X-ray confirmed the suspicion that the endodontic fillings on the two central incisors were defective. The lateral incisors had been repaired with large composite restorations. Due to the inadequate contouring of the underlying composite, the patient showed clear signs of periodontitis in the area of all four anterior teeth.

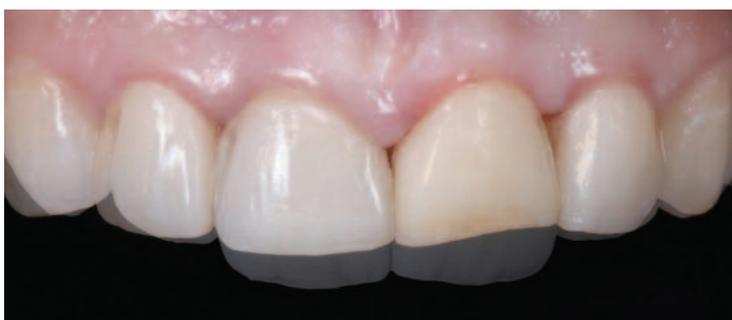
Figure 3: Smile design with newly proportioned length and width of the incisors in line with the digital smile design concept.

An impression of the situation was taken. The study model provided a physical reference that was used to mark the relevant lines and planes, align the longitudinal axes, adjust the lengths and implement cosmetic optimizations in line with the digital design concept (Fig. 3). A diagnostic wax-up was created. Then, a silicone key was produced from the wax-up for the fabrication of the temporaries. The silicone key also served as a guide in the preparation of the teeth.

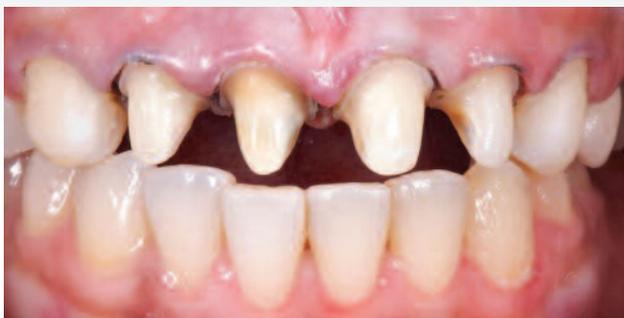
Figures 4: Crown preparations of central and lateral incisors and veneer preparation of both canines.

The existing restorations on the upper anterior teeth were removed. Teeth UR2 to UL2 were prepared with a rounded shoulder of 1 to 1.2 mm and equigingival margins, according to the preparation guidelines for all-ceramic crowns. The depth varied slightly due to the shade of the preparation and degree of discoloration. The dark discoloration on the dentin of the right central incisor required a deeper preparation in order to be able to mask the shade of the remaining tooth structure (Fig. 4). Teeth UL3 and UR3 were prepared for veneer placement with an equigingival chamfer, 0.5-mm buccal reduction and 1-mm incisal reduction (Fig. 5). An impression of the resulting situation was taken using A-silicone and then direct temporaries were created with the help of the silicone key (Fig. 6). The periodontal situation was monitored over the following two weeks. Gingival healing was uneventful. The temporary restorations allowed the final result to be visualized. At this stage, intraoral adjustments could be made to achieve a harmonious symbiosis between the lips, smile and face.

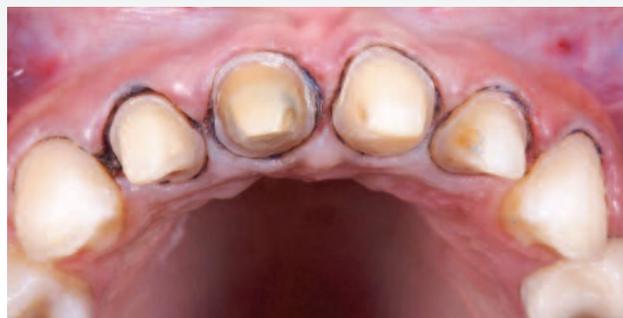
Figures 5: A deeper preparation was required in the buccal area of the upper central incisor on the right because of the pronounced dark discoloration present in that area compared with the neighbouring tooth.

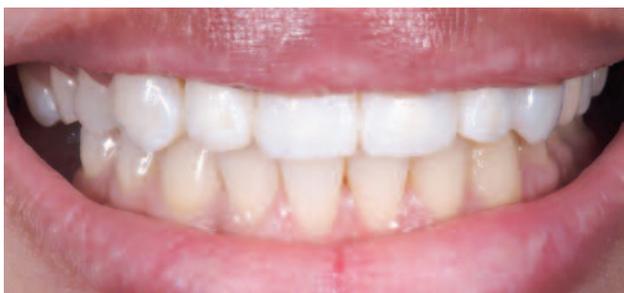
Figures 6: Direct temporaries created on the basis of the smile design wax-up.

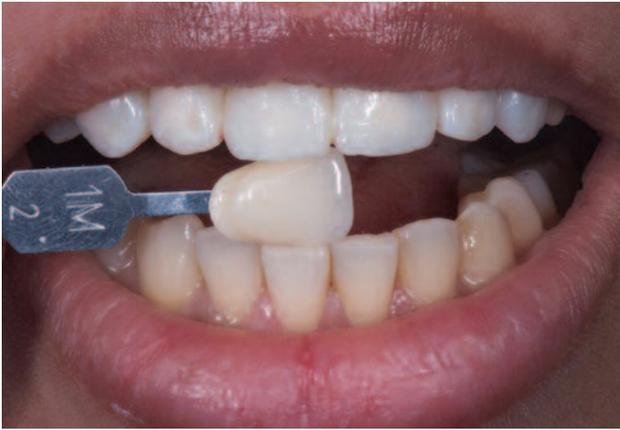
Figures 7a: Determining the shade of the lower teeth.

The desired tooth shade and the existing shade of the tooth preparations were determined under daylight conditions. When photos of the teeth were taken, darker and lighter shade tabs were held against the natural teeth, the flash was turned off and all photos were taken from a similar angle. These photos were also very helpful in the fabrication of the restorations in the laboratory (Figs 7a and b).

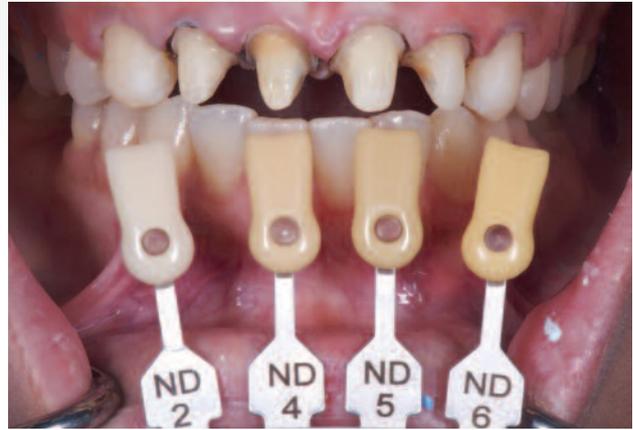
Figures 7b: Selecting the shade of the tooth preparations using the IPS Natural Die Material shade guide.

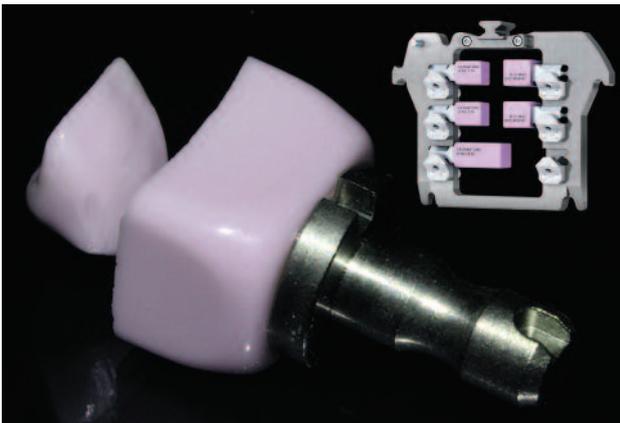
Figures 8: Lithium disilicate block (IPS e.max CAD) in the blue intermediate crystalline stage on the e.matrix holder (for the Zenotec select milling machine) ready for wet machining.

The restorations were designed in the software in line with the proportions previously established and then ground from IPS e.max CAD blocks using a Zenotec select hybrid CAD/CAM machine (Fig. 8). The IPS e.max blocks were processed in their crystalline intermediate stage ("blue" phase), which is optimally coordinated with the grinding process, providing highly accurate results. Subsequently, the restorations were crystallized in a conventional ceramic furnace, in the course of which they acquired their final material properties (e.g. shade). Once crystallized, the strength of the material increases up to 530 MPa (mean biaxial strength). IPS e.max CAD blocks are available in different translucency levels, ranging from medium opaque to highly translucent (MO, LT, MT, HT), and in two opalescent shades. The material can be used to create frameworks for veneering or to fabricate monolithic restorations (e.g. veneers, inlays, crowns and three-unit bridges). It is also indicated for hybrid abutment restorations. IPS e.max CAD is suitable for an unrivalled wide range of indications for CAD/CAM glass-ceramics. It is even suited for minimally invasive restorations such as thin veneers (0.4 mm) and adhesive crowns (1 mm).

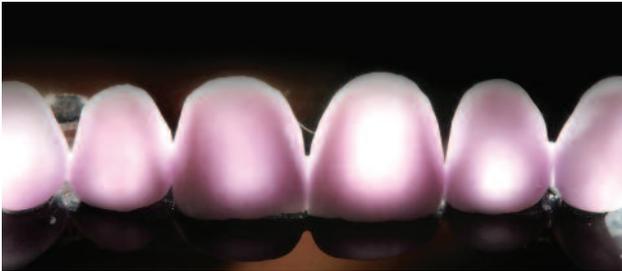
Figures 9: Restorations in transmitted light prior to crystallization (blue stage): note the differences in material thickness.

After the grinding process, a clinical try-in was performed while the restorations were still in their blue intermediate crystalline stage (Figs 9 and 10). The evaluation was carried out with the dentist's specifications and the patient's expectations in mind. In this context, photos of the lips and face of the patient play an essential role for the quality of the technician's work. Adjustments can be applied as required and the photos can be viewed from various angles.

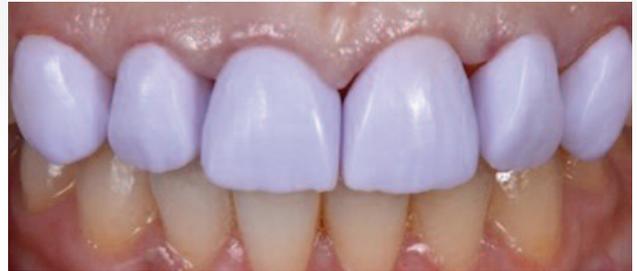
Figures 10: Try-in of the restorations in the blue intermediate crystalline stage.

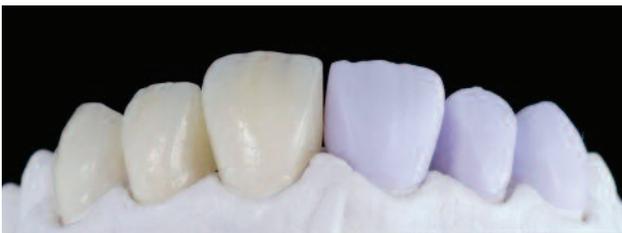
Figures 11: Restorations on the working model: restorations in the blue stage on one side and the result on the other, i.e. tooth-coloured restorations after crystallization and veneering with IPS e.max Ceram.

Following a simple cut-back in the incisal third, a natural-looking transition was created between the layers using the IPS e.max Ceram Mamelon and Opal materials as well as a variety of brighter shades (Fig. 11). After firing, a great deal of care was invested in perfecting the texture, contours and surface characteristics (Fig. 12). At the end, the shade

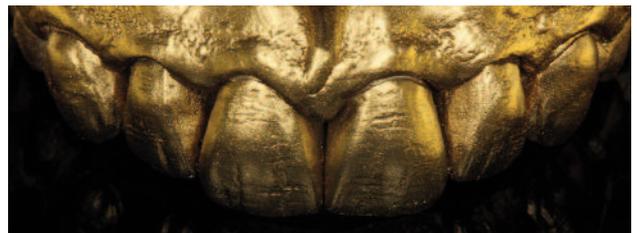
Figures 12: Verifying the contours and microtexture with gold powder.

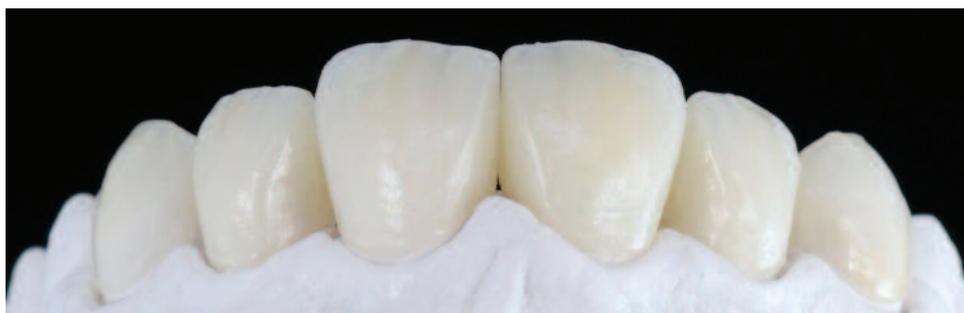
Figures 13: Examination on unsegmented model: closed interdental spaces after Glaze firing and manual polishing.

match was checked on the model dies. A variety of (try-in) materials can be used to adjust the brightness between veneers and crowns at the try-in and subsequent seating of the restorations. In addition, a natural-looking lustre blends in harmoniously with the natural surroundings in the patient's mouth. Glaze firing is therefore an important and critical firing process. It should be the result of the interplay between manual polishing, quality of gloss and the firing parameters (Fig. 13).

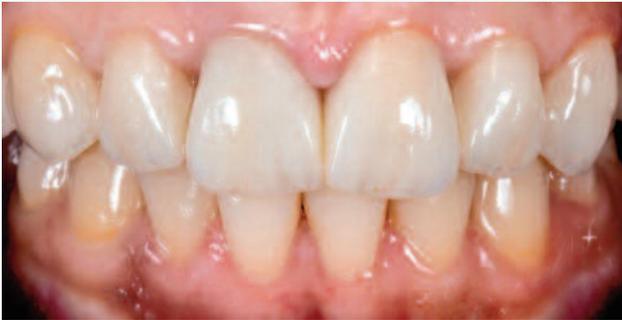
Figures 14: Result after four weeks. Note the soft feminine alignment of the teeth.

Variolink® Esthetic luting composite. This material is ideally suited for the permanent cementation of demanding ceramic restorations. Excess composite was removed with the help of fine diamond burs, rubber finishers and polishers. Occlusal interferences were eliminated. At the first recall, the restorations were inspected and some last modifications implemented (Fig. 14).

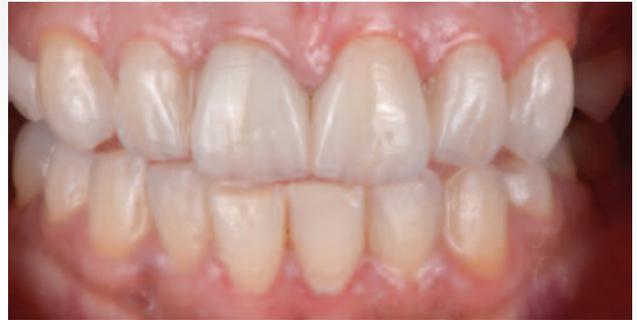
Figures 15: Restorations after six months. The restorations harmonize with the teeth in the lower jaw – the slightly lighter shade was requested by the patient.

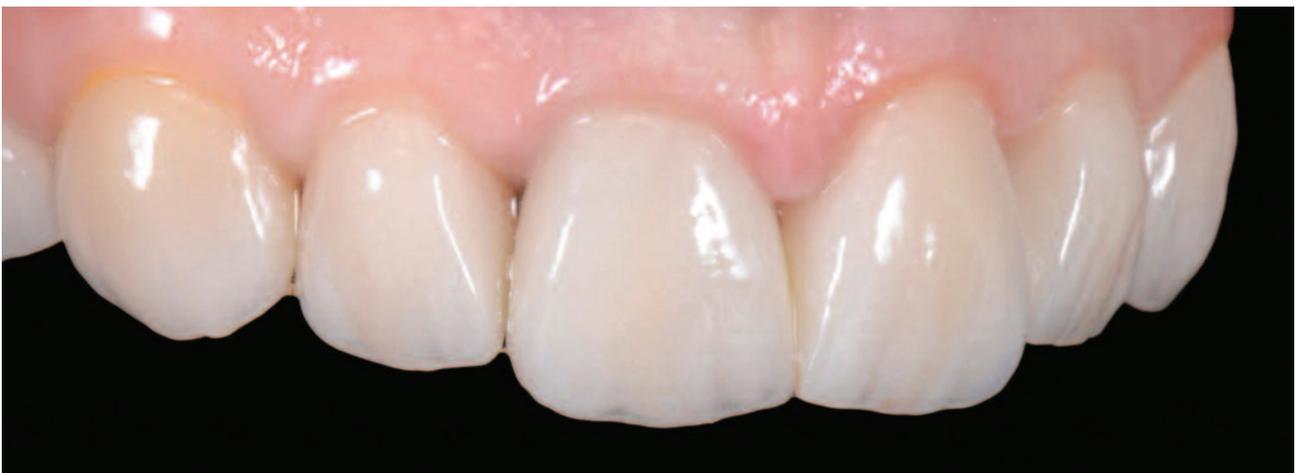
Figures 16: Restorations after 4.5 years: The four crowns and two veneers are durable, their shade has remained stable and the soft tissues surrounding them looks healthy.

for over thirty years. Past experience has shown that the quality and longevity of these restorations depend to a considerable extent on the experience of the treatment team. Modern materials, however, are offering ever more reliability and flexibility. The restorations described in this report were re-inspected after approx. 4.5 years (Figs 15 and 16). They continued to be in very good condition, reflecting the effectiveness of the material and the manufacturing process.
