A skilful combination of CAD/CAM and manual work

Aiham Farah¹ and Anas Aloum²

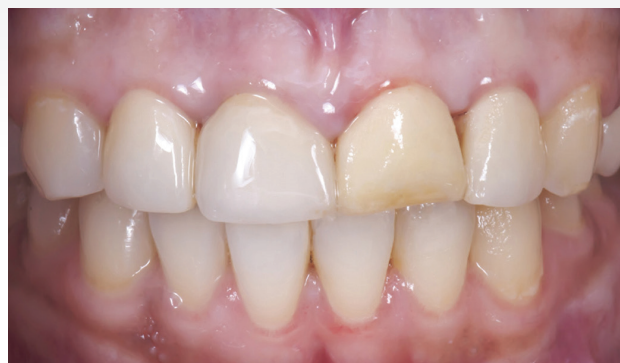
Figure 2: Preoperative oral situation with periodontitis, discoloured restorations and devitalized teeth. Inadequate esthetic characteristics of the individual teeth and inharmonious smile line.

A 29-year-old female patient consulted the practice with the wish to have a natural beautiful smile. She was dissatisfied with her upper anterior restorations and the appearance of the surrounding soft tissue. She wished for a functional and esthetic solution (Fig. 1). Photographs of the oral situation were taken during medical history-taking and the patient's expectations were discussed. The intraoral examination revealed severe discolouration, devitalized teeth and poor esthetics. In addition to an inappropriate shade, the upper anterior crowns and veneers were out of proportion, causing an inharmonious smile line (Fig. 2). An X-ray confirmed the suspicion that the endodontic fillings on the two central incisors were defective. The lateral incisors had been repaired with large composite restorations. Due to the inadequate contouring of the underlying composite, the patient showed clear signs of periodontitis in the area of all four anterior teeth.

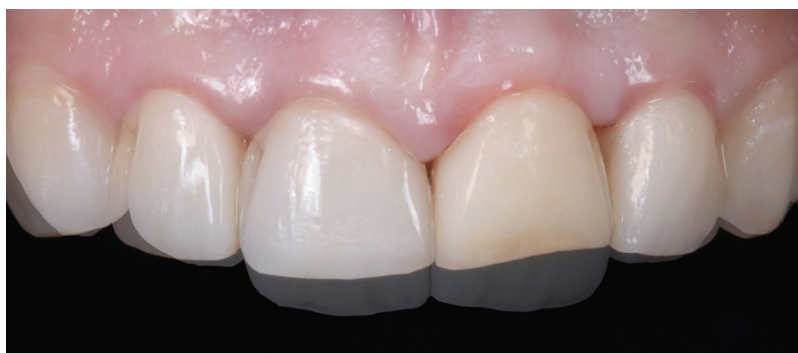
Figure 3: Smile design with newly proportioned length and width of the incisors in line with the digital smile design concept.

design concept (Fig. 3). A diagnostic wax-up was created. Then, a silicone key was produced from the wax-up for the fabrication of the temporaries. The silicone key also served as a guide in the preparation of the teeth.

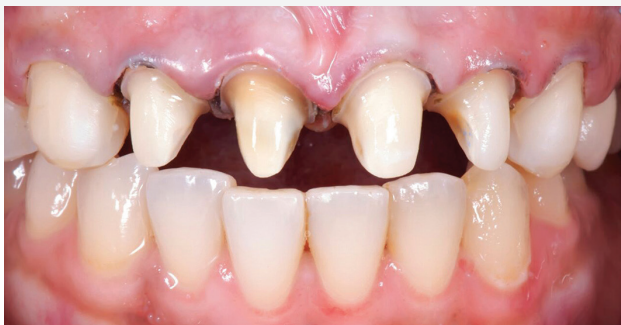
Figures 4: Crown preparations of central and lateral incisors and veneer preparation of both canines.

The existing restorations on the upper anterior teeth were removed. Teeth UR2 to UL2 were prepared with a rounded shoulder of 1 to 1.2 mm and equigingival margins, according to the preparation guidelines for all-ceramic crowns. The depth varied slightly due to the shade of the preparation and degree of discolouration. The dark discolouration on the dentin of the right central incisor required a deeper preparation in order to be able to mask the shade of the remaining tooth structure (Fig. 4). Teeth UL3 and UR3 were prepared for veneer placement with an equigingival chamfer, 0.5-mm buccal reduction and 1-mm incisal reduction (Fig. 5). An impression of the resulting situation was taken using A-silicone and then direct temporaries were created with the help of the silicone key (Fig. 6). The periodontal situation was

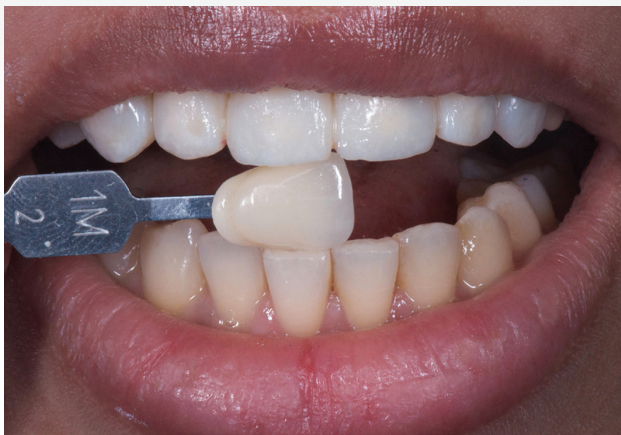
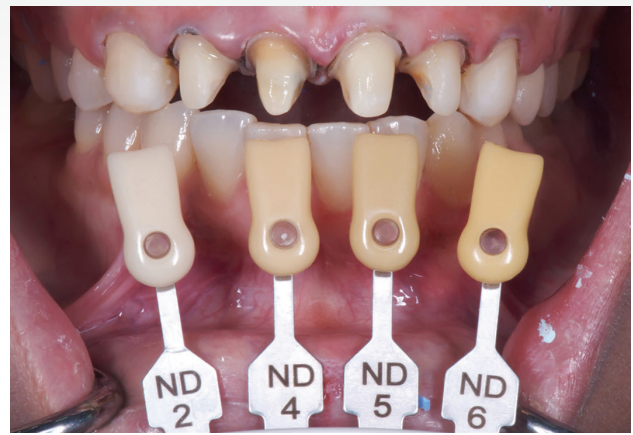
Figures 7a: Determining the shade of the lower teeth.

Figures 7b: Selecting the shade of the tooth preparations using the IPS Natural Die Material shade guide.

The desired tooth shade and the existing shade of the tooth preparations were determined under daylight conditions. When photos of the teeth were taken, darker and lighter shade tabs were held against the natural teeth, the flash was turned off and all photos were taken from a similar angle. These photos were also very helpful in the fabrication of the restorations in the laboratory (Figs 7a and b).

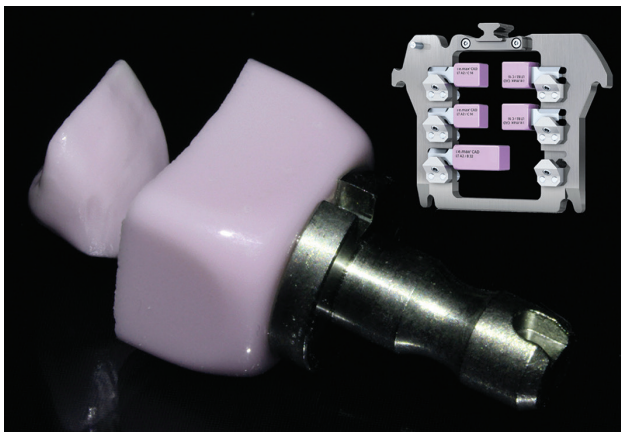
Figures 8: Lithium disilicate block (IPS e.max CAD) in the blue intermediate crystalline stage on the e.matrix holder (for the Zenotec select milling machine) ready for wet machining.

The restorations were designed in the software in line with the proportions previously established and then ground from IPS e.max CAD blocks using a Zenotec select hybrid CAD/CAM machine (Fig. 8). The IPS e.max blocks were processed in their crystalline intermediate stage ("blue" phase), which is optimally coordinated with the grinding process, providing highly accurate results. Subsequently, the restorations were crystallized in a conventional ceramic furnace, in the course of which they acquired their final material properties (e.g. shade). Once crystallized, the strength of the material increases up to 530 MPa (mean biaxial strength). IPS e.max CAD blocks are available in different translucency levels, ranging from medium opaque to highly translucent (MO, LT, MT, HT), and in two opalescent shades. The material can be used to create frameworks for veneering or to fabricate

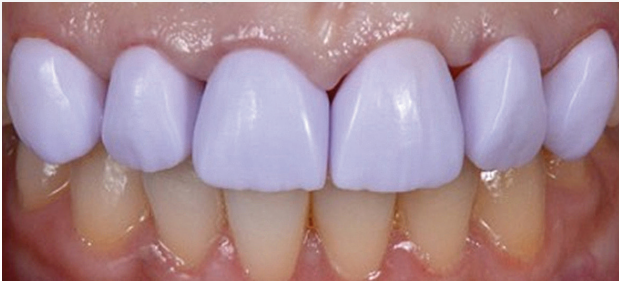
Figures 9: Restorations in transmitted light prior to crystallization (blue stage): note the differences in material thickness.

After the grinding process, a clinical try-in was performed while the restorations were still in their blue intermediate crystalline stage (Figs 9 and 10). The evaluation was carried out with the dentist's specifications and the patient's expectations in mind. In this context, photos of the lips and face of the patient play an essential role for the quality of the technician's work. Adjustments can be applied as required and the photos can be viewed from various angles.

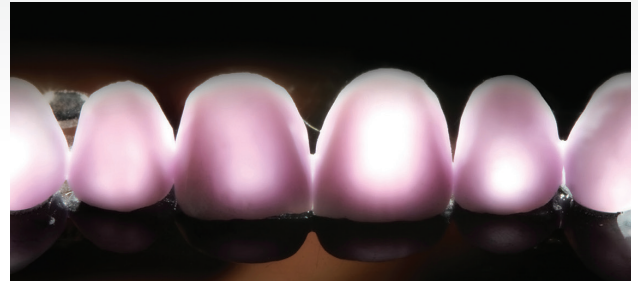
Figures 10: Try-in of the restorations in the blue intermediate crystalline stage.

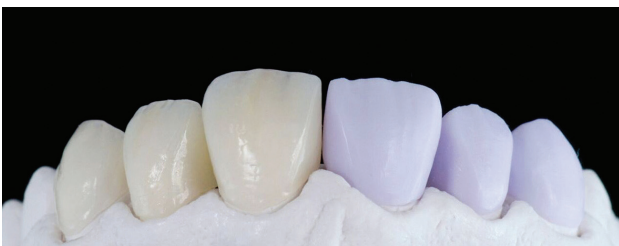
Figures 11: Restorations on the working model: restorations in the blue stage on one side and the result on the other, i.e. tooth-coloured restorations after crystallization and veneering with IPS e.max Ceram.

Following a simple cut-back in the incisal third, a natural-looking transition was created between the layers using the IPS e.max Ceram Mamelon and Opal materials as well as a variety of brighter shades (Fig. 11). After firing, a great deal of care was invested in perfecting the texture, contours and surface characteristics (Fig. 12). At the end, the shade match was checked on the model dies. A variety of (try-in) materials can be used to adjust the brightness between veneers and crowns at the try-in and subsequent seating of the restorations. In addition, a natural-looking lustre

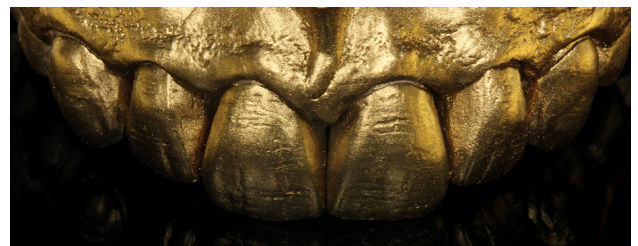
Figures 12: Verifying the contours and microtexture with gold powder.

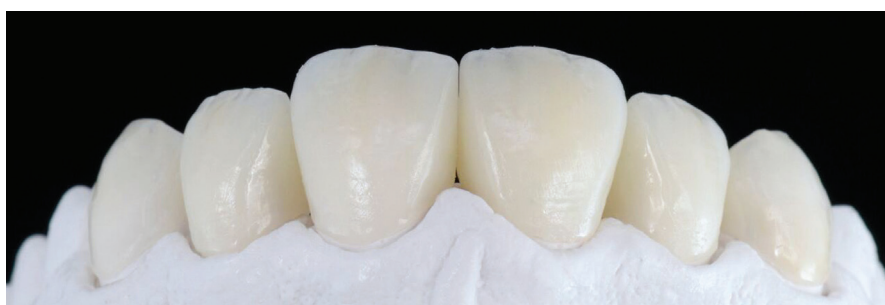
Figures 13: Examination on unsegmented model: closed interdental spaces after Glaze firing and manual polishing.

blends in harmoniously with the natural surroundings in the patient's mouth. Glaze firing is therefore an important and critical firing process. It should be the result of the interplay between manual polishing, quality of gloss and the firing parameters (Fig. 13).

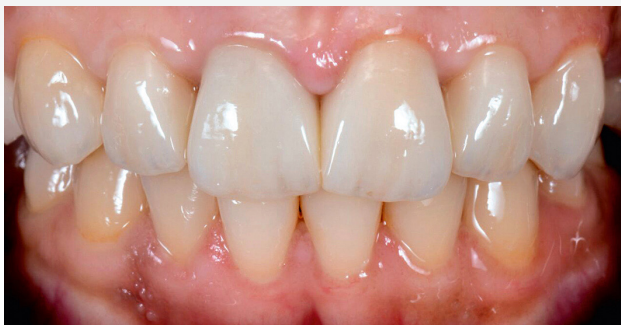
Figures 14: Result after four weeks. Note the soft feminine alignment of the teeth.

The crowns and veneers were placed adhesively using Variolink® Esthetic luting composite. This material is ideally suited for the permanent cementation of demanding ceramic restorations. Excess composite was removed with the help of fine diamond burs, rubber finishers and polishers. Occlusal interferences were eliminated. At the first recall, the restorations were inspected and some last modifications implemented (Fig. 14).

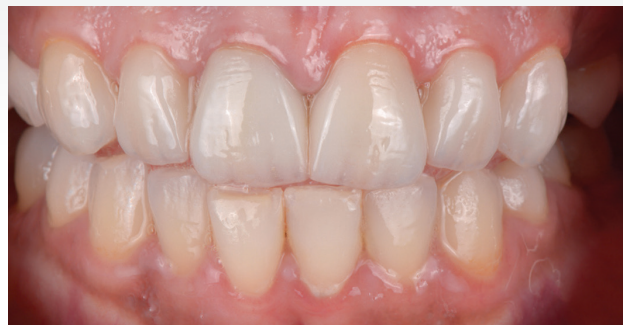
Figures 15: Restorations after six months. The restorations harmonize with the teeth in the lower jaw – the slightly lighter shade was requested by the patient.

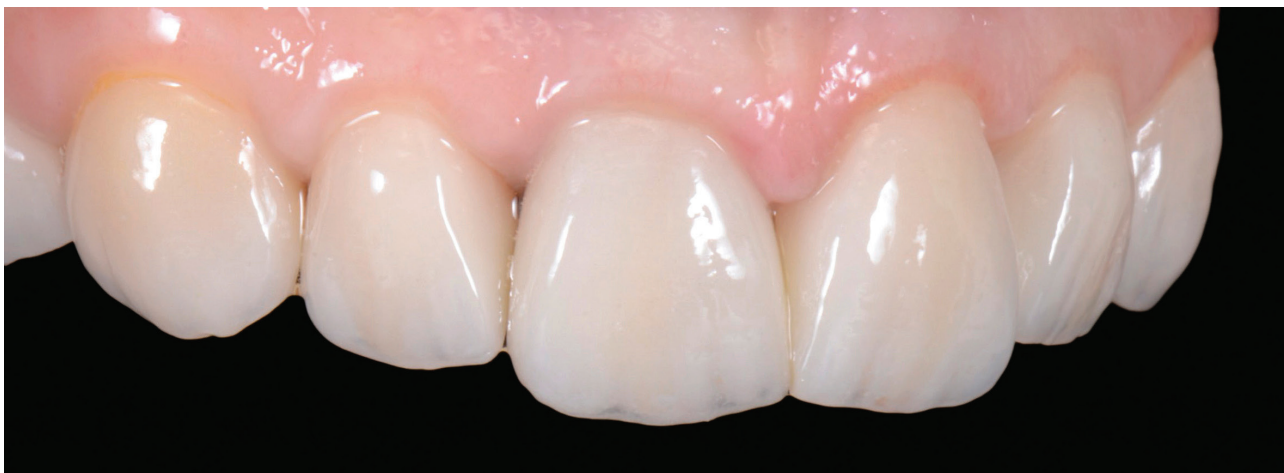
Figures 16: Restorations after 4.5 years: The four crowns and two veneers are durable, their shade has remained stable and the soft tissues surrounding them looks healthy.

Ceramic restorations have been used in cosmetic dentistry for over thirty years. Past experience has shown that the quality and longevity of these restorations depend to a considerable extent on the experience of the treatment team. Modern materials, however, are offering ever more reliability and flexibility. The restorations described in this report were re-inspected after approx. 4.5 years (Figs 15 and 16). They continued to be in very good condition, reflecting the effectiveness of the material and the manufacturing process.
